# Environment Restoration Operations Summary of the Mixed Waste Landfill Borrow Pit Reclamation May - August 2013

Sandia National Laboratories/NM

Subject: Department of Energy/National Nuclear Security Administration, Sandia National Laboratories  
Environmental Restoration Operations, Reclamation of the Mixed Waste Landfill Borrow Pit

**Summary of Mixed Waste Landfill Borrow Pit Reclamation  
May – August 2013**

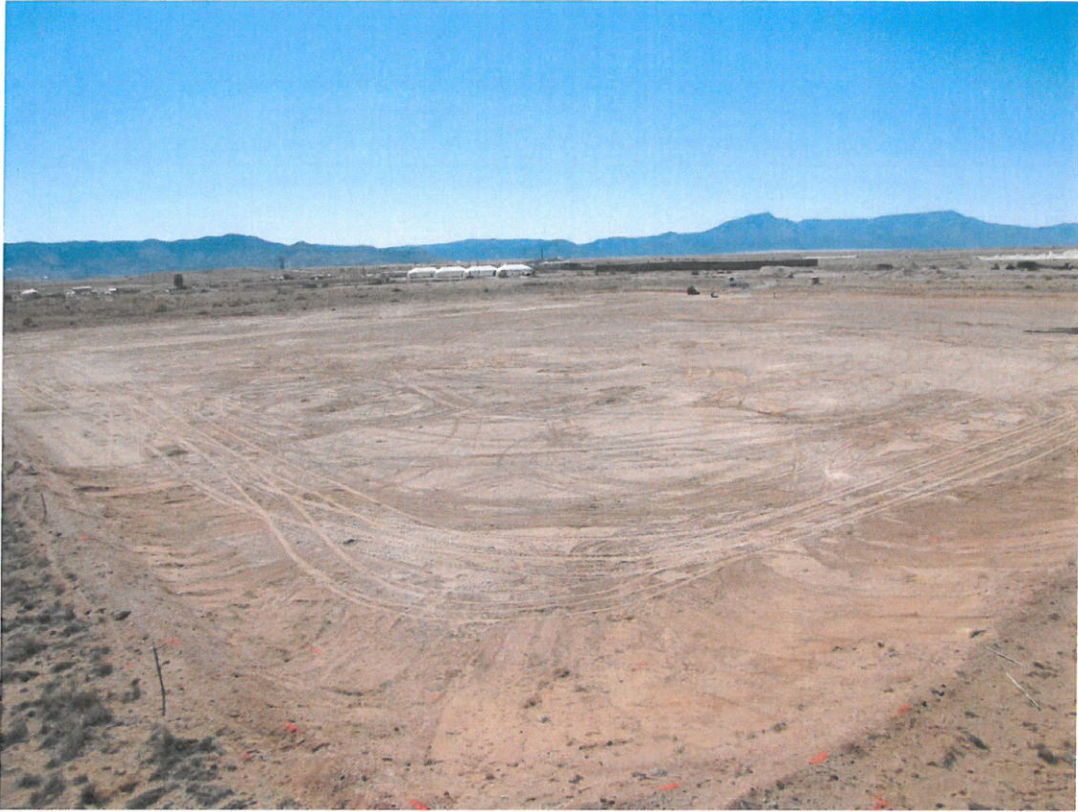
Borrow Pit in May 2013 at the start of the reclamation effort. View from northwest corner to southeast.

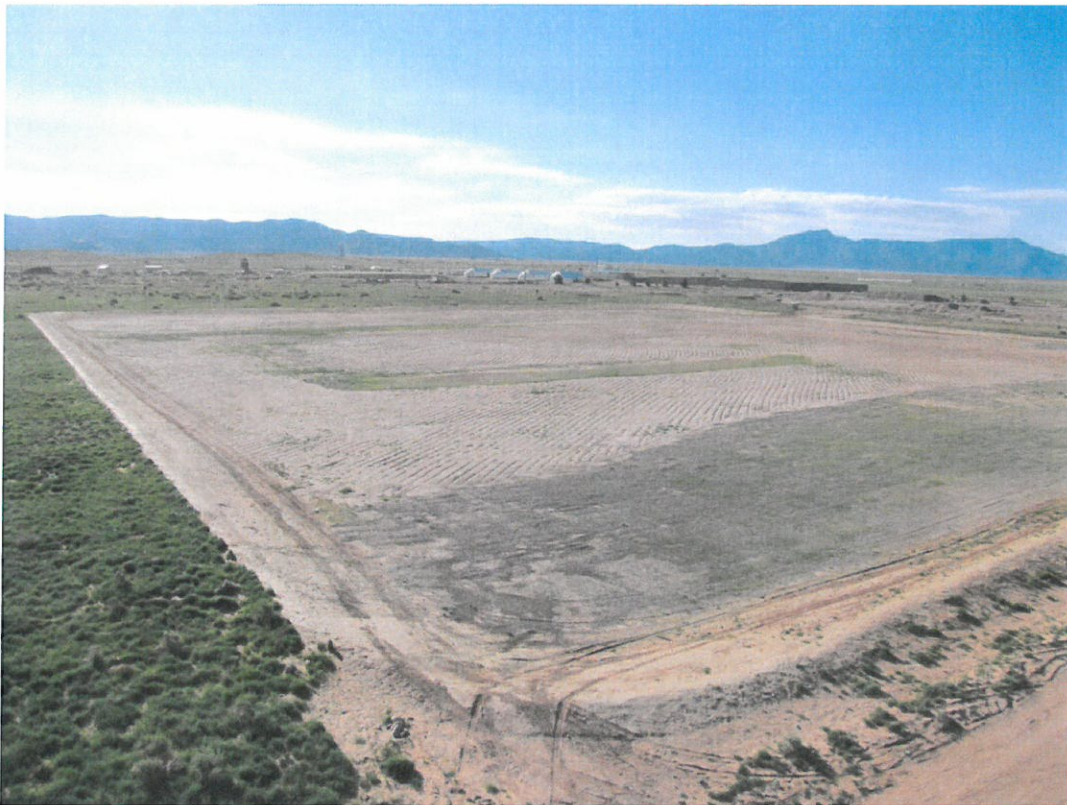
Borrow Pit in August after completion of the reclamation effort. View from northwest corner to southeast.
