# An Epidemiologic Characterization of Motor Vehicle Crashes on, and an Evaluation of Geometric Design Criteria for, U.S. Highway 666, Milepost 92.7 to 93.6, Shiprock, New Mexico

Indian Health Service, Office of Environmental Health.

JS. Peabody

Peabody JS. An epidemiologic characterization of motor vehicle crashes on, and an evaluation of geometric design criteria for, U.S. Highway 666, Milepost 92.7 to 93.6, Shiprock, New Mexico. Indian Health Service, Staff Office of Planning, Evaluation and Research, Rockville, MD 20857 (E-93). 1988

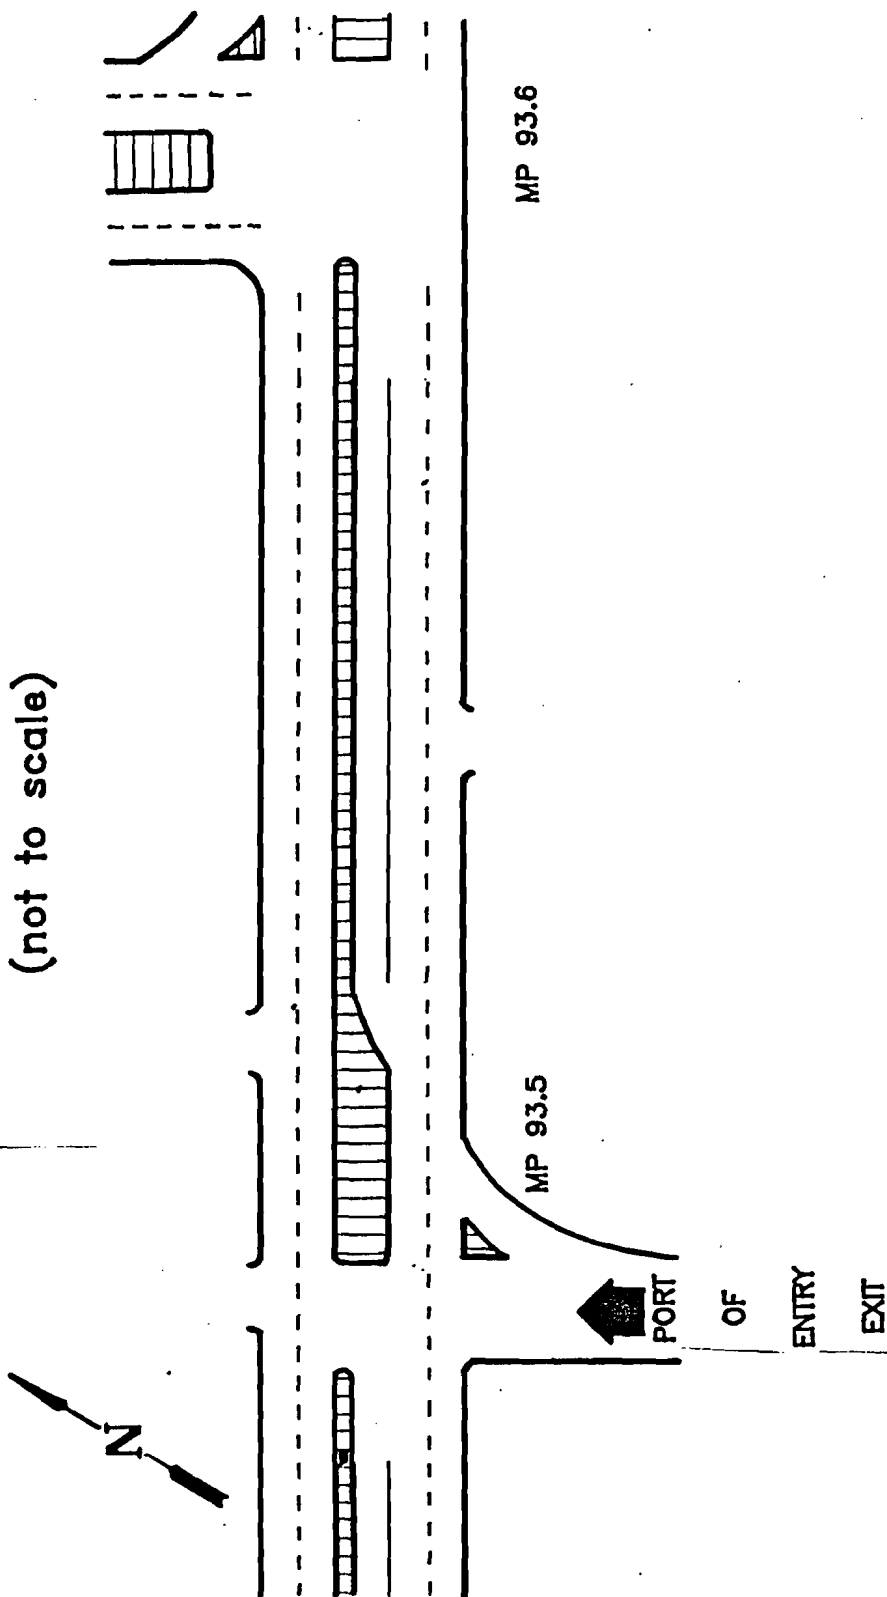
APPENDIX C - Detail Map

Of particular concern are the left turn maneuvers made by the tractor-trailers. As stated in the previous section, the median is not wide enough to allow perpendicular storage of a standard size passenger vehicle, let alone a tractor-trailer. As such, tractor-trailers are required to make a single movement across the north bound traffic lanes, across the median, and into the south bound traffic lane. Potential traffic conflicts due to this type of maneuver are common. In fact, during the study period 5 crashes were specifically attributed to left turns from this port-of-entry exit. Two of these crashes involved tractor-trailers.

Left turn exits by tractor-trailers from the port-of-entry present potential traffic conflicts on a regular basis for traffic in either direction. A tractor-trailer must first cross the two northbound traffic lanes and the median, before making the left turn into the southbound lane. This is not a rapid maneuver. Tractor-trailers making this left turn were timed from the moment they started forward at this exit until the rear of the trailer cleared the inside north bound traffic lane. The average time was 11 seconds. At 40 miles per hour, this crossing time provides a potential conflict zone to north bound traffic for 645 feet upstream from that exit. This is particularly a problem during periods of heavier traffic to drivers who are several vehicles back from the port-of-entry exit. These drivers may not notice the exiting tractor-trailer but suddenly have to contend with the braking vehicle ahead of them. An even more serious problem is occasionally seen, also during periods of heavy traffic. As several tractor-trailers queue up at this exit, the leader, through presumed impatience, will cross to the median and stop until the southbound lanes clear, and then will complete the left turn. During the median stop the north bound traffic lanes are blocked by the trailer.

This port-of-entry exit intersection is less than 550 feet west of the U.S. 666-U.S. 550 intersection. Sight distance beyond this main intersection is hampered. The north leg of the main intersection is visible for some distance to the north of that intersection, but the traffic signal phase must also be evaluated to determine if that approaching traffic will affect the left turn maneuver from the port-of-entry exit. The east leg of the U.S. 666-U.S. 550 intersection is not readily visible beyond that intersection due to a curve and due to vision interference by traffic signals. The failure to have sufficient sight distance for left turn maneuvers from the port-of-entry exit, particularly for the tractor-trailers, would justify the modification of this intersection.

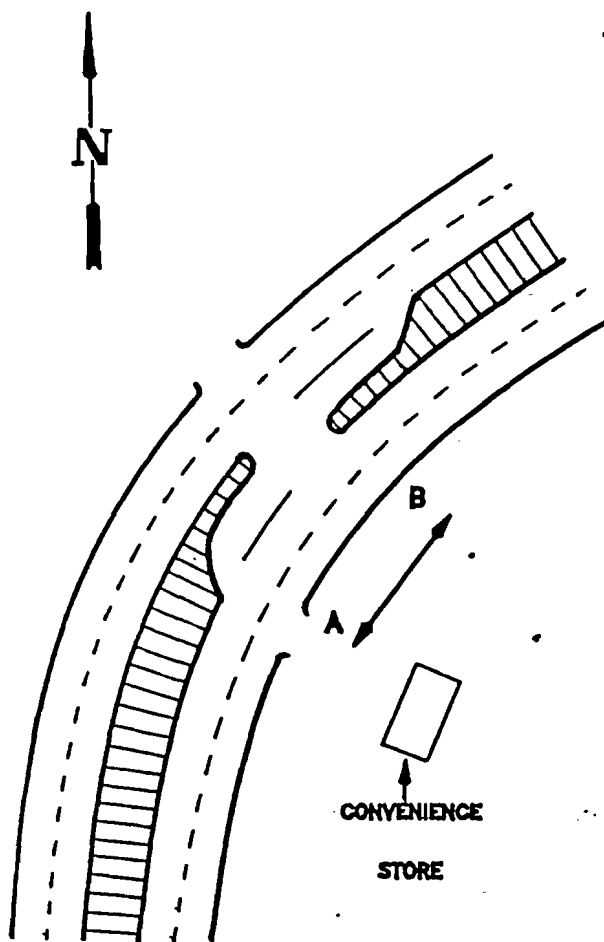
OFF-SET LEFT TURN  
U.S. 666, MP 92.8  
SHIPROCK, NEW MEXICO  
(not to scale)

Left turn lane positioning was of interest because of an off-set left turn lane for southbound traffic near milepost point 92.8. Drivers using this left turn lane for access into the 7-2-11 Convenience Store have to make a long diagonal movement across the northbound traffic lanes to reach the business access. The extent of the off-set from the end of the center median to the nearest side of the business access is 134 feet. This maneuver is not rapid, and the potential for traffic conflicts is considerable. Passenger vehicles performing this maneuver were timed, with an average time calculated. The average time from start of forward movement until the outside north bound traffic lane was cleared by the rear of the vehicle was 6.9 seconds. At 40 miles per hour this provides a potential conflict zone of 405 feet upstream from the business access point in the north bound lane. This potential conflict zone extends around a curve and more than half way to the major intersection (U.S. 666-State 504) at mile post point 92.7. During the two year study period, two crashes were attributed to these long left turns into the 7-2-11 store.

At the long left turn near milepost point 92.8, the median itself is a significant contributor to the problem. A major function of a median is to channel traffic into desired paths or directions. In this case, the median left turn lane for southbound traffic is channeling traffic into an unsafe maneuver.

- DISTANCE FROM POINT A  
TO POINT B = 134 FT.
- AVERAGE TIME TO COMPLETE  
TURN = 6.9 SECONDS.
- POTENTIAL UPSTREAM  
CONFLICT ZONE = 406 FT.
