# Water Resources Assessment of the Rito Peñas Negras

## **Final Report**

**Water Resources Program  
University of New Mexico  
Albuquerque, NM 87131**

**September 2011**

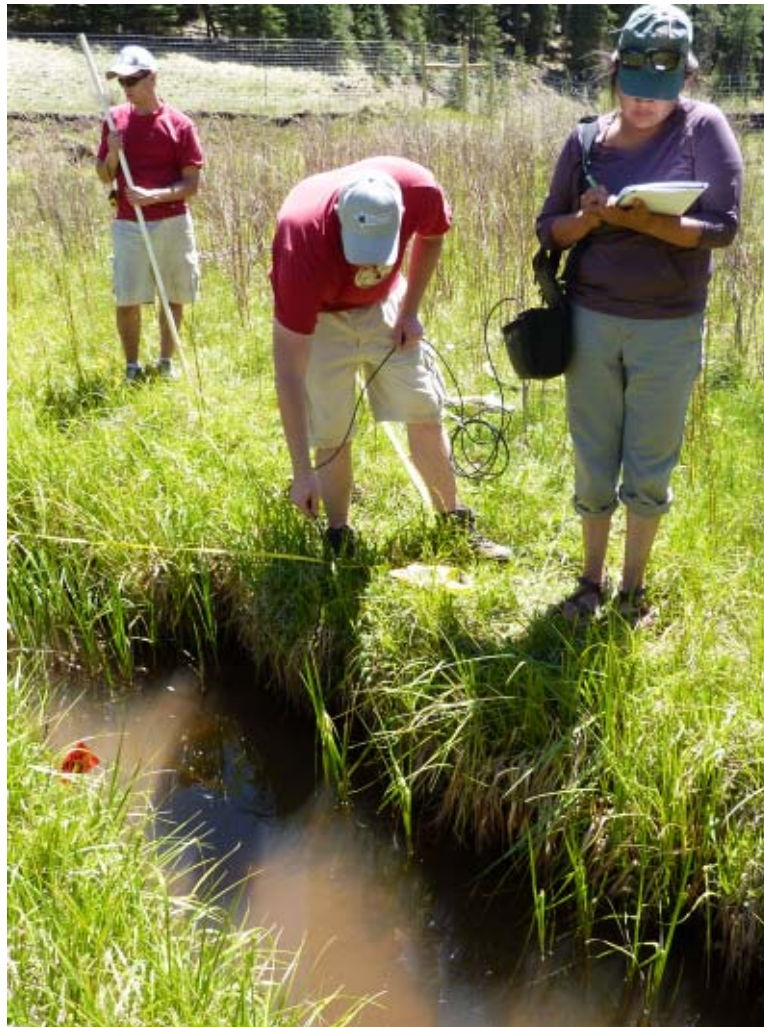
Wide meadows predominate assessment sites RPN0, RPN1 and RPN2, and these sites appear to be characterized by significant stream degradation in which the stream is currently located one to two m below the meadow. The stream gradient is approximately 0.8% based on elevations from USGS topographic maps. The stream channel is incised and shallow throughout this section, with some incisions exceeding two m. With the exception of recently planted trees in the exclosures near RPN 1, no woody riparian vegetation was noted. Unlike the presence of abandoned beaver dams in the 2005 assessment, our assessment did not find any evidence of past beaver activity in RPN 0 or RPN1. Both assessment sites are characterized by a lack of woody riparian vegetation and the presence of cow paths to the stream suggests impacts on stream banks of grazing activities.

Figure 7. Photograph of Rito Peñas Negras at assessment site RPN0.

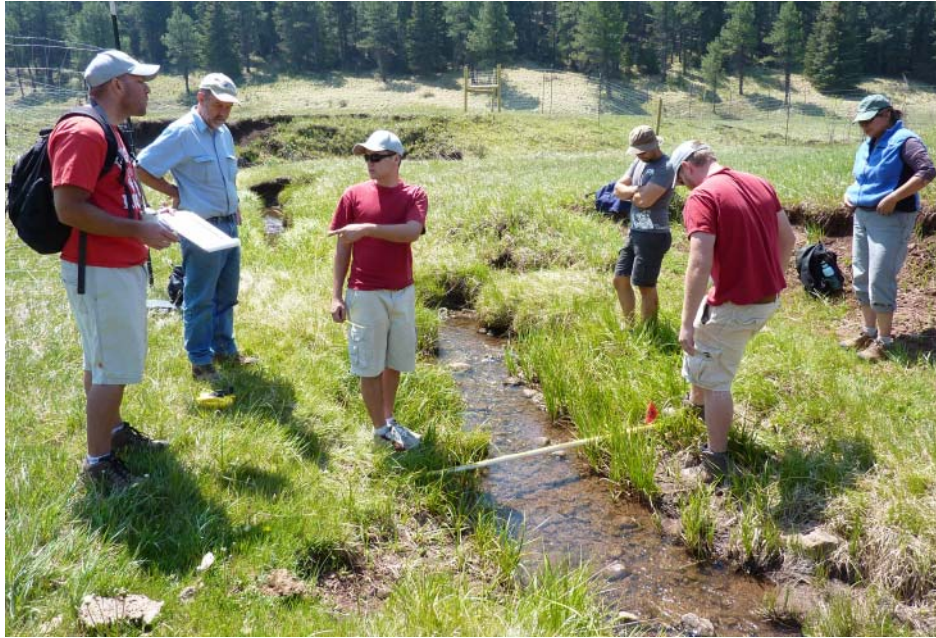
Figure 8. Photograph of Rito Peñas Negras at assessment site RPN1.

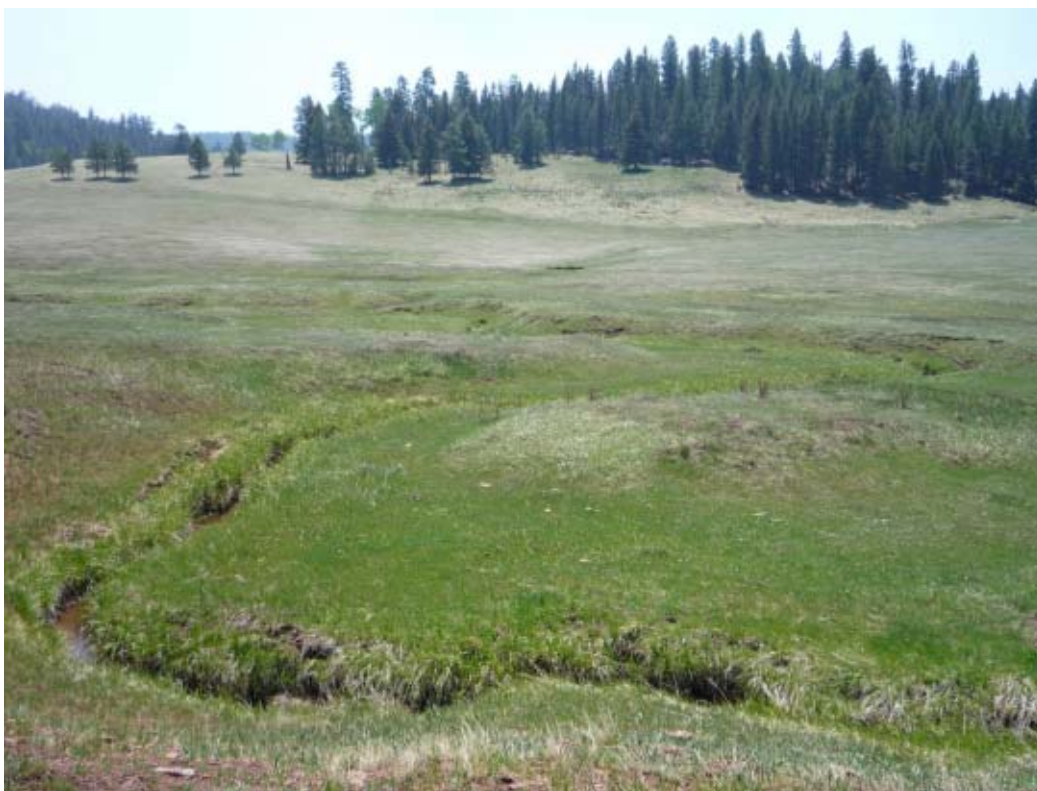
The present study found that limited evidence of active erosion. Though head cuts were noted at some locations, stream banks at each of the five assessment sites were found to be in generally good condition with only limited damage noted due to cattle grazing. Each of the sites in the lower meadows, reaches two and three in Figure 4, had a good mixture of pool and riffle zones, and had extensive regions with undercut banks that will provide protection for fish. However, as noted before, there was virtually no riparian vegetation except grasses, and thus no shade or

woody debris in the stream. Further, the stream bottom was covered by a thin layer of silt at sites RPN0 through RPN2 (Figure 9).

Figure 9. Photograph of the Rito Peñas Negras at assessment site RPN2.

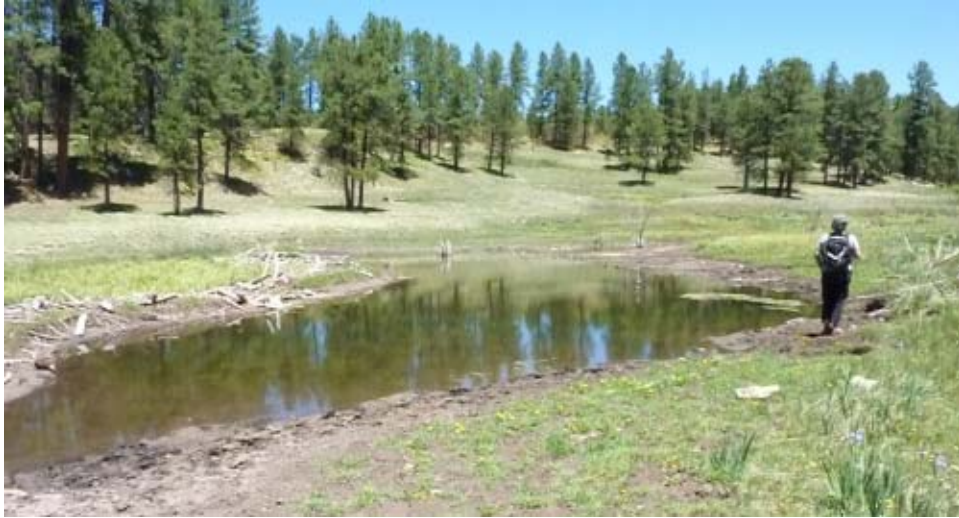
RPN 3 was located approximately 500 feet downstream of FR 527. Stream gradient in this section increases to 1.2% (USFS, 2007). The 2005 assessment noted the presence of thick clumps of Alder along the stream as well as several abandoned beaver ponds. One notable feature was that many of the Alder trees near the stream in this section were dead. Most of the beaver dams, however, were intact, though none showed evidence of any recent beaver activity whatsoever.

Figure 10. Photograph of inactive beaver pond on the Rito Peñas Negras just below assessment site RPN3.

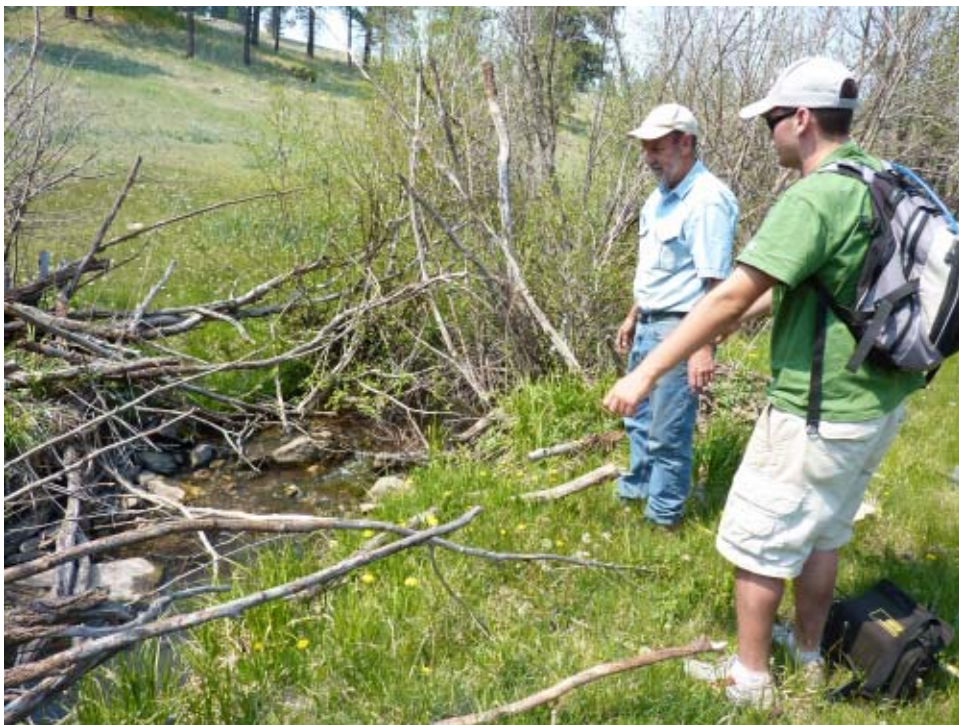
Figure 11. Photograph of the Rito Peñas Negras at assessment site RPN4.

Stream conditions at assessment site RPN4 were significantly better with substantial woody riparian vegetation and little or no silt on the stream bottom (Figure 11).

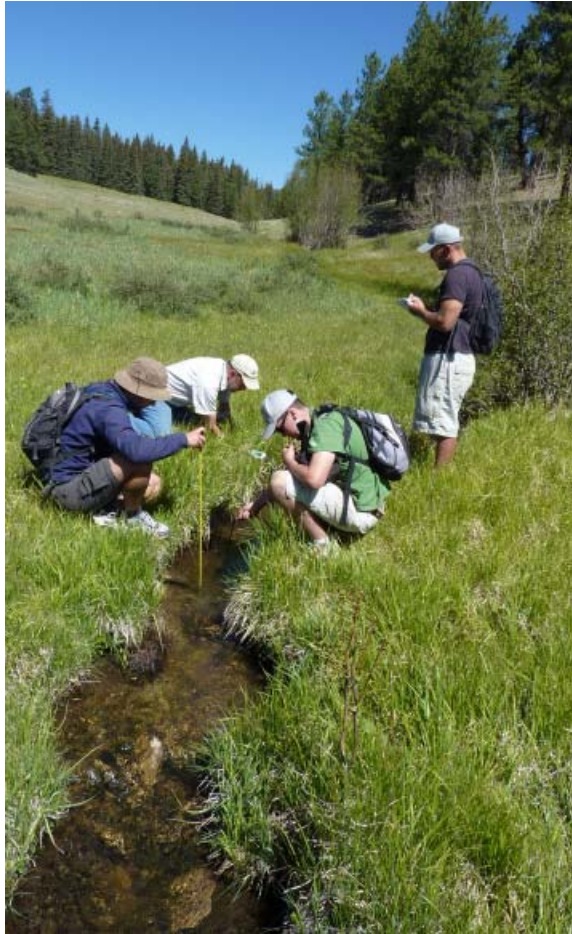
Figure 12. Photograph of the Rito Café just above confluence with the Rito Peñas Negras.
