Urbanization of Seven Springs, New Mexico: An Evaluation of Current and Projected Impacts on Ground- and Surface-Water Resources

A Professional Project Report prepared in partial fulfillment of the requirements

Master of Water Resources Administration

June 2000

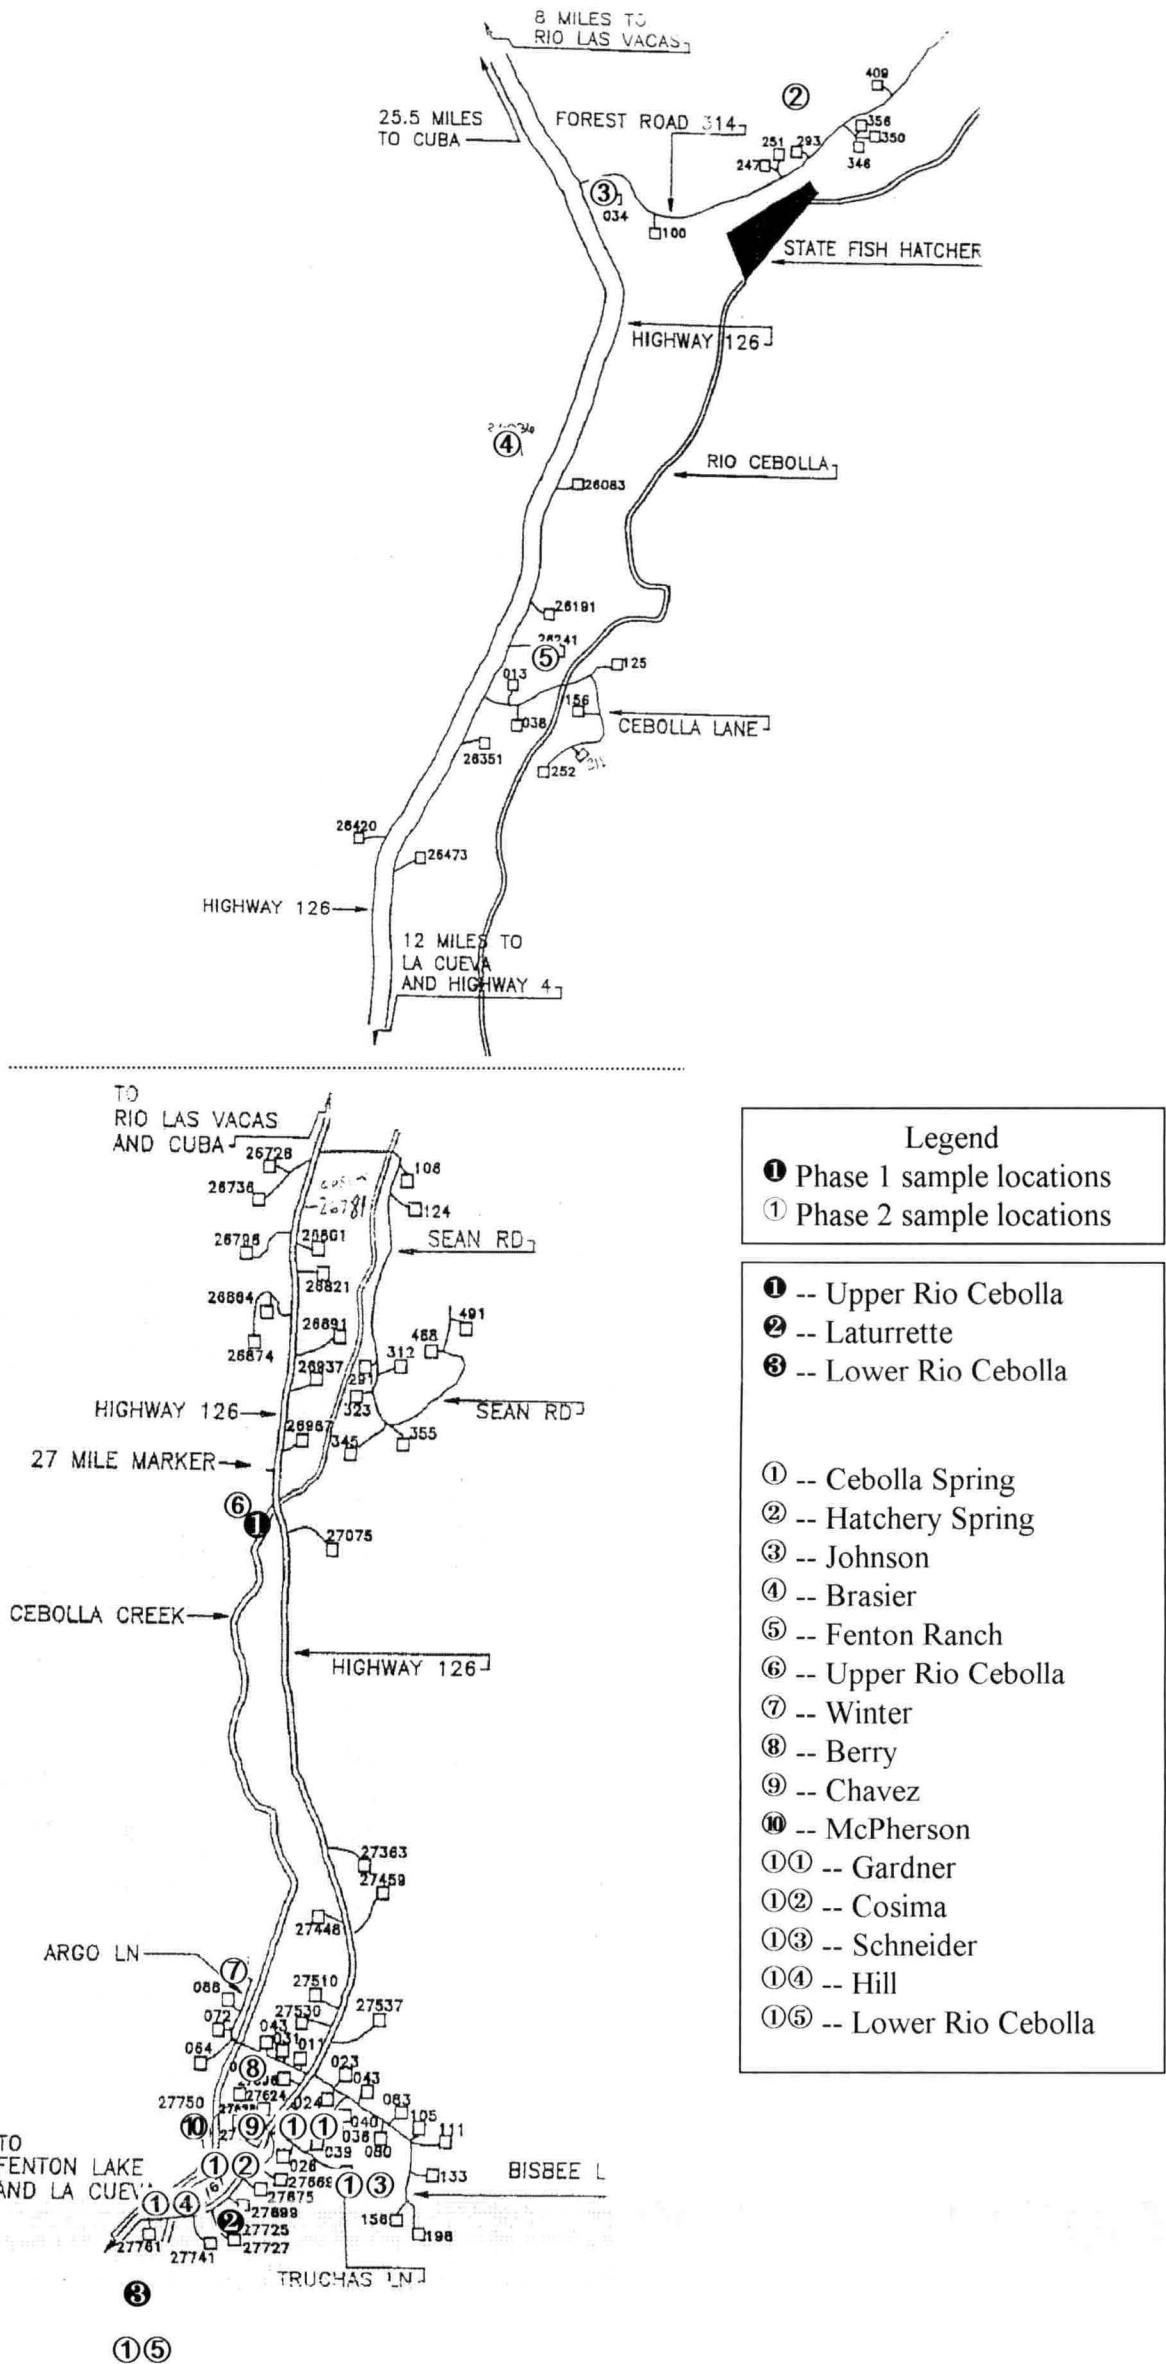
Figure 5. Sample location map for Spring and Summer 1999.
 (Composite of two maps joined at dashed line -- source Seven Springs Homeowner Association).
 Note that the Hatchery has moved east of the map location,
 Cebolla Spring is east of Hatchery on south side of Forest Road 314.

7. Coliform bacteria were found in all river and spring samples. Cebolla Spring, from which many residents and tourists get drinking water, tested positive for total coliforms, but fecal coliforms were not present.

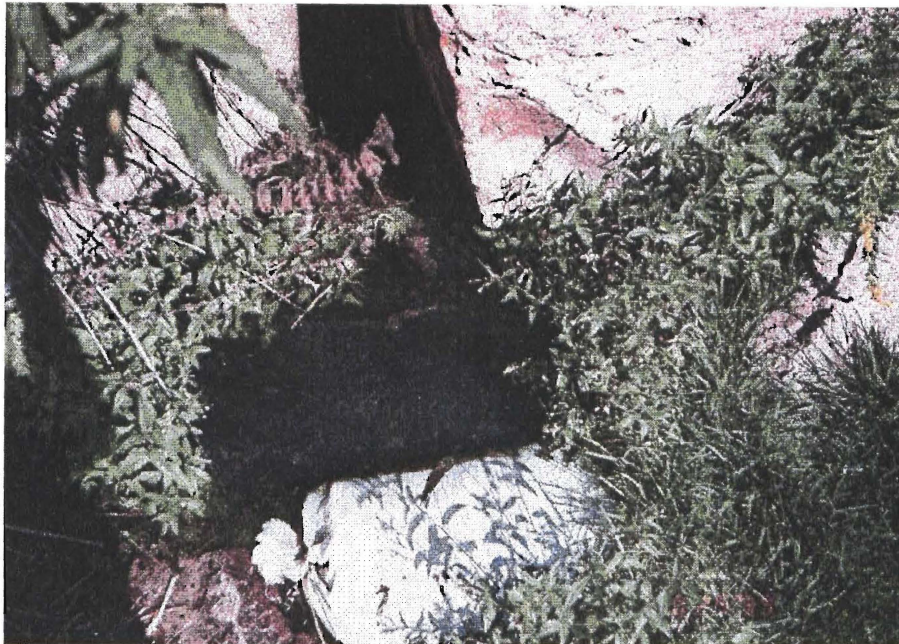
'Hatchery Spring' -- upper pool

Note sandbag dam used to create pool. Pipe runs from upper pool to lower pool as shown in photo below.

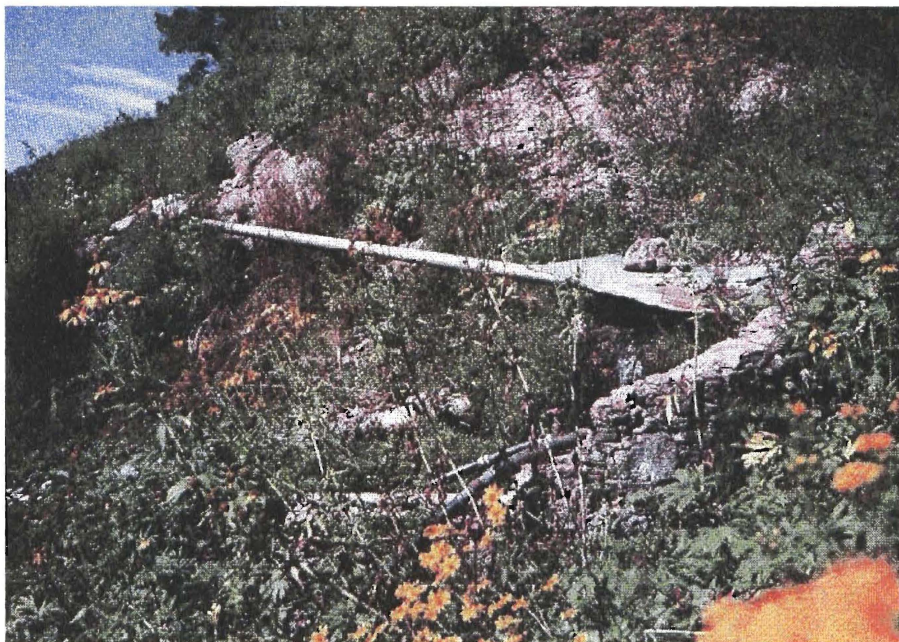
'Hatchery Spring' -- lower pool

Pipe runs from upper pool (upper left corner of photo) to lower pool (also an open-air pool) where a distribution pipe (lower left corner of photo) carries spring water to Hatchery residences by gravity flow.

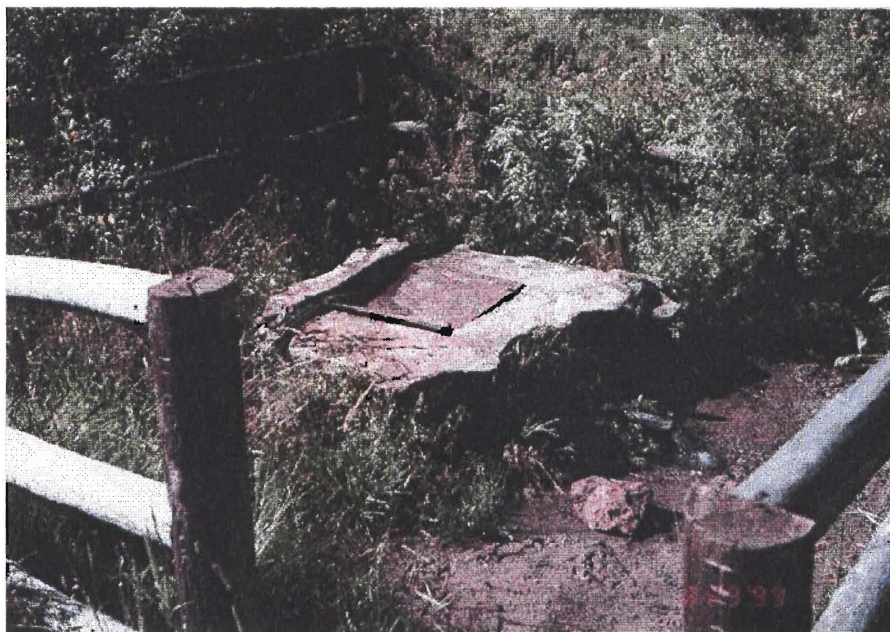
'Cebolla Spring'

Located west of the Hatchery. Residents and tourists fill water containers from discharge pipe. Note hinged steel cover on top of collection box allowing access to the spring.

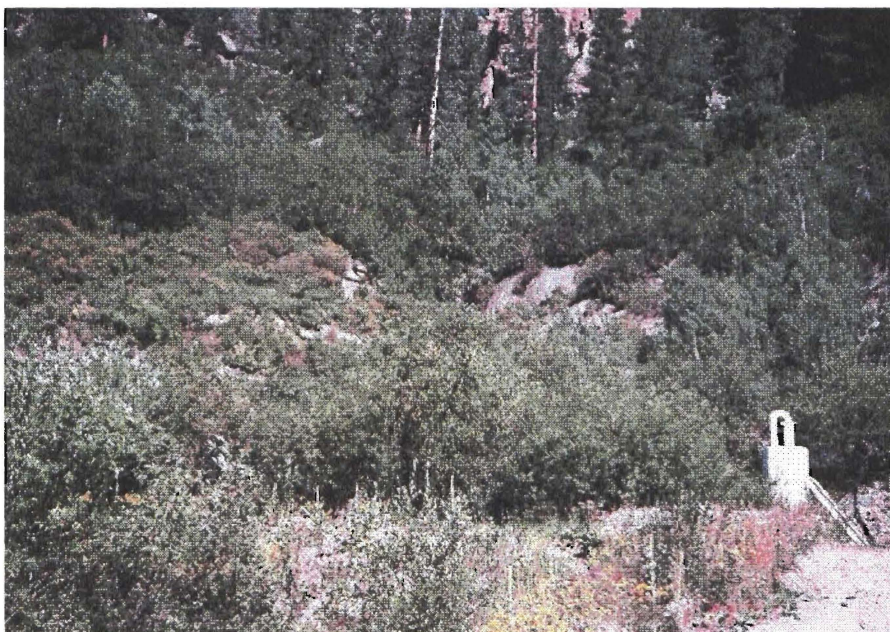
'Hatchery Spring'

View north from road at the Hatchery. Spring is in the left-center of photograph.
