Mixed Waste Landfill Annual Long-Term Monitoring & Maintenance Report, January- March 2014 for Sandia National Laboratories/ New Mexico, EPA ID Number NM5890110518

**MIXED WASTE LANDFILL
ANNUAL LONG-TERM MONITORING & MAINTENANCE REPORT
JANUARY – MARCH 2014**

Facility: Mixed Waste Landfill

Location: Sandia National Laboratories
Albuquerque, New Mexico

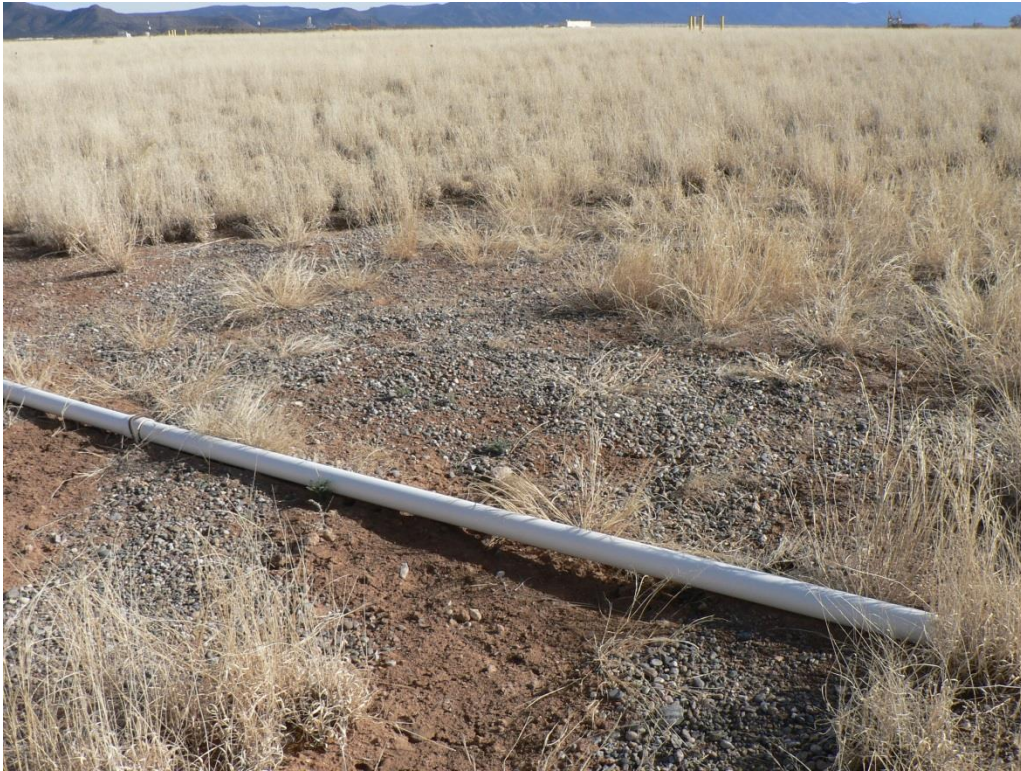
Northwest corner of cover: facing center of cover
(This small area has the lowest density of native perennial plants on the cover)

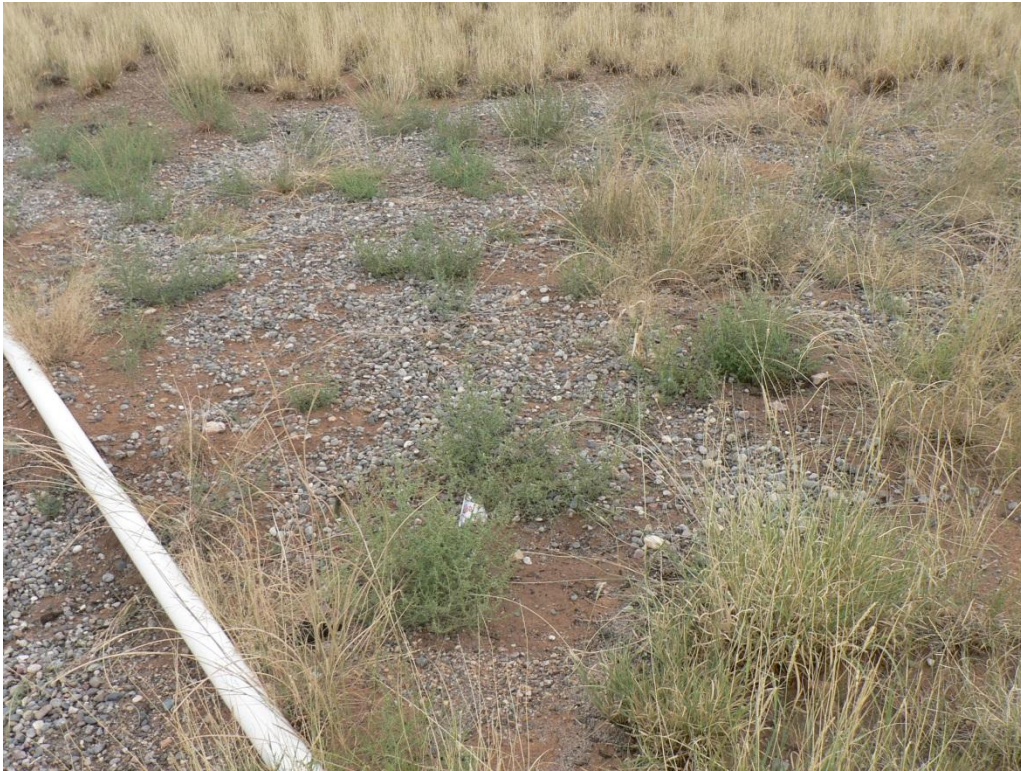
Northwest corner of cover: facing center of cover
(This small area has the lowest density of native perennial plants on the cover)
