Justification for Class III Permit Modification July 2004 DSS Site 1091 Operable Unit 1295 Building 6720 Septic System

DSS Site 1091
Operable Unit 1295
Building 6720 Septic System

**SWMU ASSESSMENT REPORT AND
PROPOSAL FOR NO FURTHER ACTION
BUILDING 6720 SEPTIC SYSTEM,
DRAIN AND SEPTIC SYSTEMS SITE 1091**

June 2003

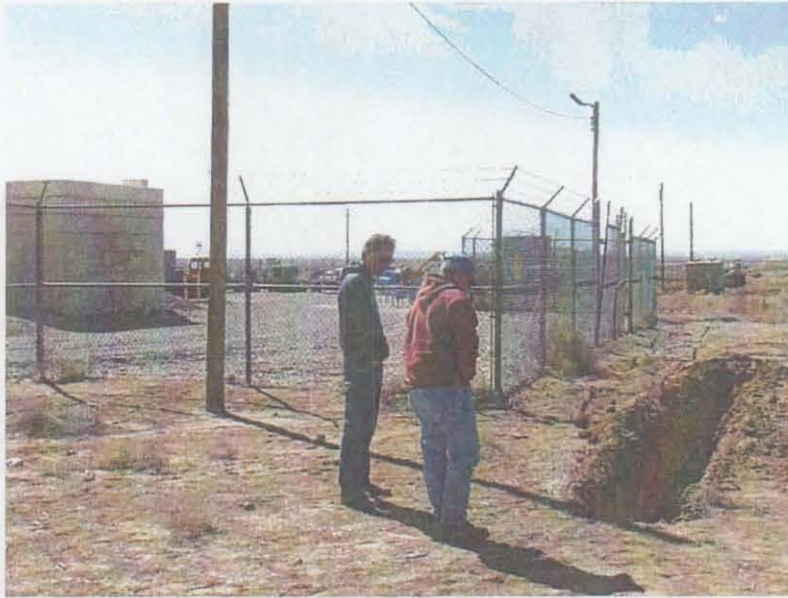
On March 19, 2002, a backhoe was taken to the site and two trenches were excavated to locate buried components of the system. Neither the SNL/NM Facilities Engineering digging permit maps nor the utility location markings for the excavation work showed any indication of a septic system at this facility, which again suggested that the system did not exist. One trench was excavated across the drain line locations shown on the engineering drawing (Figure 4-1). The second trench was excavated at the septic tank location shown on the drawing (Figure 4-2). No evidence of the drainfield drain lines, aggregate-filled drain line trenches, or a septic tank were found in either of the excavated trenches. It was consequently concluded that the septic system shown on the 1982 engineering drawing had never been constructed at this facility, and therefore did not exist.

Figure 4-1
Trench Excavated East to West North of Building 6720 to Locate Possible Drainfield.
No drainlines were found and the septic system (DSS Site 1091) was
determined not to exist. March 19, 2002

- The Building 6720 septic system has never been constructed, and therefore does not exist.

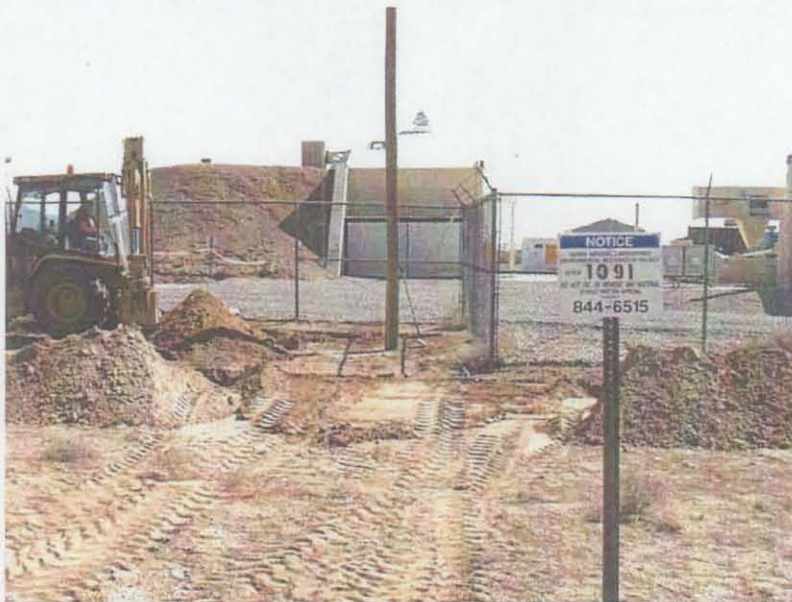
Figure 4-2
Trench Excavated at Septic Tank Location as Shown on
Engineering Drawings North of Building 6720.
Partly backfilled drainfield exploratory trench shown in Figure 4-1 is in the foreground.
No evidence of a septic tank was found, and the septic system (DSS Site 1091) was
determined not to exist. March 19, 2002
