## Calendar Year 2009 Report to the Rio Grande Compact Commission

U. S. Department of the Interior  
Bureau of Reclamation  
Albuquerque Area Office  
Albuquerque, New Mexico

March 2010

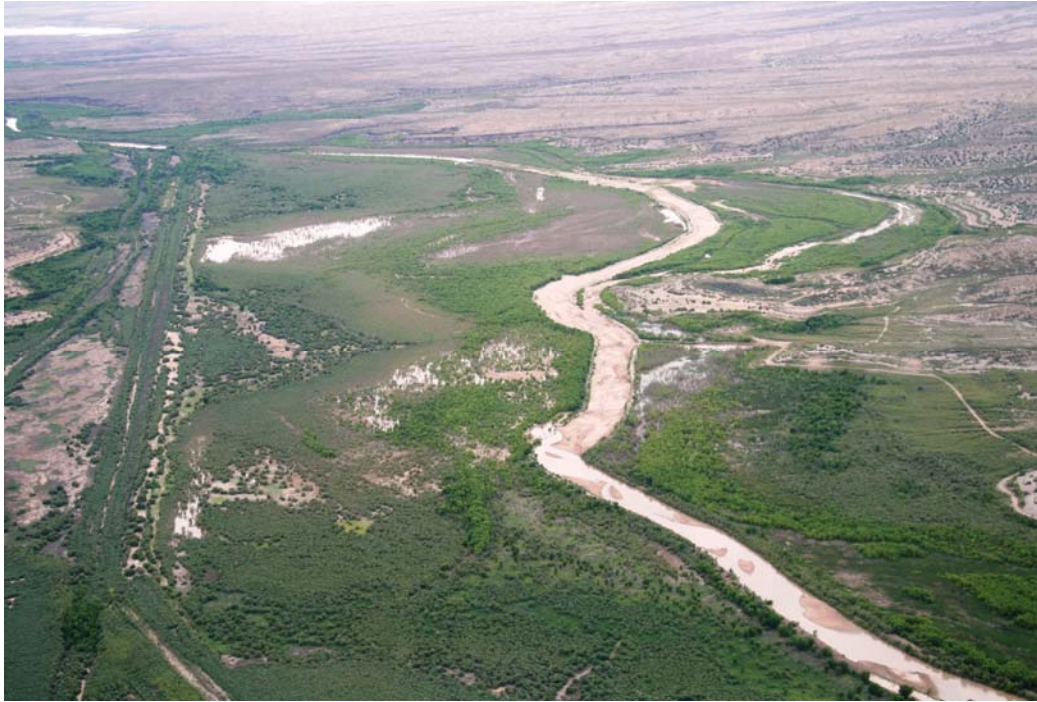
Photo 2: 2009 Temporary Channel sediment plug, looking downstream with Red Rock Staging Area approximately in the center of the photo (August 2009, Gonzales)

Reclamation's Socorro Field Division began excavating a pilot channel, approximately 25 feet in width, through the sediment plug in early August and completed the pilot channel in mid October. Work continued on repair of berm breaches and widening of the pilot channel until October 21st. NMISC's contractor took over the berm repairs in December, and that work is still in progress.

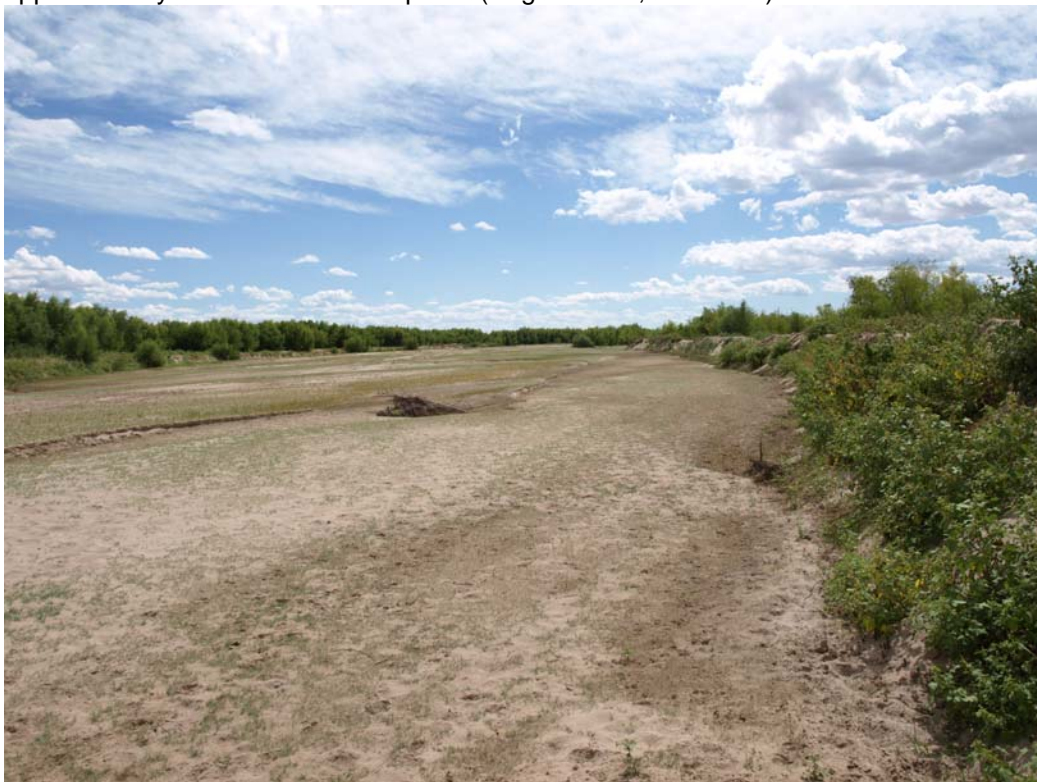
Photo 3: Temporary Channel sediment plug, taken just downstream of Red Rock Staging Area, looking downstream (September 2009, Rolland)

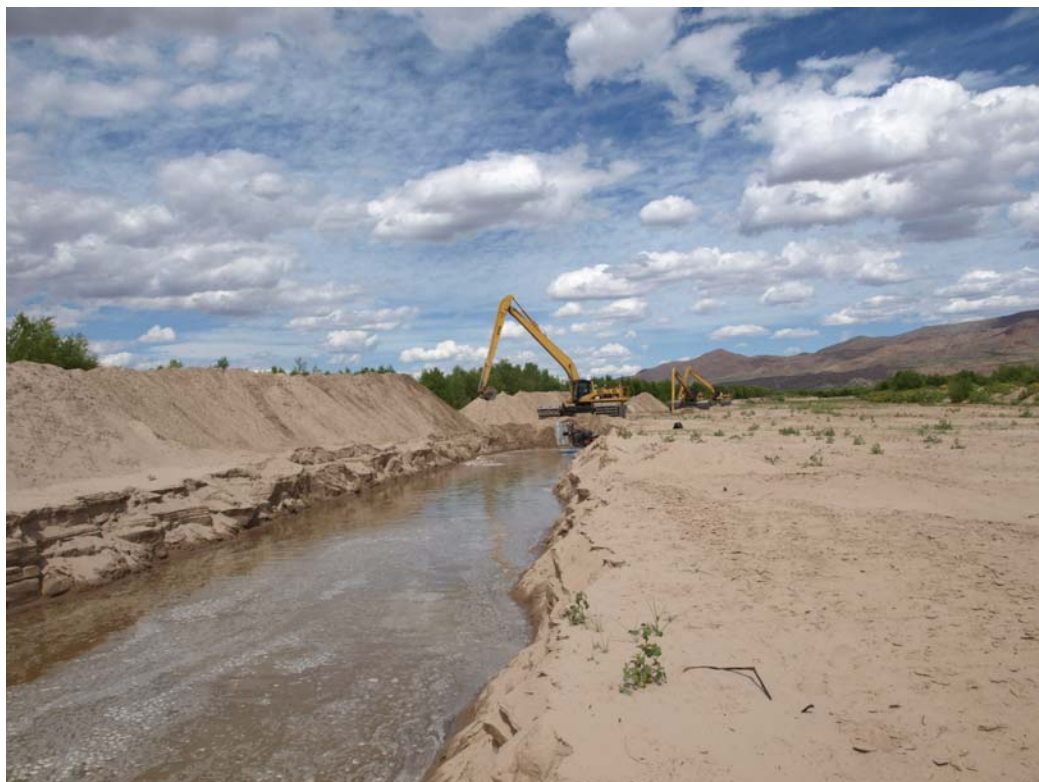
Photo 4: Excavation of pilot channel through Temporary Channel sediment plug. Taken approximately ½ mile downstream of Red Rock Staging Area, looking upstream (September 2009, Rolland)

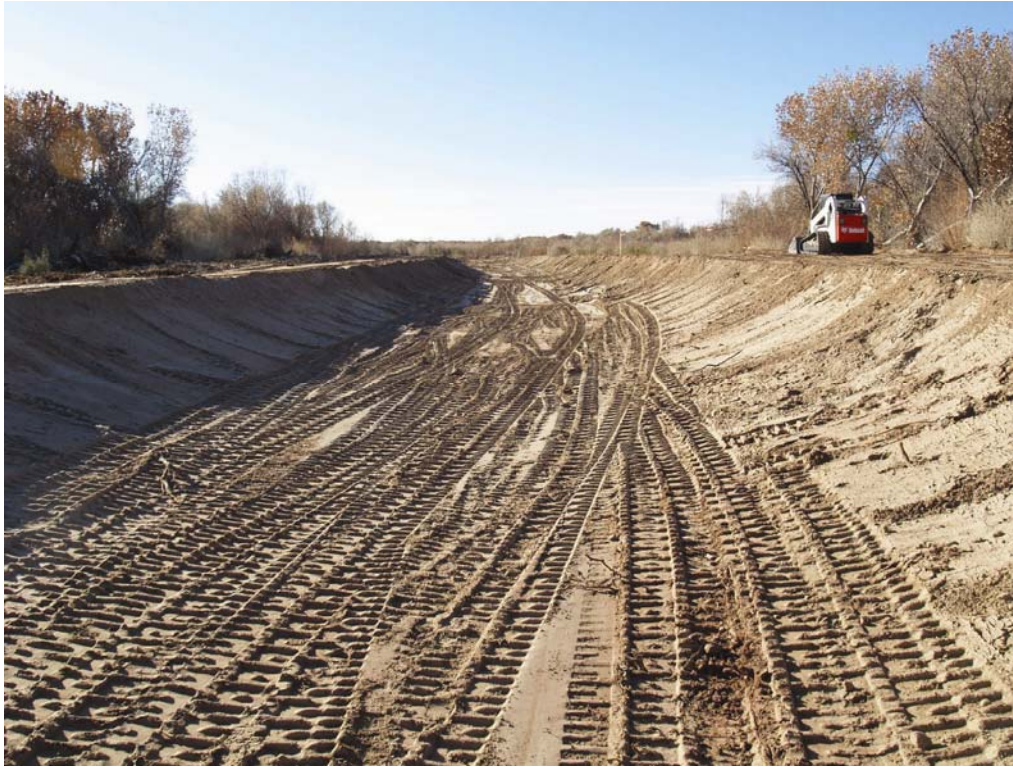
Photo 5: Recently excavated Escondida Drain outfall channel, looking west towards the Rio Grande (December 2009, Everetts)

- Escondida Drain: Improvements to this drain have been ongoing for the last 3 years, with work divided into two phases. Phase II work was completed in 2009, and included mowing of the drain prism and reestablishing the outfall into the Rio Grande, which had filled with sediment. Reclamation awarded a contract to Stoven Construction Inc. for the Phase II work, with NMISC contributing \$100,000 of Agreement funds for the project. See Photo 5.

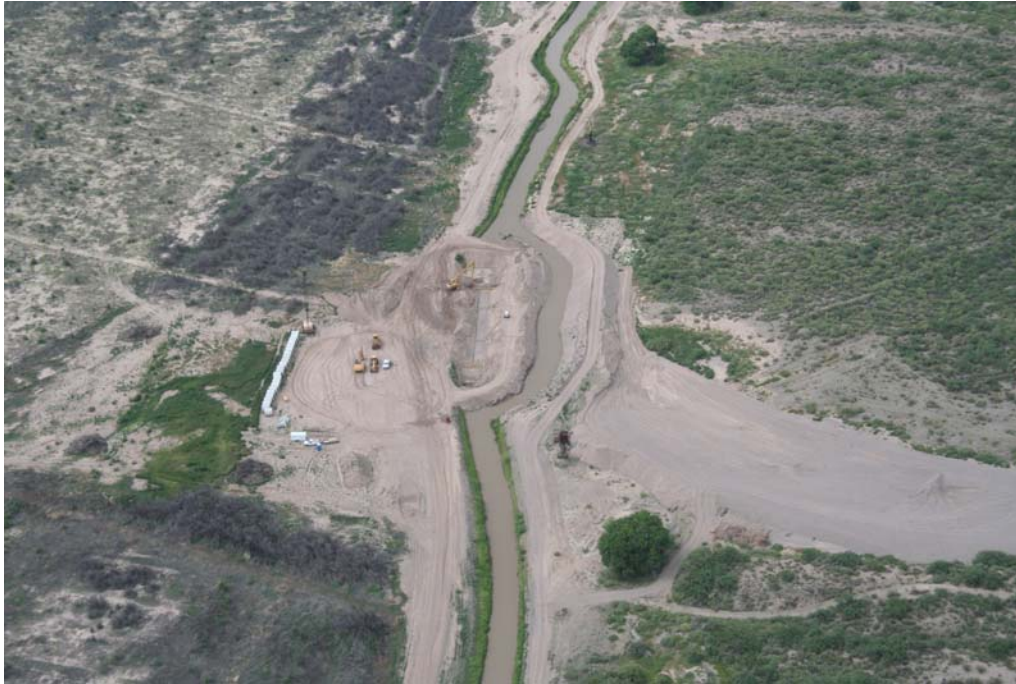
Photo 6: Elmendorf Drain culvert replacement in progress, looking south (August 2009, Gonzales)

- Elmendorf Drain: A corrugated metal culvert which conveys drain flows under an arroyo collapsed in 2007, and was removed. The culvert was located within Bosque del Apache National Wildlife Refuge (BDANWR) and was replaced in 2009 as a joint venture, with partners including Reclamation, NMISC, Middle Rio Grande Endangered Species Collaborative Program, and BDANWR. NMISC contributed \$20,000 of Agreement funds for the project. Reclamation's Socorro Field Division completed the work, with dewatering assistance from BDANWR. Work began in June 2009, and was completed in November 2009. See Photos 6 and 7.

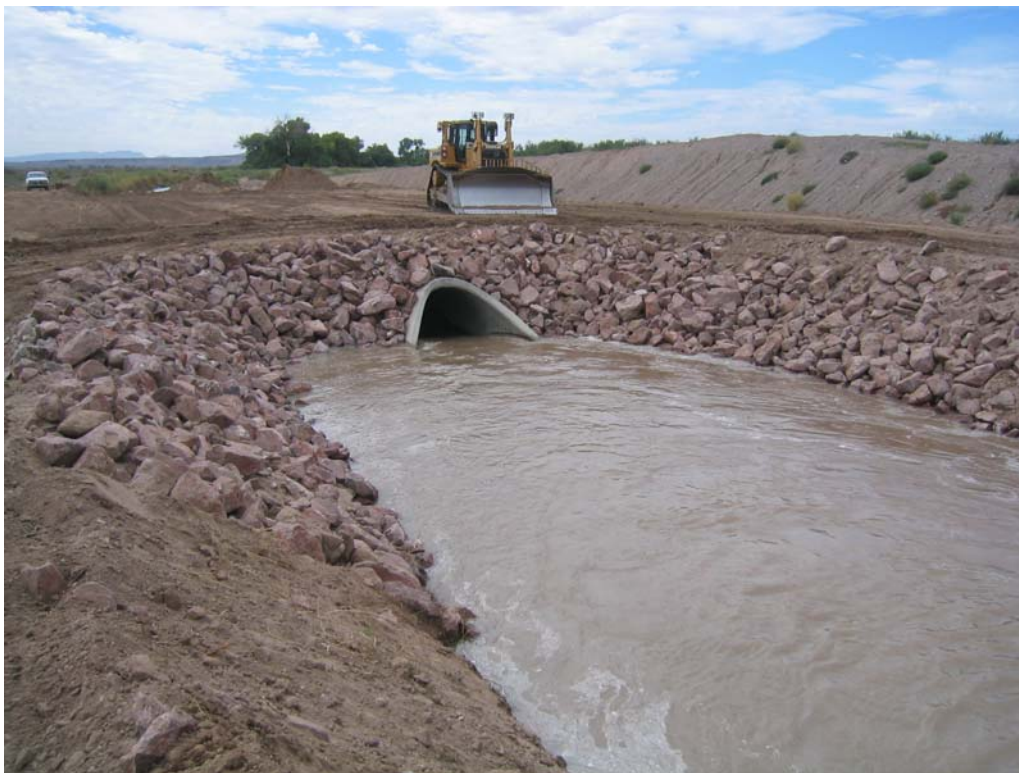
Photo 7: Elmendorf Drain culvert replacement, showing the new 84-inch diameter concrete pipe, looking downstream (October 2009, Everetts)

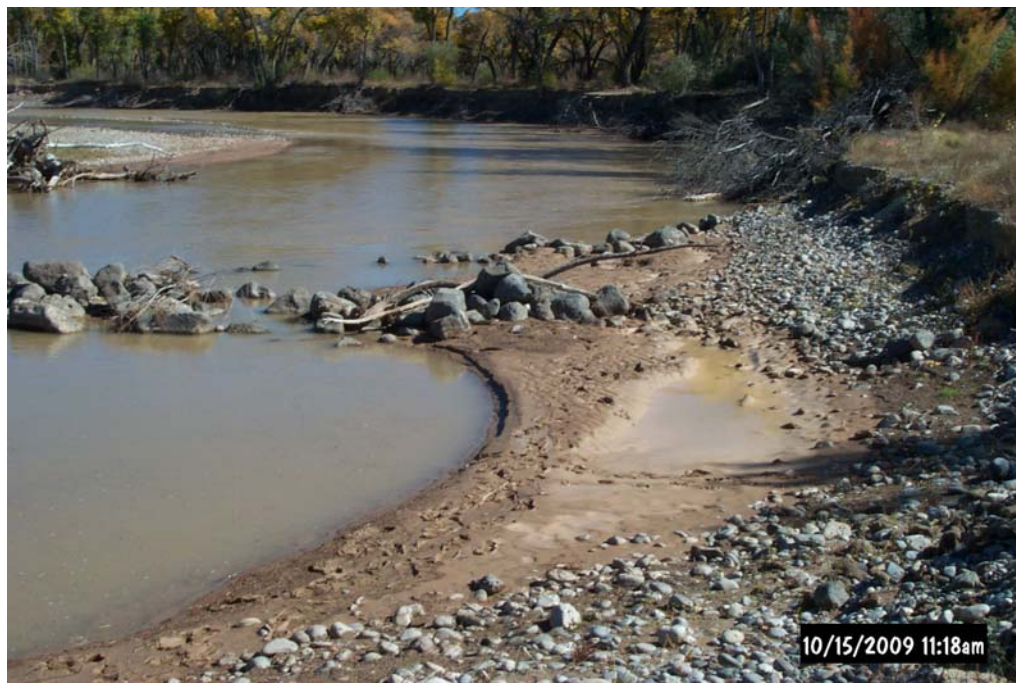
Photo 8: San Ildefonso bankline erosion and exposure of previously buried rock vanes (October 2009, AuBuchon)

flanking protection and additional bankline stabilization for the previously placed rock vanes, providing time for the development and permitting of a longer term solution.

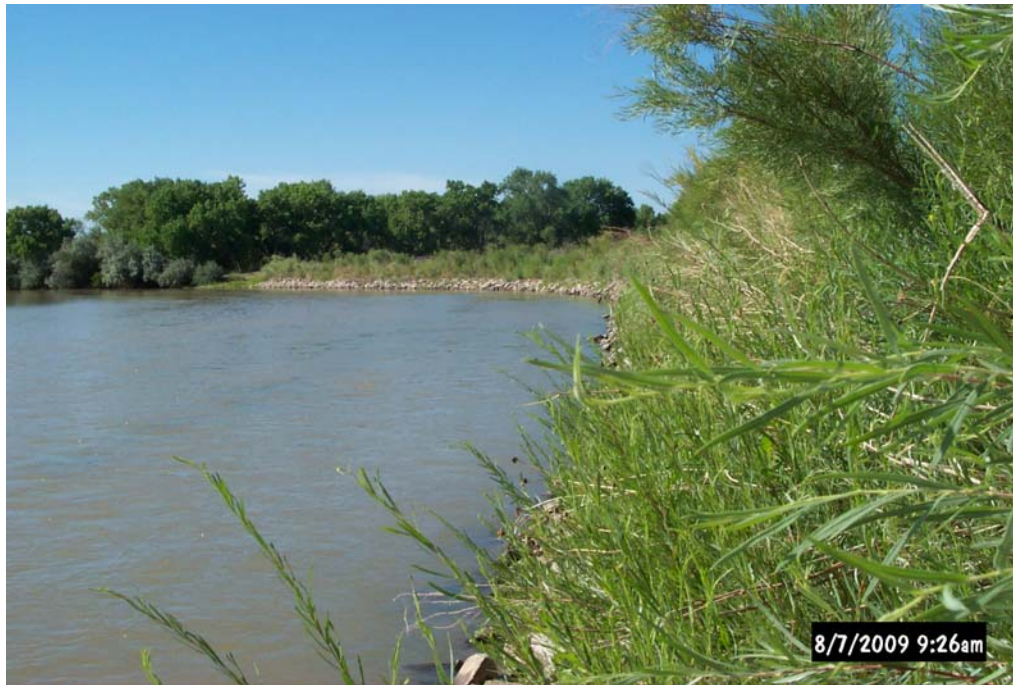
Photo 9: Bankline protection on the Pueblo of Cochiti at RM 231.3 (August 2009, AuBuchon)

Construction at both sites was completed by Reclamation's Socorro Field Division during the summer of 2008. While poles were planted as part of the bioengineered bankline, additional planting may still be required in the areas disturbed by construction activities. A site review in August 2009 revealed that native vegetation was already returning to the site, so Reclamation and the Pueblo de Cochiti agreed that for the immediate future only periodic monitoring is warranted. If future site visits reveal the need for revegetation, Reclamation will coordinate that effort with the Pueblo de Cochiti to minimize the impact on established native vegetation.

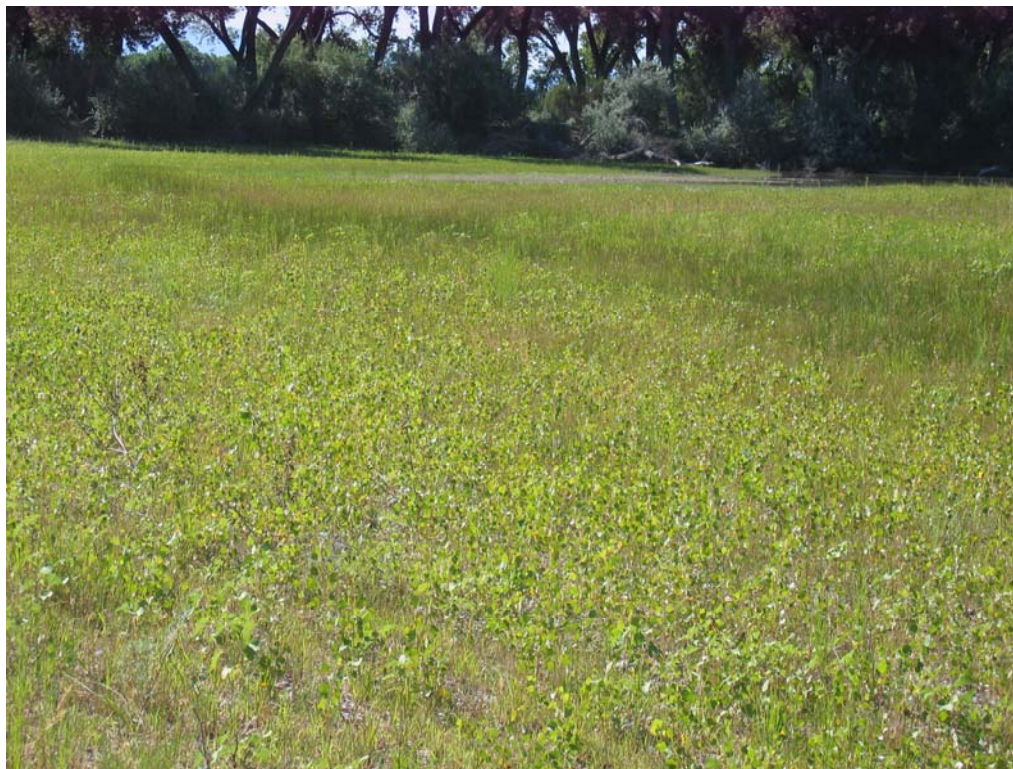
Photo 10: Backwater area on the Pueblo of Cochiti constructed as part of the construction at RM 228.9 (August 2009, Maxwell)

There are two priority sites on the Pueblo of Cochiti: one, at RM 231.3, is on the west side of the Rio Grande about 1 mile downstream of Cochiti Dam, and the other, at RM 228.9, is on the east side, about 3 miles downstream of the dam. At RM 231.3, the west bank of the channel is very close to a road and some agricultural fields (Photo 9). At RM 228.9, a secondary channel was slowly, but steadily, migrating eastward toward the levee and riverside drain (Photo 10).

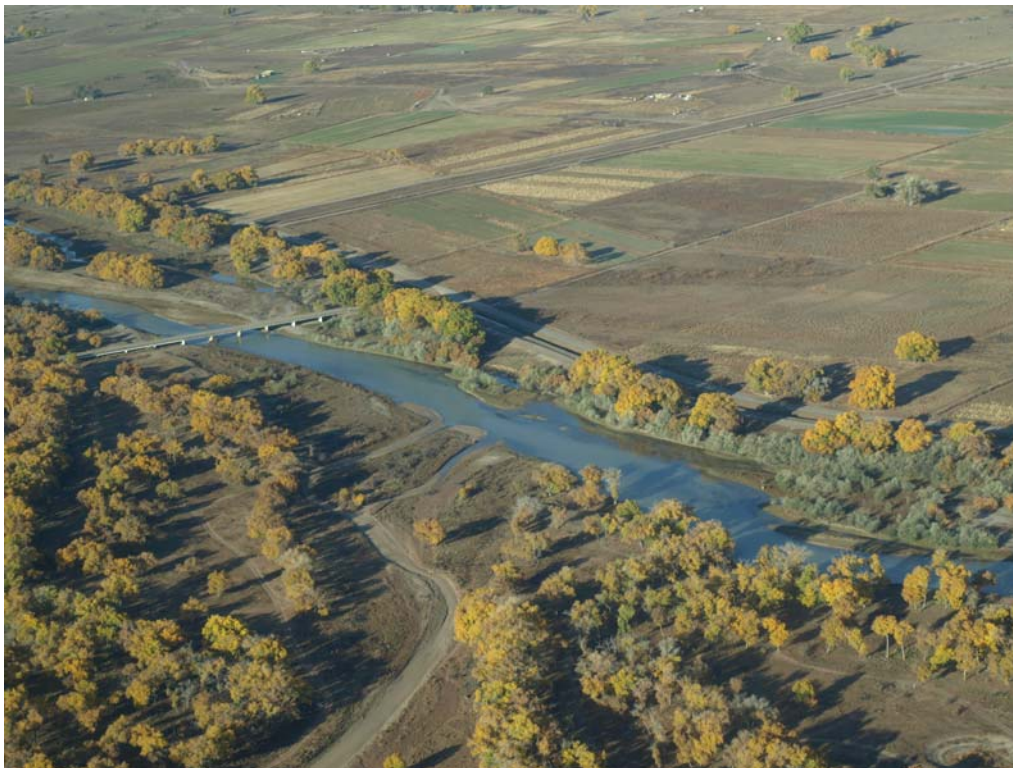
Photo 11: Santo Domingo Priority Site No. 2 (RM 224.6), looking southwest (October 2009, Padilla)

There are currently three priority sites on the reach of the Rio Grande passing through the Pueblo of Santo Domingo (RM 225.1, RM 224.6, and RM 223.9). At these sites, bankline erosion on the west side of the river is cause for concern because of the close proximity to the levee and riverside drain. Priority Site No. 2 (RM 224.6), which is across from the confluence of the Rio Galisteo, is shown in Photo 11, and Site No. 3 is shown in Photo 12. A Data Collection and Confidentiality Agreement was executed between the Santo Domingo Tribe and Reclamation in August 2007, to allow collection of design data for the three priority sites. An evaluation of design alternatives has been completed for each of the sites and the preferred alternatives have been presented to Santo Domingo for their approval. Construction may begin late in 2010 if a consensus is reached with Santo Domingo.

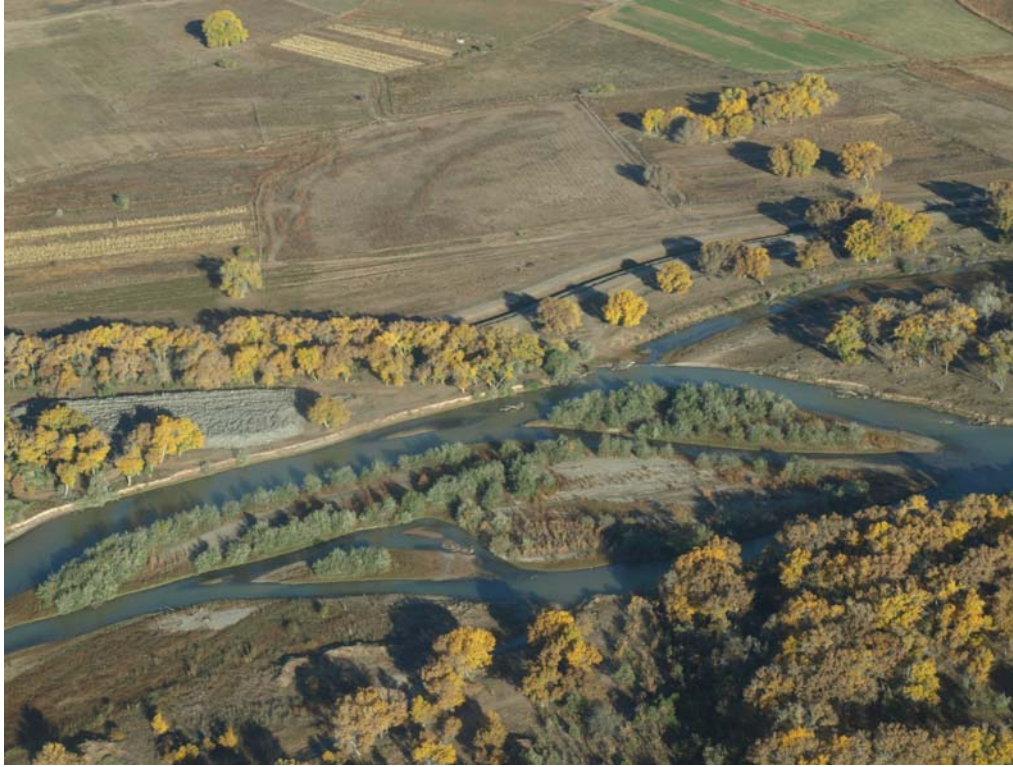
Photo 12: Santo Domingo Priority Site No. 3 (RM 223.9), looking west (October 2009, Padilla)

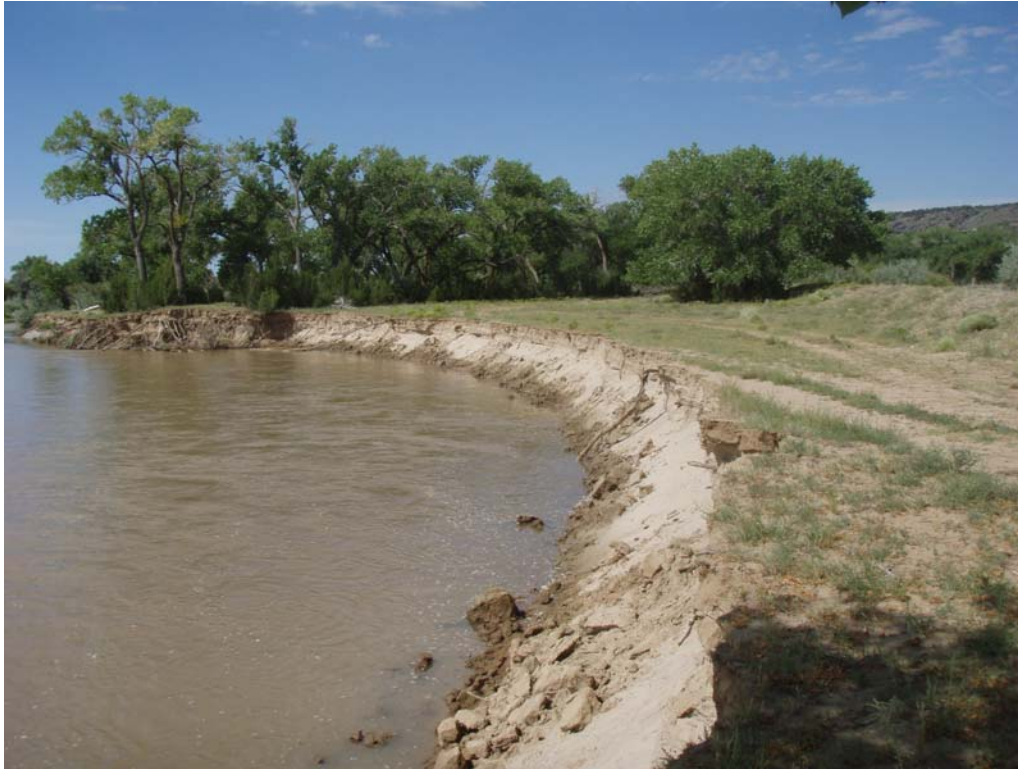
Photo 13: Downstream view of eroding terrace at Priority Site 213.4, San Felipe (July 2009, Donnelly)

There are currently nine river maintenance priority sites on the Pueblo of San Felipe. Current conditions at these sites could lead to damage of levees, irrigation infrastructure, roads, and a residential area of the Pueblo. In late 2006, Reclamation obtained permission from the Pueblo to collect cross-section and bed material data for use in designs to address these sites. Construction is anticipated to begin at four of the sites in 2010. Photo 13 shows the site at RM 213.4.

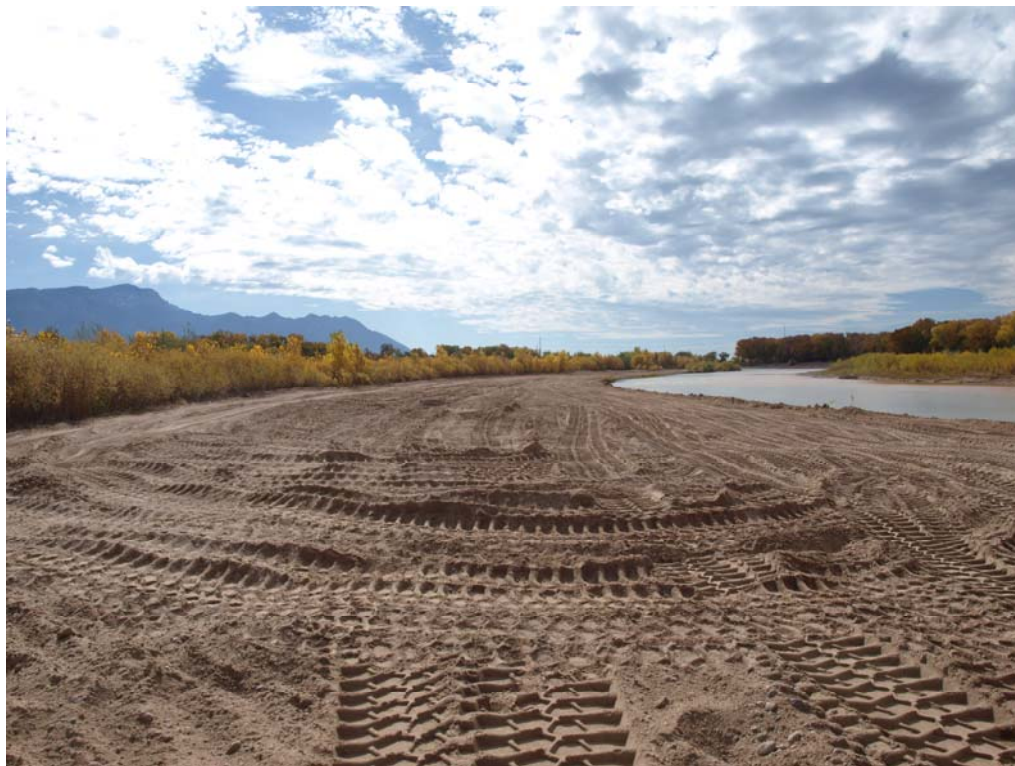
Photo 14: Looking downstream at location of sediment spoil pile on the Pueblo of Santa Ana after sediment has been removed. Flow in the Rio Grande is approximately 500 cfs (October 2009, AuBuchon)

A willow trench was constructed by the Pueblo of Santa Ana in January 2008, according to a Reclamation design that would allow natural vegetation to provide ongoing protection of the east bank once the sediment spoil piles have been removed. In October 2009, Reclamation's Socorro Field Division removed the remaining sediment spoil piles to allow increased inundation of the floodplain (Photo 14). Planting of native vegetation on the redistributed sediment will be accomplished through an existing 638 contract in place with the Pueblo of Santa Ana.

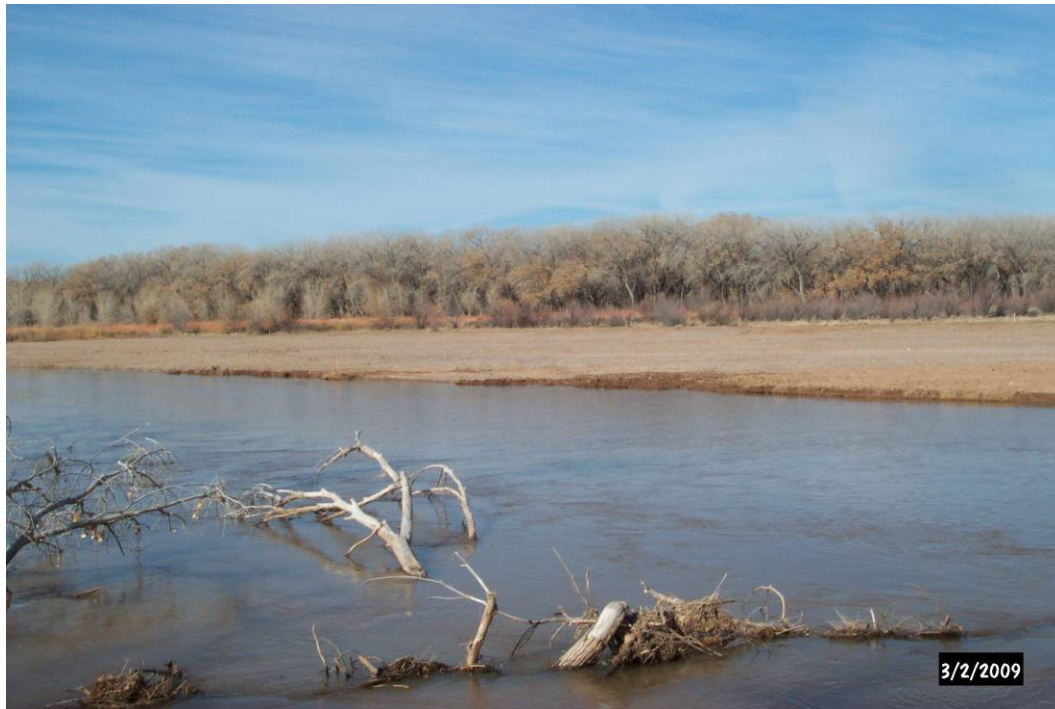
Photo 15: Corps of Engineers' bar lowering at the Pueblo of Santa Ana across from the Santa Ana RM 205.8 priority site (March 2009, AuBuchon)

Due to the close proximity of the spoil levee and the amount of bankline erosion observed during 2008, this site was elevated to the status of a priority site. The Corps of Engineers, through their 1135 project authority, undertook an island and bar lowering project on the Rio Grande through the Pueblo of Santa Ana, a portion of which was adjacent to this priority site (Photo 15). Observations from the 2009 spring runoff indicate that this project helped reduce the active bank erosion at this site (Photo 16). Reclamation is currently working with the Pueblo of Santa Ana to develop a preferred protection strategy.

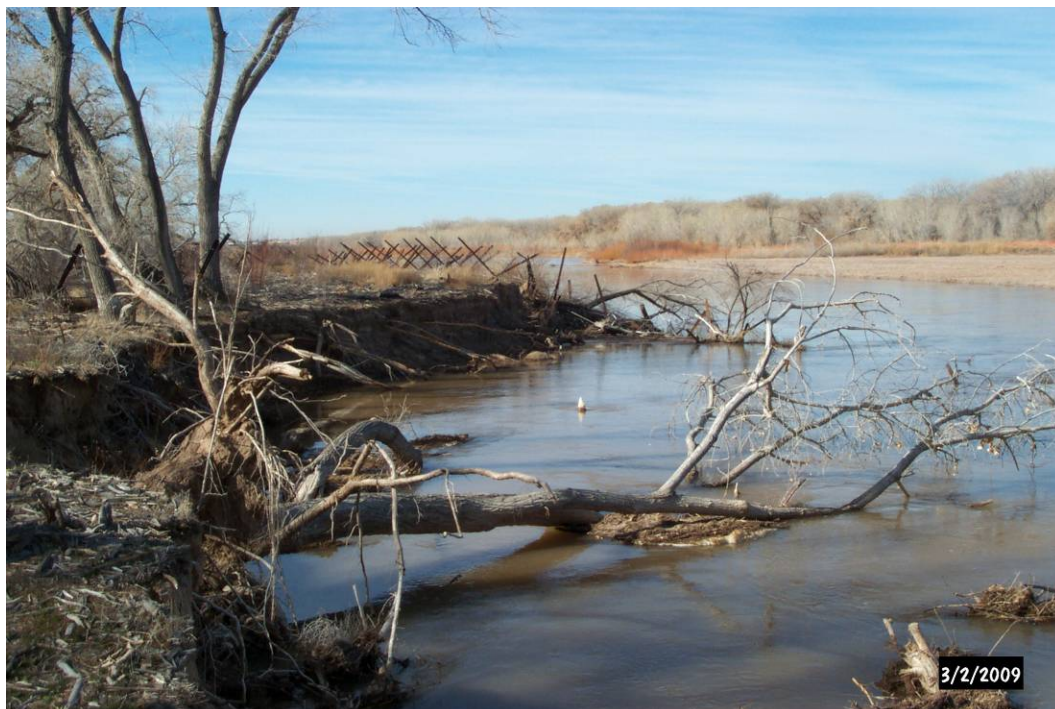
Photo 16: Looking downstream at the bend erosion at the Santa Ana RM 205.8 priority site (March 2009, AuBuchon)

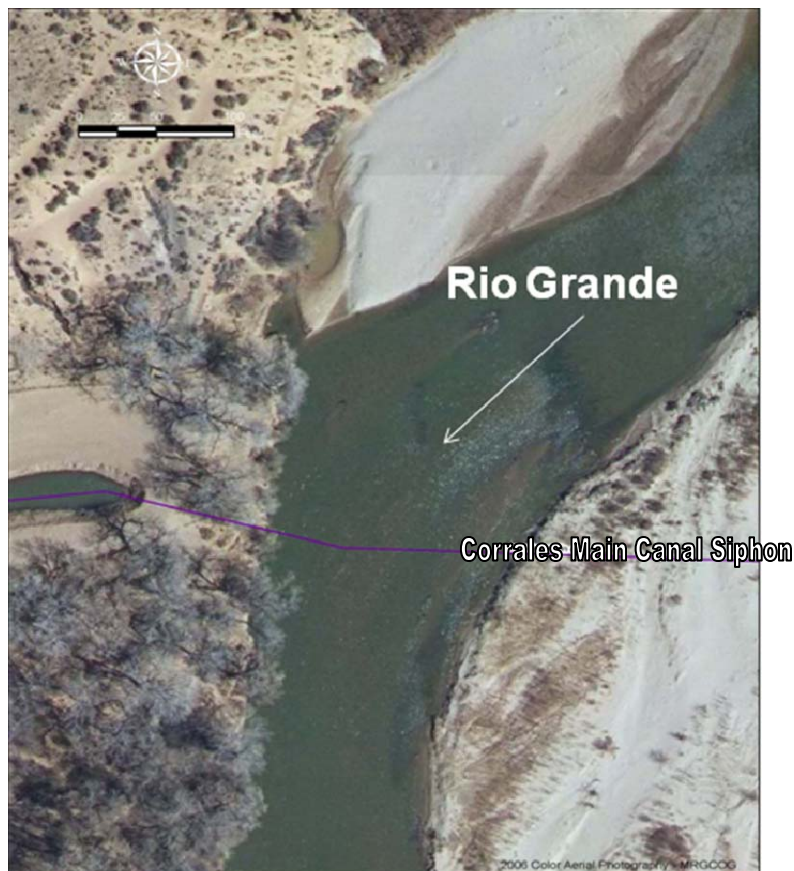
However, in early 2008, Reclamation became aware that the inverted siphon consists mostly of a wood pipeline that was constructed in the 1930s. Because of concerns about the stability of the wood pipeline when subjected to the loading and vibration of construction equipment, vibration testing and video examination of the pipe were performed. While the video was inconclusive, the vibration testing indicated that equipment should stay approximately 50 feet from the pipe to avoid damaging it. In addition, conditions at the site have changed, as deposited sediment and high flow side channels cut in the bar on the opposite bank by the Pueblo of Sandia, have alleviated some of the pressure at the higher discharges (Photo 17).

Photo 17: Corrales Siphon priority site

Reclamation is currently considering designs on a reduced scale that would further stabilize the upstream sediment deposition, thereby protecting the undercut bank.

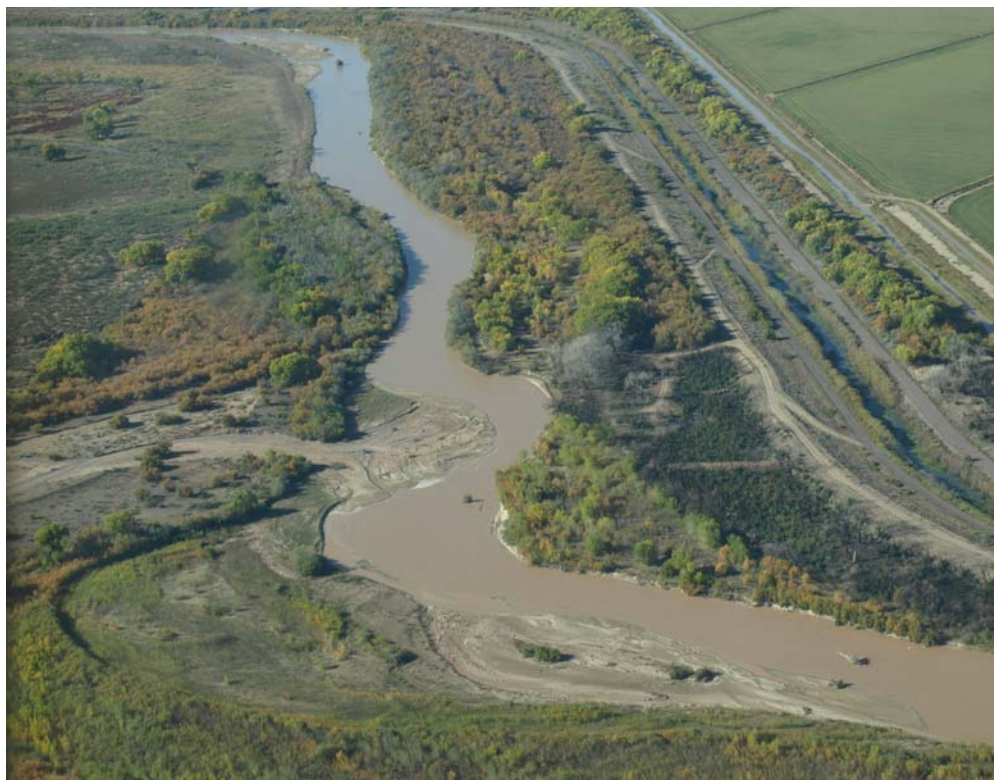
Photo 21: Aerial photograph looking downstream showing deposition at the mouth of the Arroyo de las Cañas and the burned vegetation on the west bank in the vicinity of the priority site (October 2009, Padilla)

This river maintenance site is located at RM 95.5 on the west bank of the Rio Grande, upstream of Arroyo de las Cañas. When the site was identified in 2005, the bankline was less than 100 feet from the levee toe, and the thalweg was along the outside of the bend nearest the levee. While the bankline was eroded during the 2005 runoff, subsequent years (2006 and 2007) saw extensive deposition at this site. Spring runoff conditions in 2008 and 2009, along with a fire that burned a majority of the vegetation in the area in the early part of 2009 (Photo 21), have again raised concerns that this site may be susceptible to erosion. Additional geomorphic investigations and site analyses are being undertaken to help determine the status of this river maintenance site and if proactive bank stabilization on depositional features should be taken to help reduce the risk of erosion in the future.

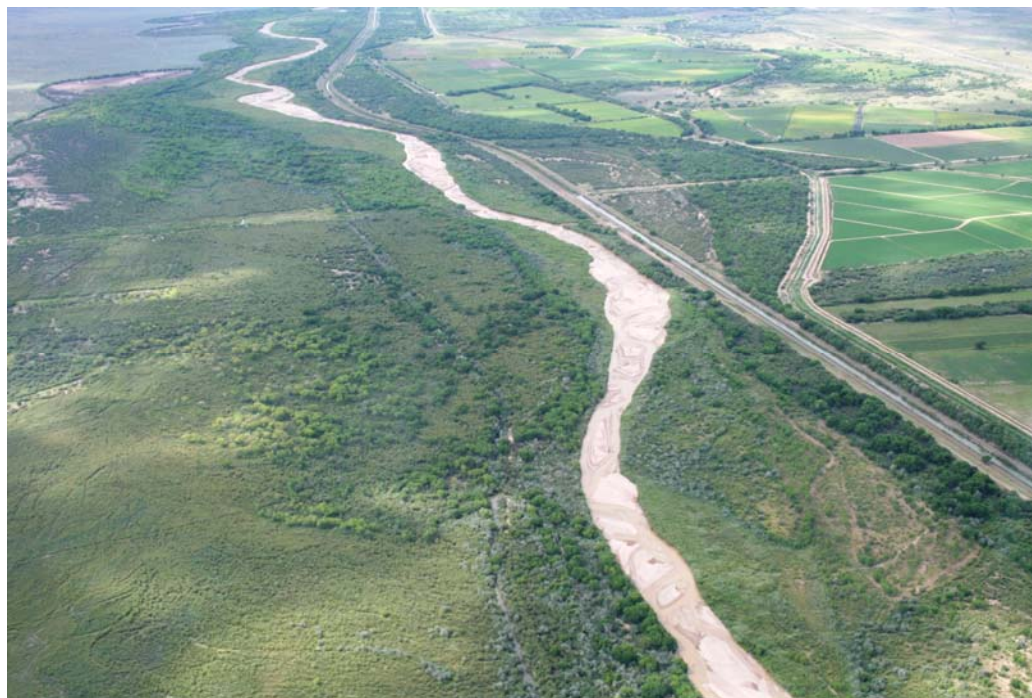
area thought to currently have the greatest potential for sediment plug formation is shown in Photo 22.

Photo 22: The reach of river currently considered most prone to sediment plug formation, taken from just north of the North Boundary BDANWR, looking south (August 2009, Gonzales)

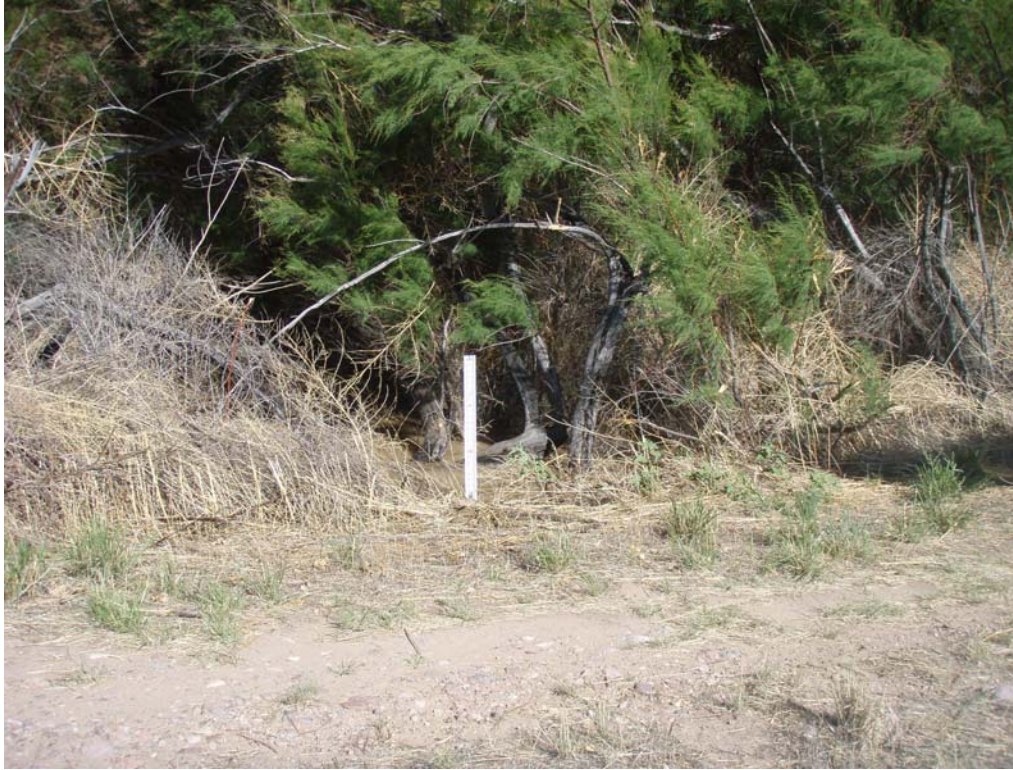
Photo 23: A staff gage installed on the east slope of the Bosque del Apache Levee for monitoring the water surface during the 2008 spring runoff. Foreground is the top of the levee (May 2008, Rolland)

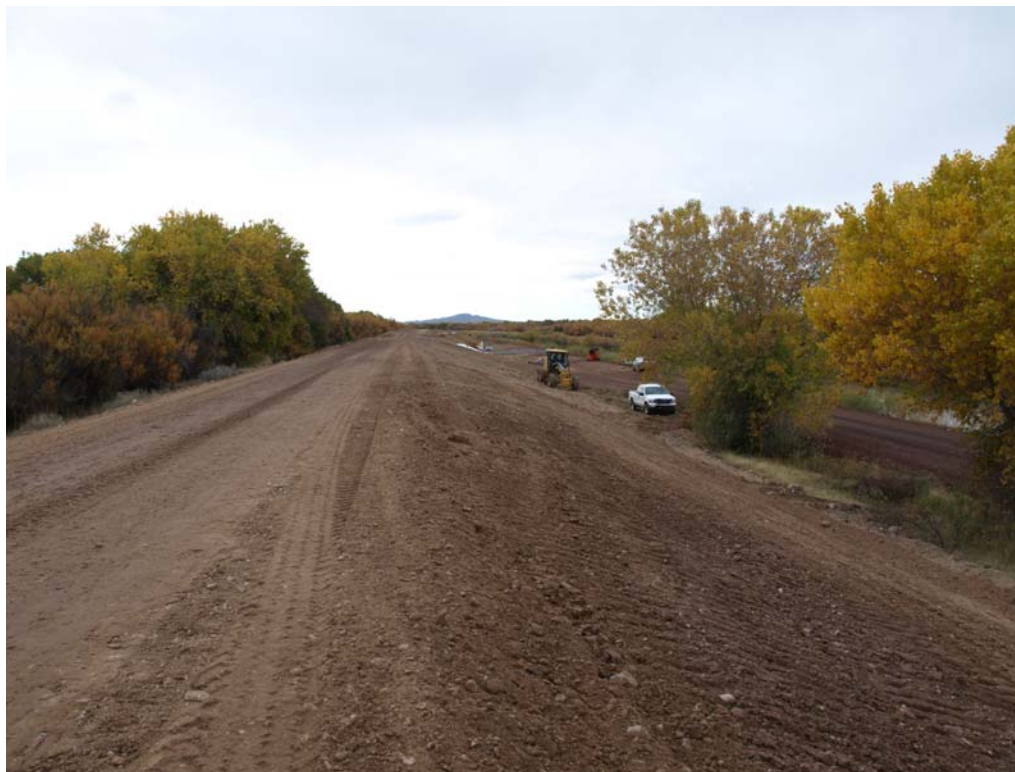
Photo 24: A completed section of the 2009 Bosque del Apache Levee ARRA improvements (October 2009, Rolland)

In 2009, Reclamation requested American Recovery and Reinvestment Act (ARRA) funds for improvements to the levee, and received \$2 million. The improvements include raising low areas and widening narrow areas within a three mile stretch of levee where conditions are of greatest concern. This work was awarded to Stoven Construction, Inc., by a task order under the 2009 Simplified Acquisition of Basic Engineering Requirements (SABER) contract. Contract work included loading and hauling 126,000 tons (approximately 81,300 cubic yards) of Government-furnished borrow material from the Valverde borrow site to the levee. Reclamation's Socorro Field Division shaped the material on the levee after it was dumped by the contractor.

construction for this project was divided into two periods of performance. The first period ran from October 26, 2009, to November 10, 2009, and provided approximately 52,200 tons (33,700 cubic yards) of material on the levee. The remaining contract hauling will begin in March 2010. The Reclamation crew is currently working on a portion of the levee north of BDANWR.

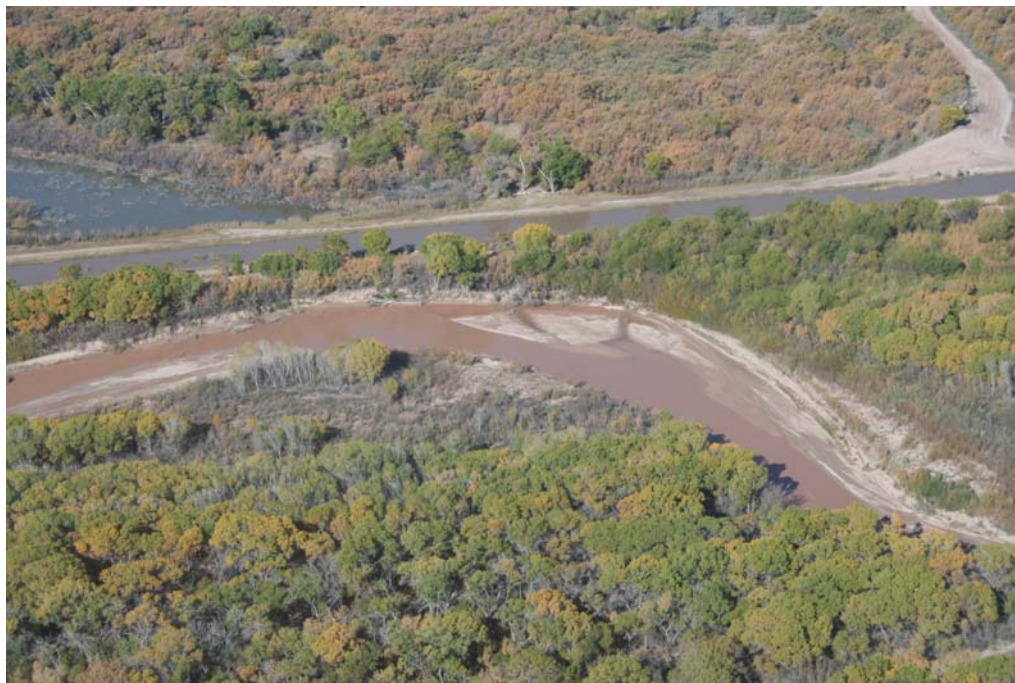
Photo 25: Fort Craig Bend priority site, looking west (October 2009, Gonzales)

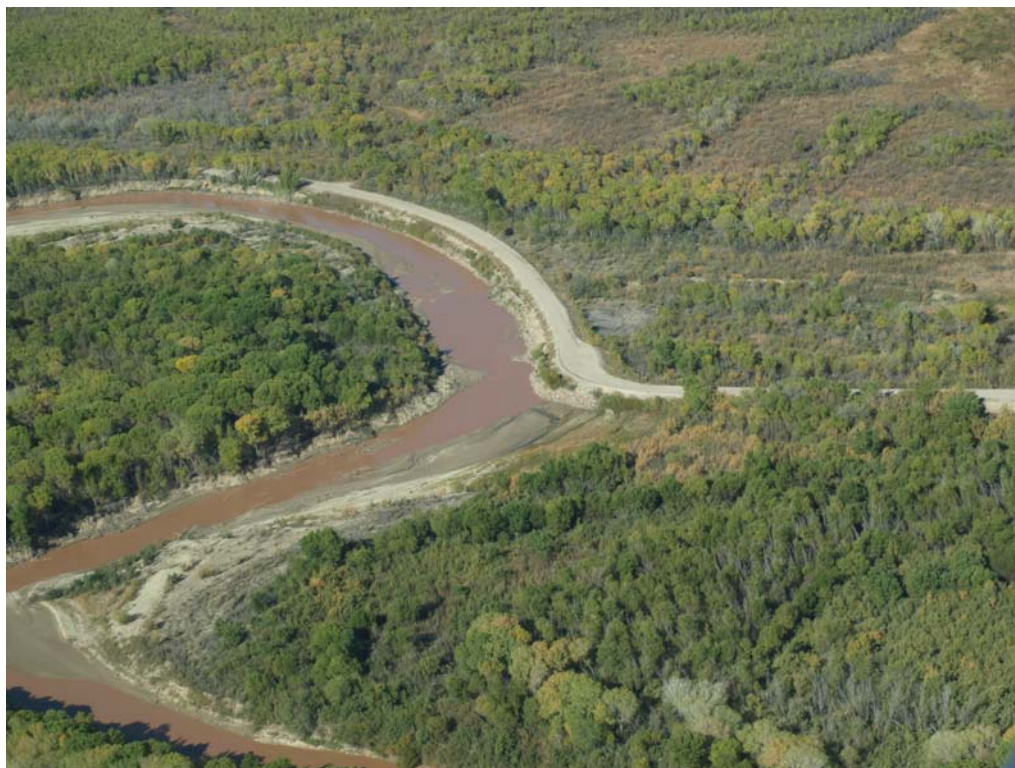
The site has been an area of some concern for many years but erosion has become more aggressive since 2005 due to river channel degradation through this reach. The upstream end of the site has been monitored closely in recent years because of a deep scour hole caused by the abrupt bend, and the possibility for undercutting of the riprap that protects the road embankment. The upstream end of the site has been fairly stable in the last two years, but a significant amount of bankline erosion has occurred at the downstream end, where the road is not protected by riprap. There is a fairly high probability the road could be impacted during the 2010 runoff. The site will be monitored closely and the road will likely be closed during the runoff due to safety concerns.

Photo 26: River Mile 60 priority site, looking southwest (October 2009, Padilla)
