Justification for Class III Permit Modification January 2008 DSS Site 1101 Operational Unit 1295 Building 885 Septic System (TA-1)

AOC 1101 Drain and Septic System (Building 885)

**SWMU ASSESSMENT REPORT AND
PROPOSAL FOR NO FURTHER ACTION
DRAIN AND SEPTIC SYSTEMS SITE 1101,
BUILDING 885 SEPTIC SYSTEM**

**RESPONSE TO REQUEST FOR SUPPLEMENTAL
INFORMATION AND PROPOSAL FOR
CORRECTIVE ACTION COMPLETE,
DRAIN AND SEPTIC SYSTEMS SITE 1101
BUILDING 885 SEPTIC SYSTEM, ADDITIONAL
EXCAVATION AND SOIL SAMPLING**

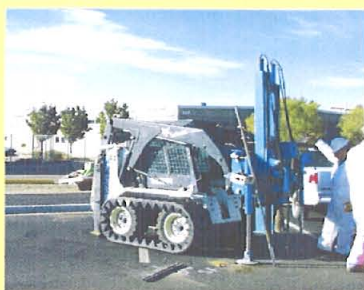
Auger drilling at the DSS Site 1101. Building 885 septic system seepage pit was located in the parking lot north of Building 885. View to the southwest. October 21, 2002.

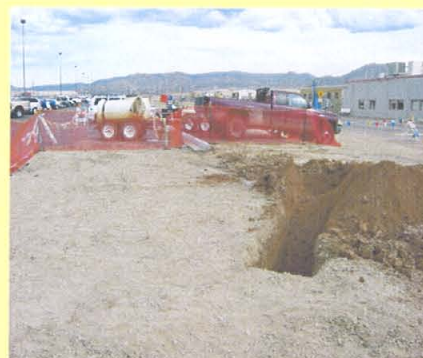
Backhoe Excavation #2 completed in the asphalt, curb, and gutter removal area at DSS Site 1101 to locate the buried drain line from Building 885. View to the southeast. March 3, 2006.

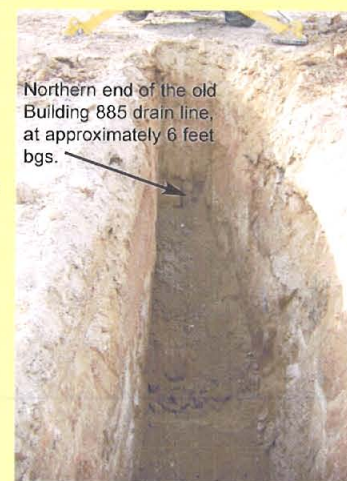
Photograph showing Backhoe Excavation #3 and the broken northern end of the old drain line running north from Building 885 and which marks the presumed location of the southern end of the former septic tank. View to the south. March 4, 2006.

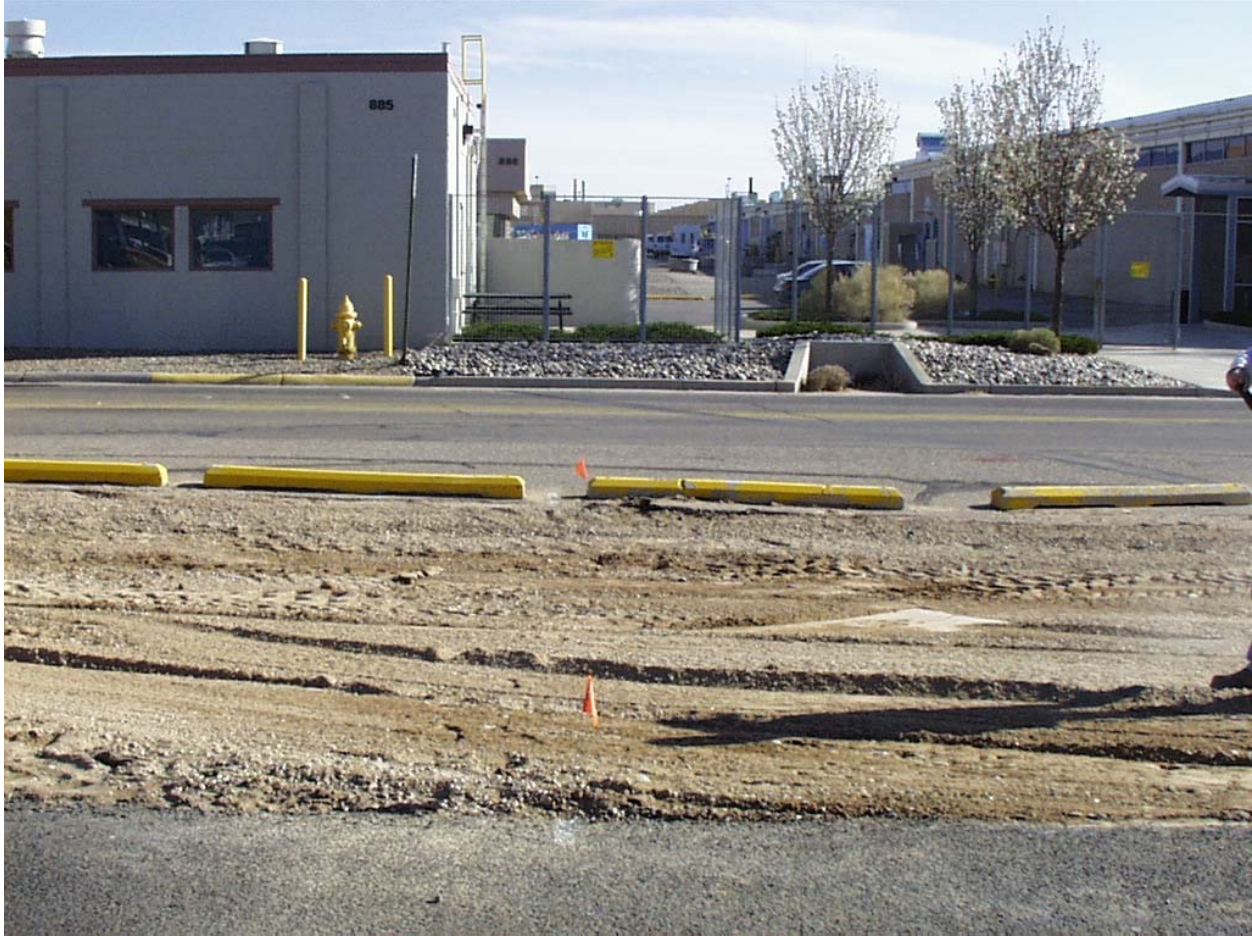
Figure 3.2-1
Two orange pinflags mark the location of the DSS Site 1101, Building 885 septic system,
drain line running north from Building 885 (upper left of photo) and beneath "H" Street.
View to the south. March 26, 2002

On March 26, 2002, a backhoe was used to locate and expose the septic system drain line shown on the engineering drawing (SNL/NM June 1980) running north from the northwest corner of Building 885 to the former septic system. The line was located at an average depth of approximately 5 feet in the unpaved strip between “H” Street and the south side of the parking lot. The line was followed north to the point where it continued under the paved pedestrian walkway on the south side of the parking lot (Figure 2.2.1-2). The backhoe work was stopped at this point in order to prevent damage to the concrete curb and gutter and asphalt pavement and evaluate noninvasive methods that might be used to locate the seepage pit beneath the pavement. The location of the trench excavated to expose the drain line in this area is marked by orange pinflags shown in Figure 3.2-1. No visible evidence of stained or discolored soil indicating possible leakage from the drain line was observed during the excavating procedure. No samples were collected during the backhoe excavation at the site.

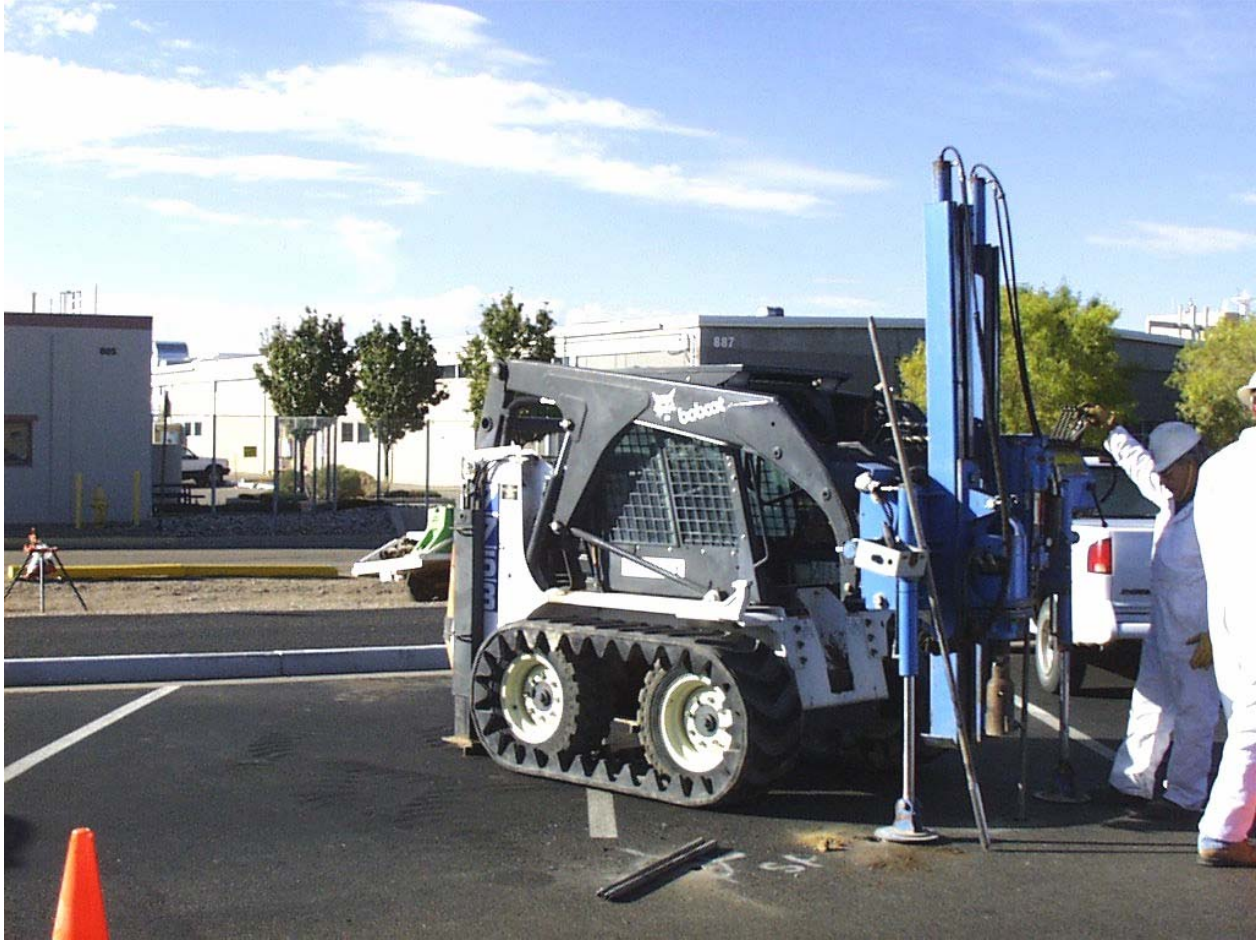
Figure 3.4-1
Auger drilling at the DSS Site 1101, Building 885 septic system seepage pit location in the parking lot north of Building 885, shown in the center-left side of the photo.
View to the southwest. October 21, 2002

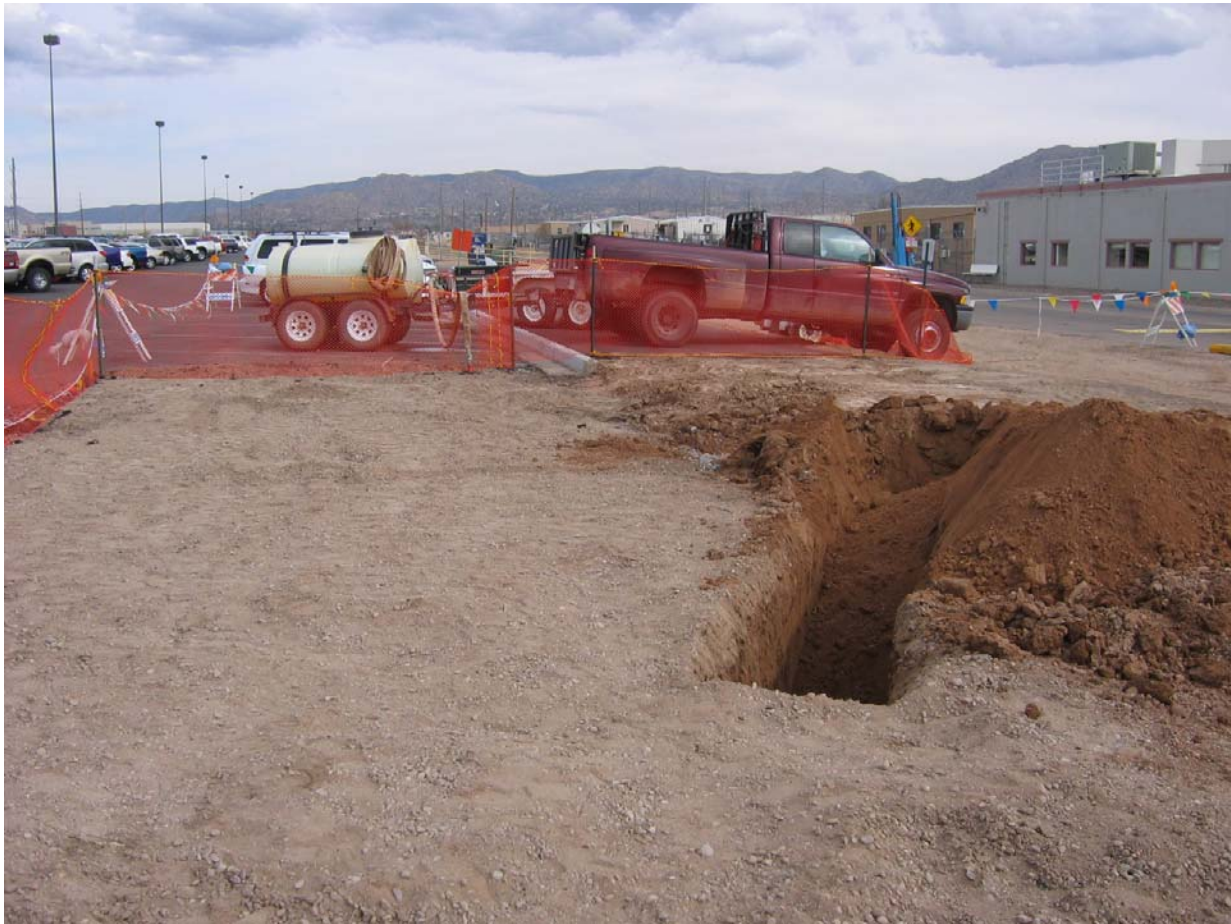
Figure 2-1
Backhoe Excavation #2 completed in the asphalt, curb, and gutter removal area at
DSS Site 1101 to locate the buried drain line from Building 885.
View to the southeast. March 3, 2006.

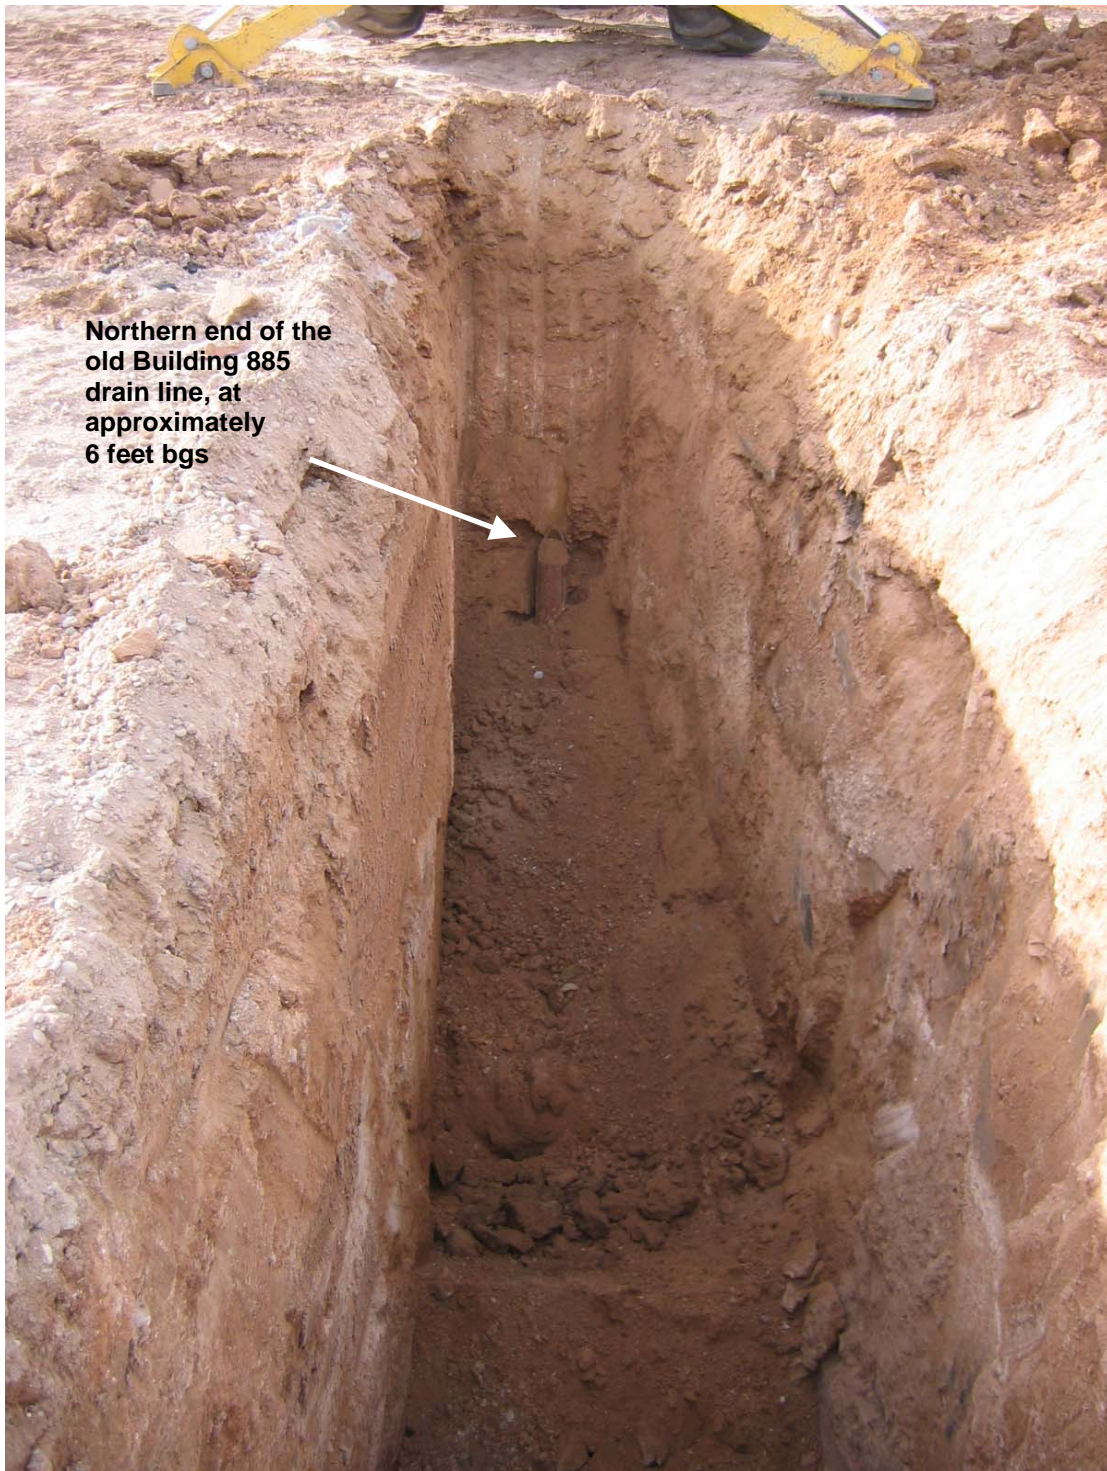
Figure 2-2
Excavation #3 showing the broken northern end of the
old drain line running north from Building 885 and which marks the presumed location of the
southern end of the former septic tank. View to the south. March 4, 2006.

Excavation #3 was completed on March 4, 2006. Digging started at the northern edge of the asphalt-cleared area and proceeded south toward the location of the drain line where it was found in Excavation #2. This trench was excavated to the maximum depth possible with the backhoe (approximately 13 feet bgs), and digging continued until the northern end of the old Building 885 drain line was encountered (Figure 2-2). No indication, or remains, of either a septic tank, seepage pit, seepage pit aggregate, or a northeast-trending drain line running toward the northeast seepage pit were found in this excavation. It was therefore concluded that the septic system components (septic tank and one or two seepage pits) had been completely removed from the site before the parking lot and walkway were constructed.

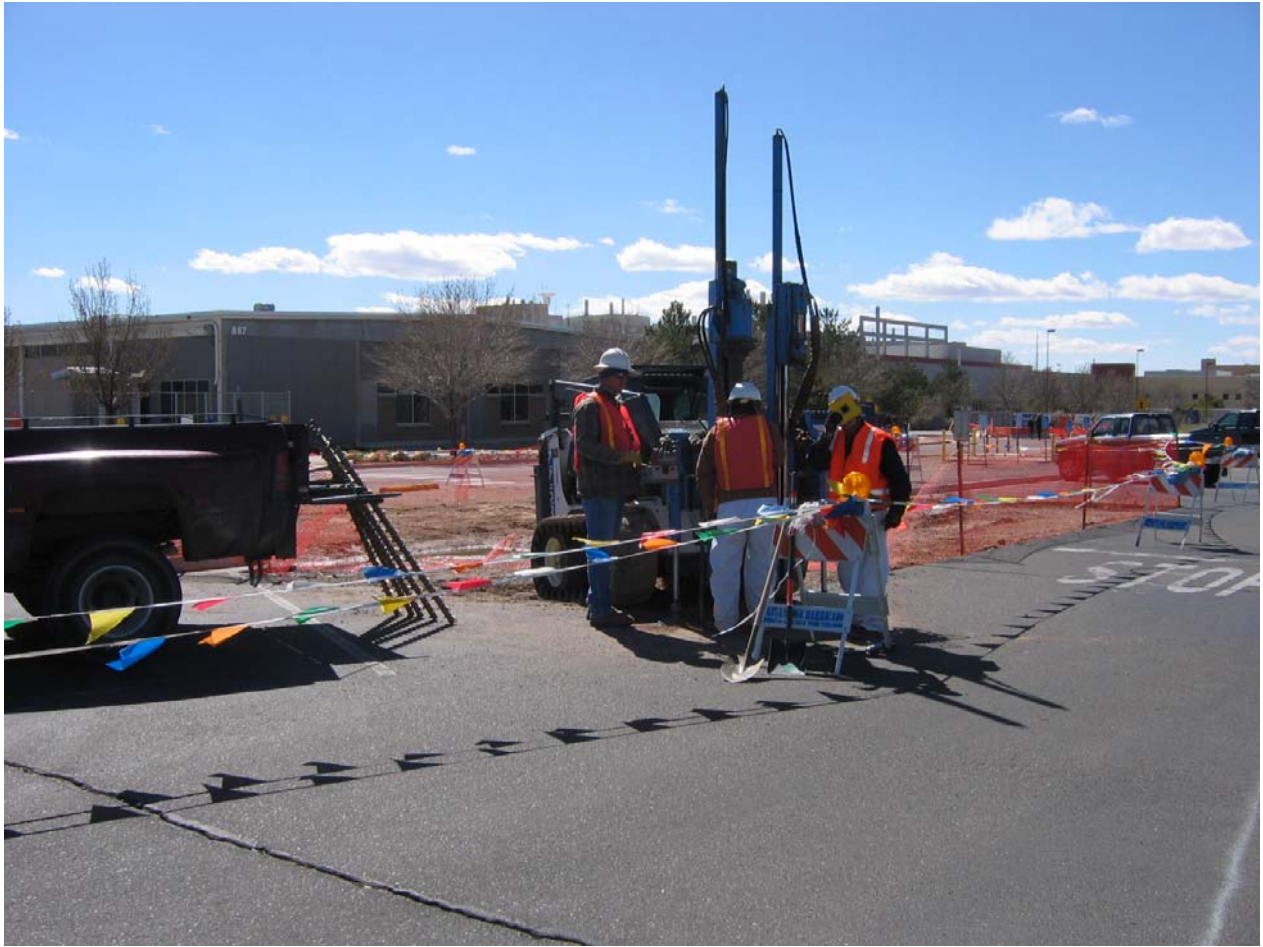
Figure 3-1
Collecting soil samples with the auger rig from beneath the center of the former northeast seepage pit location as indicated in engineering drawings.
View to the southwest. March 13, 2006.

On March 13, 2006, the auger rig was positioned over the location of the center of the northeast seepage pit shown in the June 1980 engineering drawing, and at the location where a failed attempt to collect soil samples was made in October 2002 (Figure 3-1). Once again, an obstruction was encountered at 23 feet bgs. This time, however, it was concluded that this most likely represented the same rocky layer encountered in the southwest seepage pit borehole location, instead of remains of a seepage pit, as was assumed in 2002. This layer was also penetrated with the 3-inch augers, and soil samples were successfully collected at depths starting at 25 and 30 feet bgs at this location (885-SP1-BH2 in Figure 1-2).
