Past, Present, Future: The Evolution of a Wetland Treatment System in Dutchman Canyon on Vermejo Park Ranch

A Professional Project Proposal Submitted in Partial Fulfillment of the Requirements for
the Degree of

Master of Water Resources

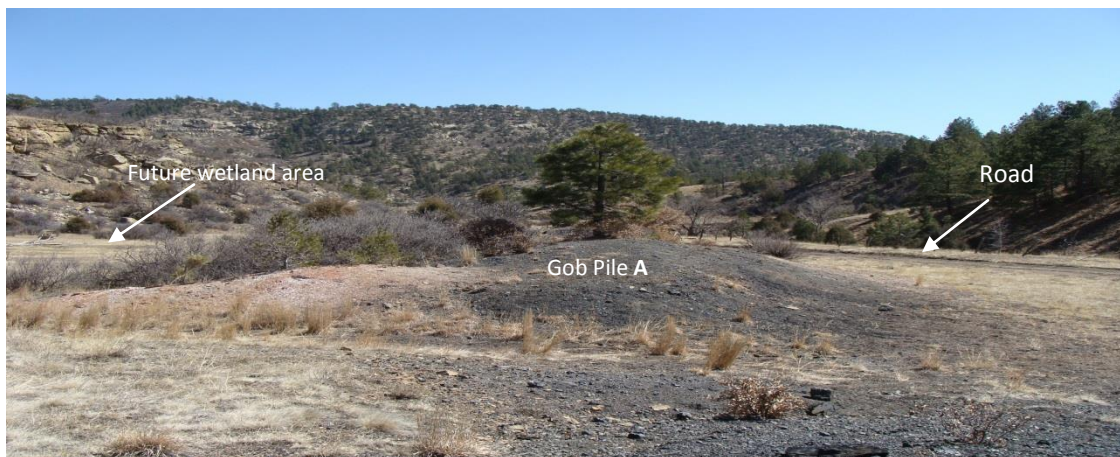
Figure 5: Standing at downstream edge of second pond looking east (2009 EA)

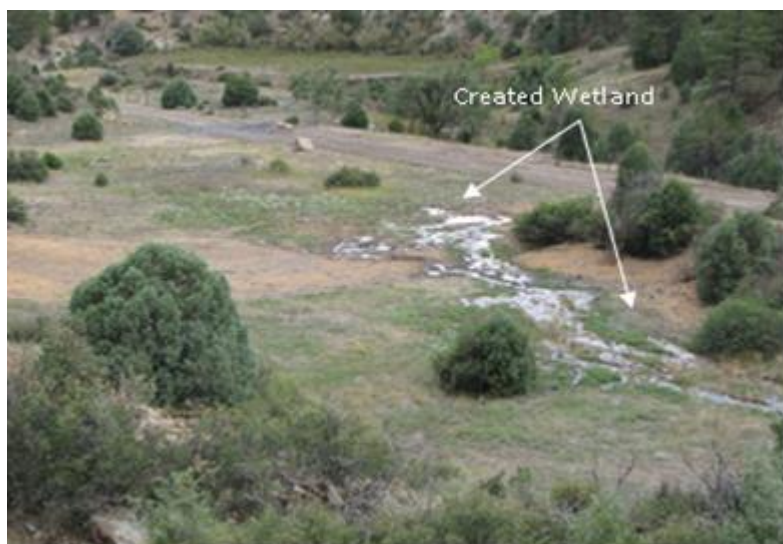
Figure 8: Genesis of wetland August, 2012 (Isaacson 2012)

small meadow below the ponds. The road grade flanking the ponds was elevated, and the waste piles surrounding the meadow were reclaimed in-situ. Once the area adjacent to the spillway was deemed sufficiently hydrated, salt tolerant wetland plugs were planted. Willow stakes were also planted in groups at the far end of

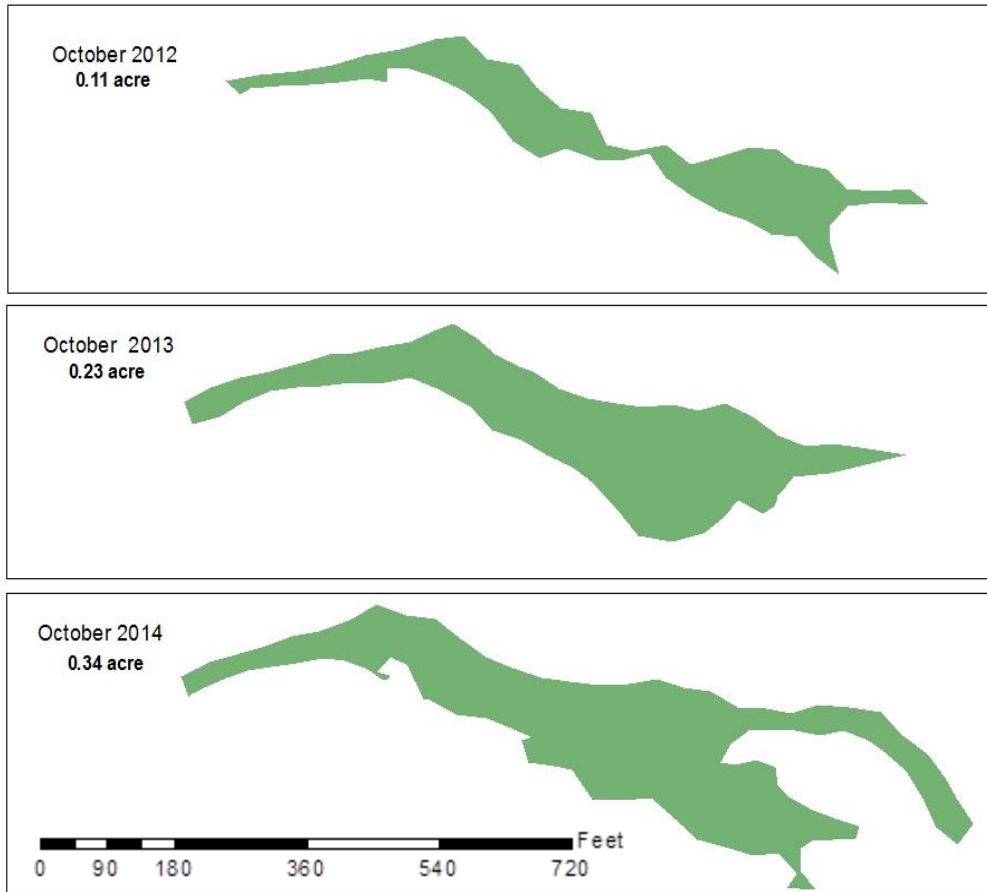
Figure 12: Change in wetland extents through time (Isaacson 2014)

The total wetland acreage as of October 2014 is 0.63 acres; according to Lawler 2007, an emergent wetland can produce up to 4 pounds of biomass per 10 ft.² per year, this equates to 10,977 pounds of biomass produced each year by the newly constructed wetland. This has significant impacts on carbon storage, nutrient cycling, and water holding capacity of soils to name a few. Wetlands also provide between 3,000 to 5,000 pounds of forage per acre per year (Zeedyk, 2014). The constructed wetland provides large ungulates and other grazing animals with 1,800 to 3,150 pounds of food mass, not to mention the habitat created for insects and other primary consumers that in-turn provide food for a plethora of wetland-dependent biota.

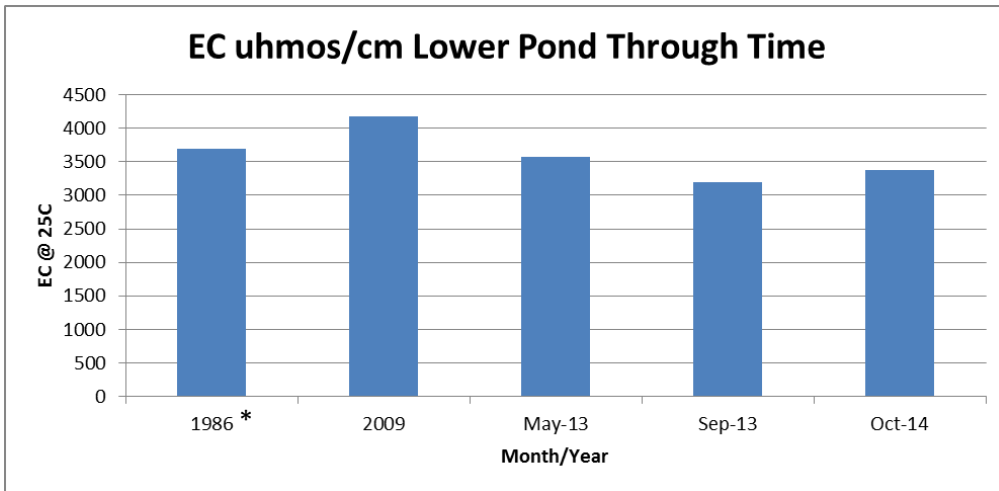
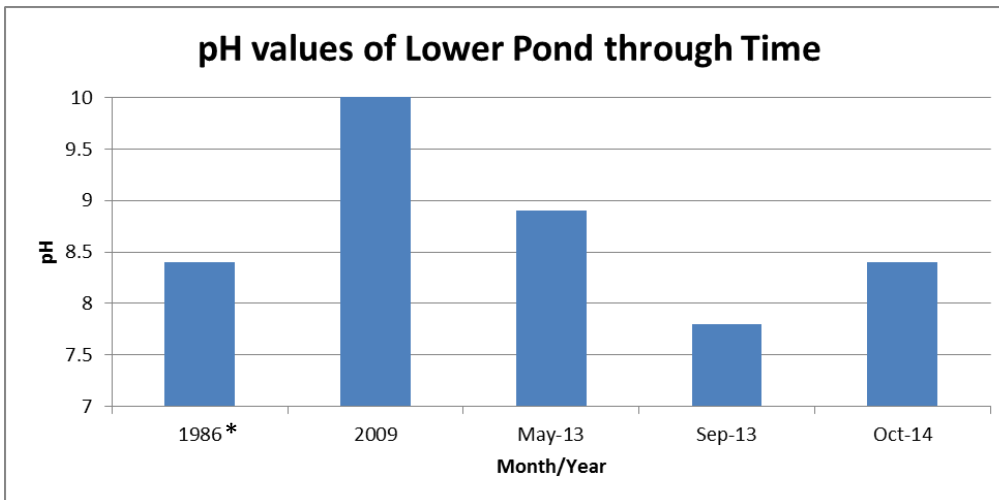
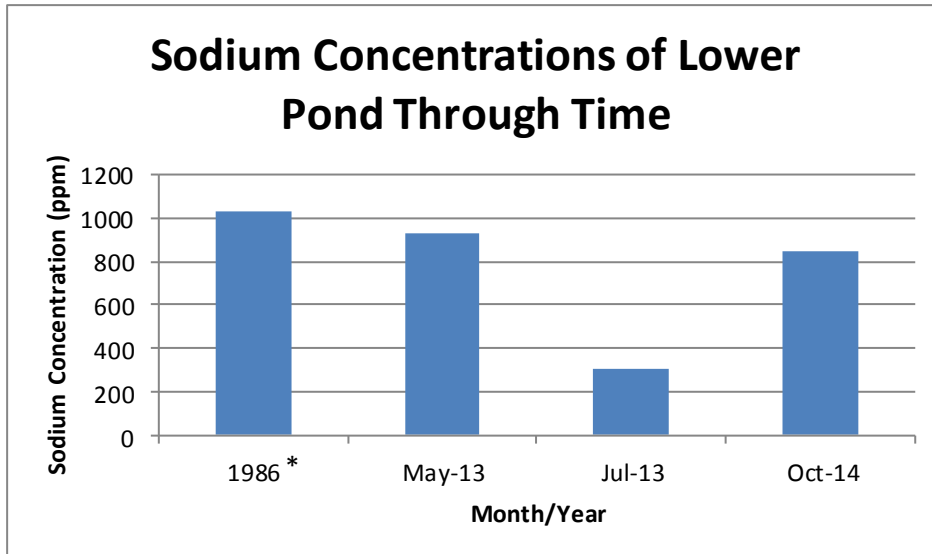
Figures 14, 15, 16, and 17: Analyte concentrations decrease through time; possible correlation with the implementation of wetland (Isaacson 2014)

occasions except on testing date 05/21/2013; transect ZI-4 had a pH value of 9.2. All samples indicated that this water was extremely alkaline. Bicarbonate as HCO_3 more often than not, exceeded 2000 mg/l. The alkalinity of this water indicates that the water body has a robust capacity to buffer against larger shifts in pH, however, this contradicts the comparison of the 2009 results to the latest 2014 results. This suggests that there was an error in the reports from 2009.

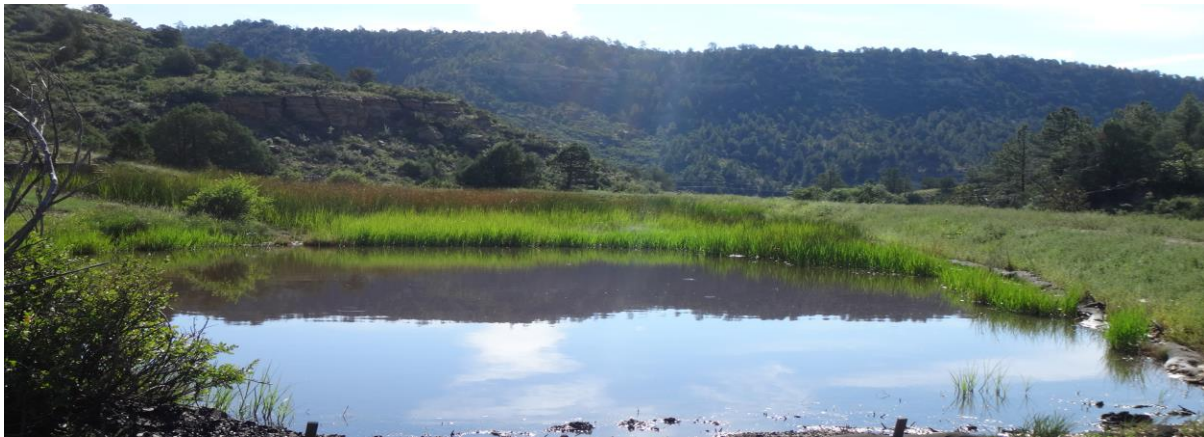
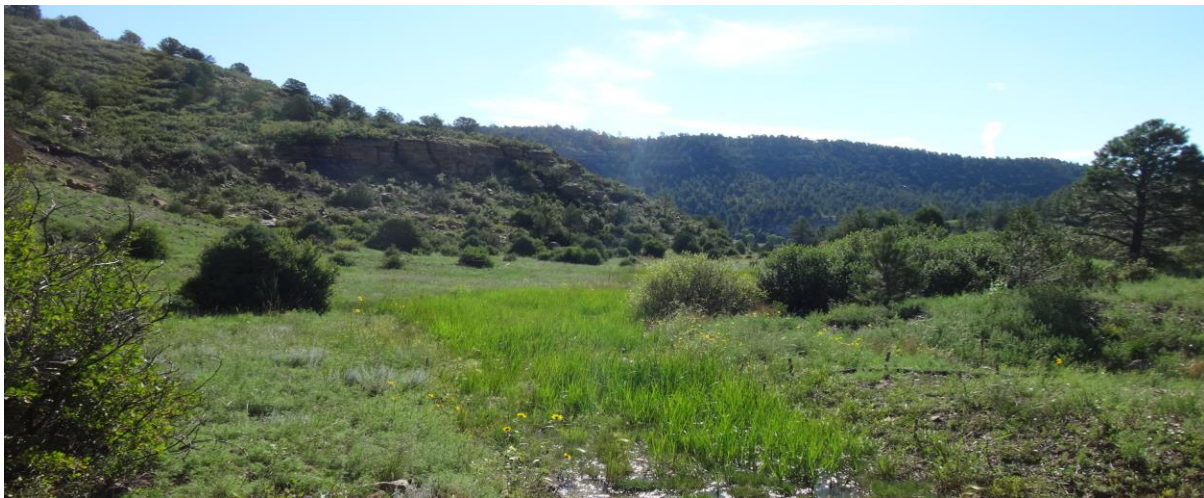
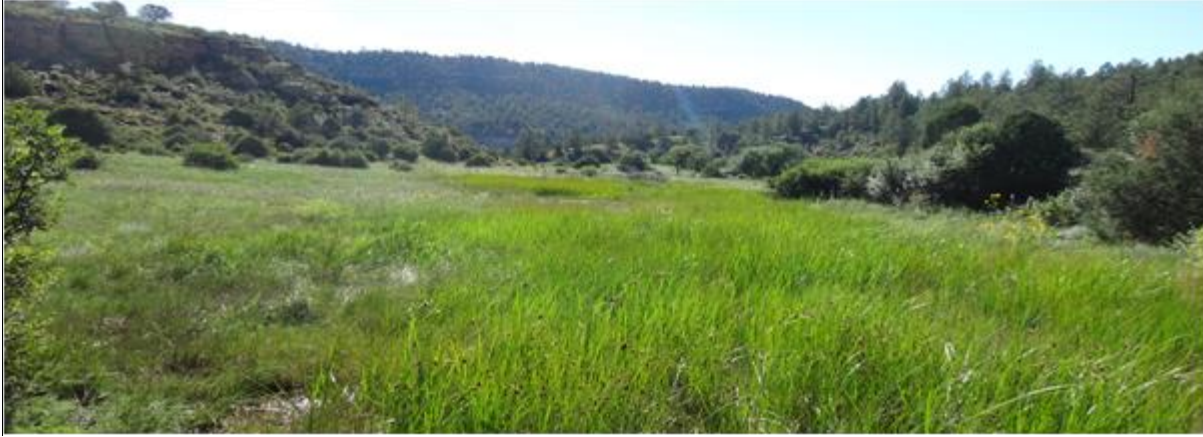
Figures 18, 19, and 20: Photos taken August 2014 from lower pond to downstream extents (Isaacson 2014)

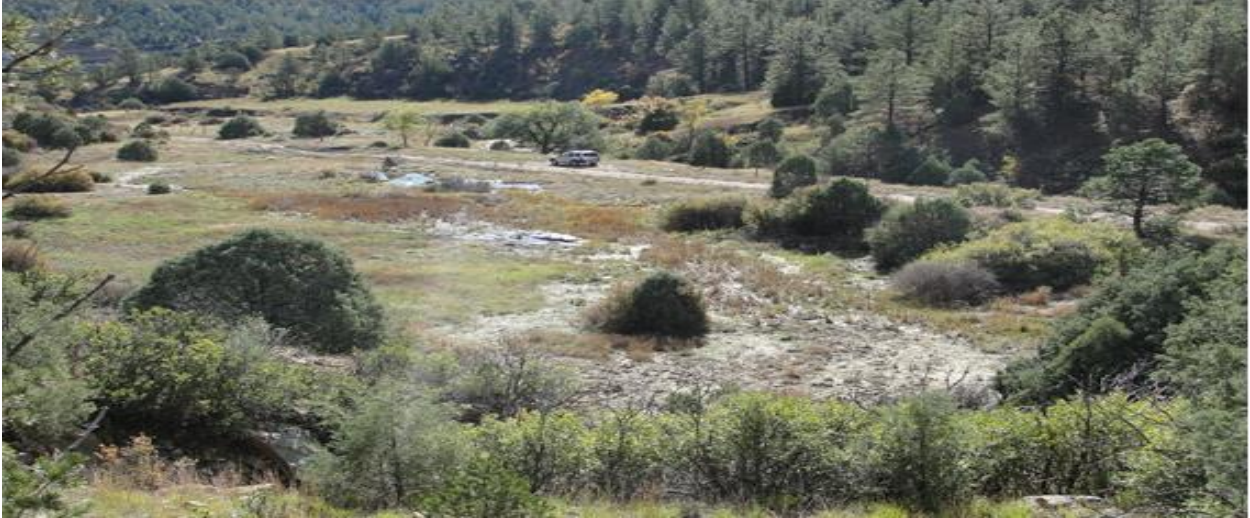
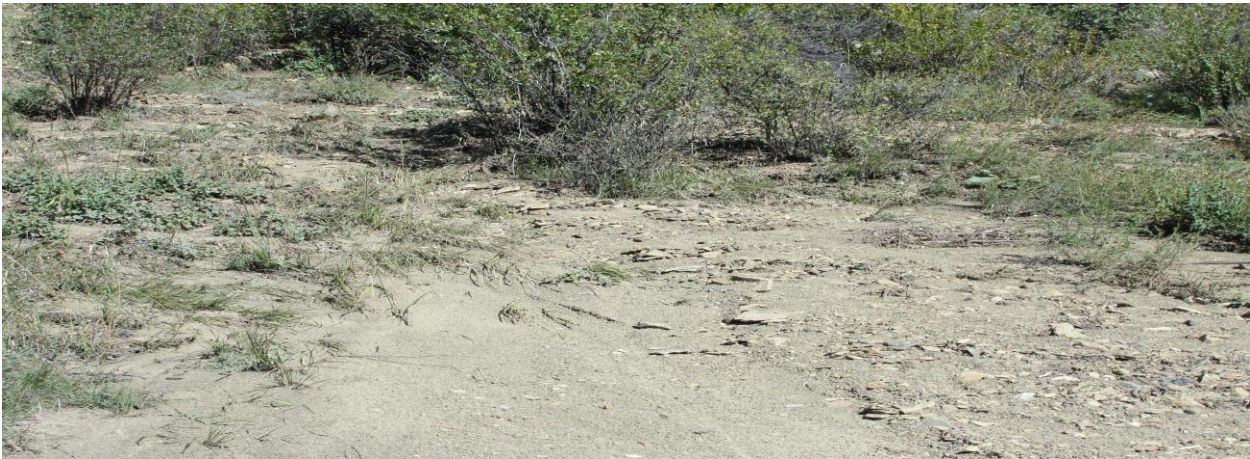
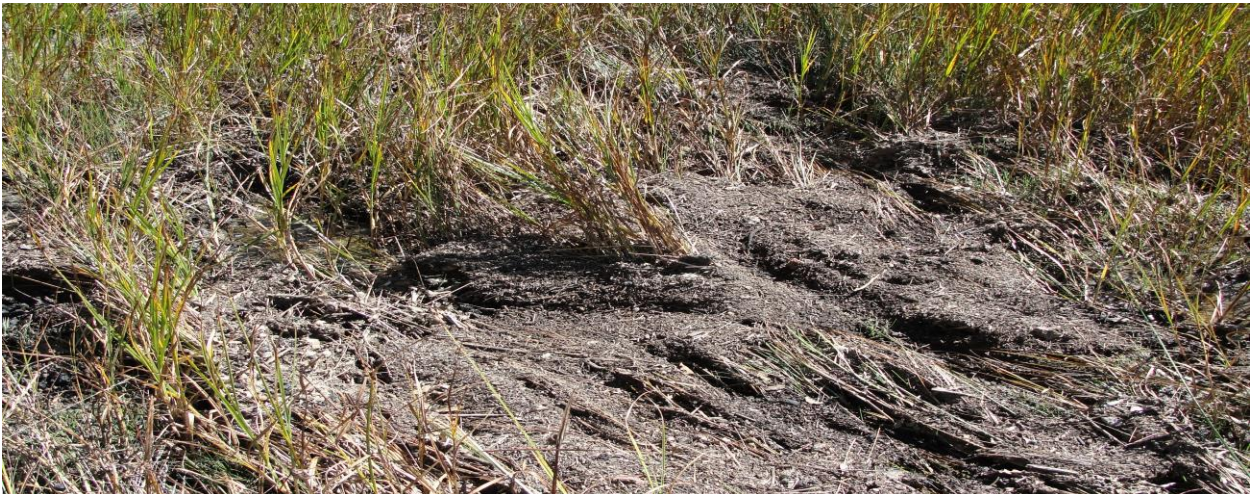
Figure 22, 23, and 24: Photos of post flood damage (Isaacson 2014)

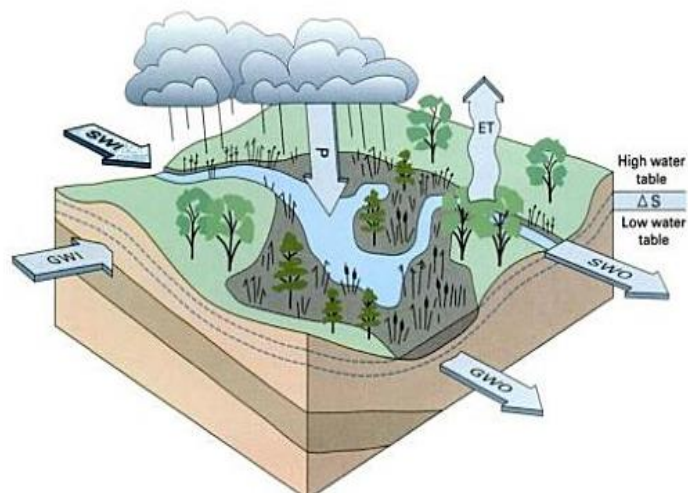
Figure 32: Hydrologic process of wetlands (Carter, 1996)
