# **Taking Out the Jacks**

## **Issues of Jetty Jack Removal in Bosque and River Restoration Planning**

**By Kathy Grassel**

**Water Resources Program  
The University of New Mexico  
Albuquerque, New Mexico 87131-1217  
[www.unm.edu/~wrp/](http://www.unm.edu/~wrp/)  
Publication No. WRP-6  
July 2002**

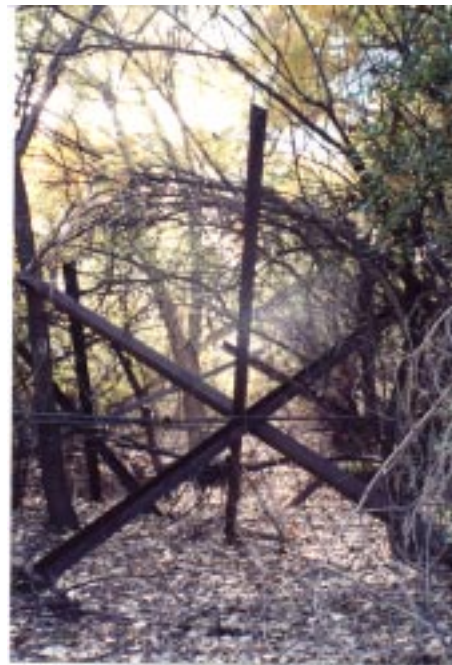
*Fig. 2: Intact jack in the bosque*

These days we observe a Kellner jetty in less than mint condition and it is most often tangled with vegetation, underwater, detached from its original line, or partly exposed. Occasionally we see a fairly intact high-and-dry jetty line as in the Fig. 2 above that gives us an idea of how it might go together. It is

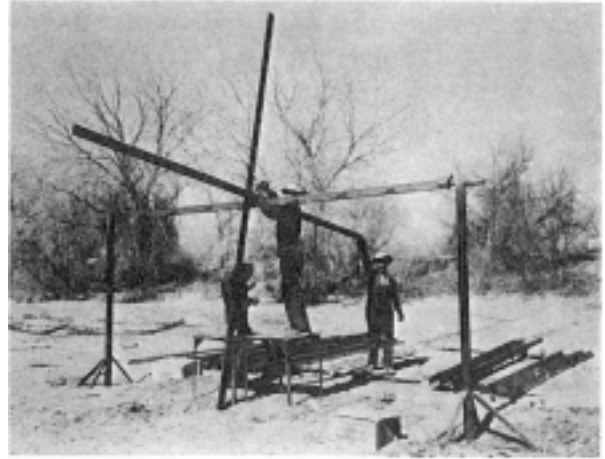
*Fig. 3: Workers assemble a jack on site. Casa Colorado area, Middle Rio Grande Project, NM. Photo:Herman E. Carter, Bureau of Reclamation (Carlson and Enger 1956).*

The angles were set at the factory, after which connection holes and lacing holes were punched into the angles. At this point, the parts were ready to ship to the user. From the Topeka factory, the Kellner Jetties Company would send out crates full of steel angles, lacing wire, cable, cable clamps, and railroad ties. The shipment would be hauled to the job site for assembly. The company also furnished a construction supervisor who employed a crew of 12 laborers—12 was optimum—using hand tools. The crew assembled the units (see Fig. 3), then carried, hauled (see Fig. 4), rolled, or rafted them into place, 12 ½ feet apart. They then threaded the units together with double lines of thick ¾-inch diameter cable and clamped the cables together at the unit center points. Excavation was rarely required to position the jacks (U.S. Army Corps of Engineers 1953). See a schematic of a jetty field in Fig. 5.

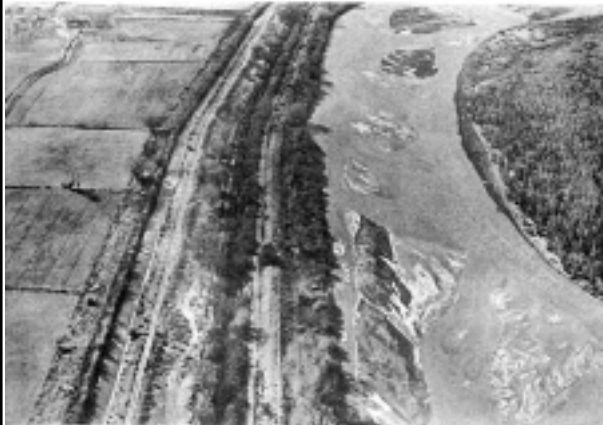
*Fig. 9: Installation of jetty field on the Rio Grande near Bernalillo, NM. Aerial photos by the Corps of Engineers.*

*Fig. 9(a): Location of the jetty installation. Photo: Dec. 12, 1952.*

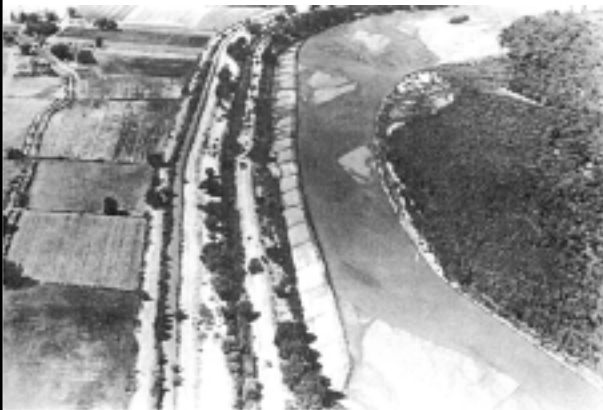
*Fig. 9(b): Jetty field installed. Photo: Aug. 12, 1953.*

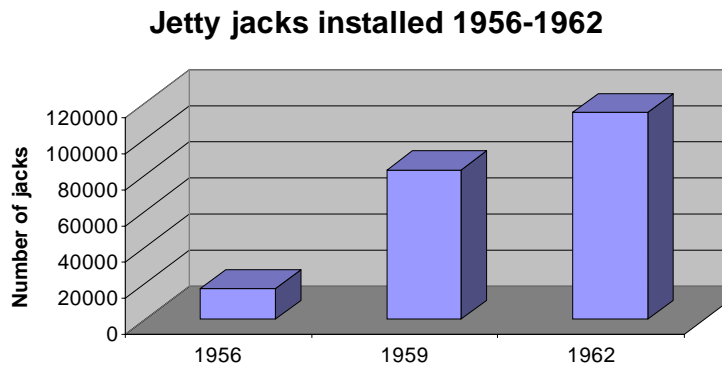
*Fig. 10: Straightening the channel with jetty jacks*

more units were installed. By 1962, a total of 115,000 jacks were in place (Lagasse 1980). Fig. 10 illustrates the rapidity of jetty jack installation between 1956 and 1962. These same years were years of low flow, so conditions were perfect both for rapid installation and subsequent

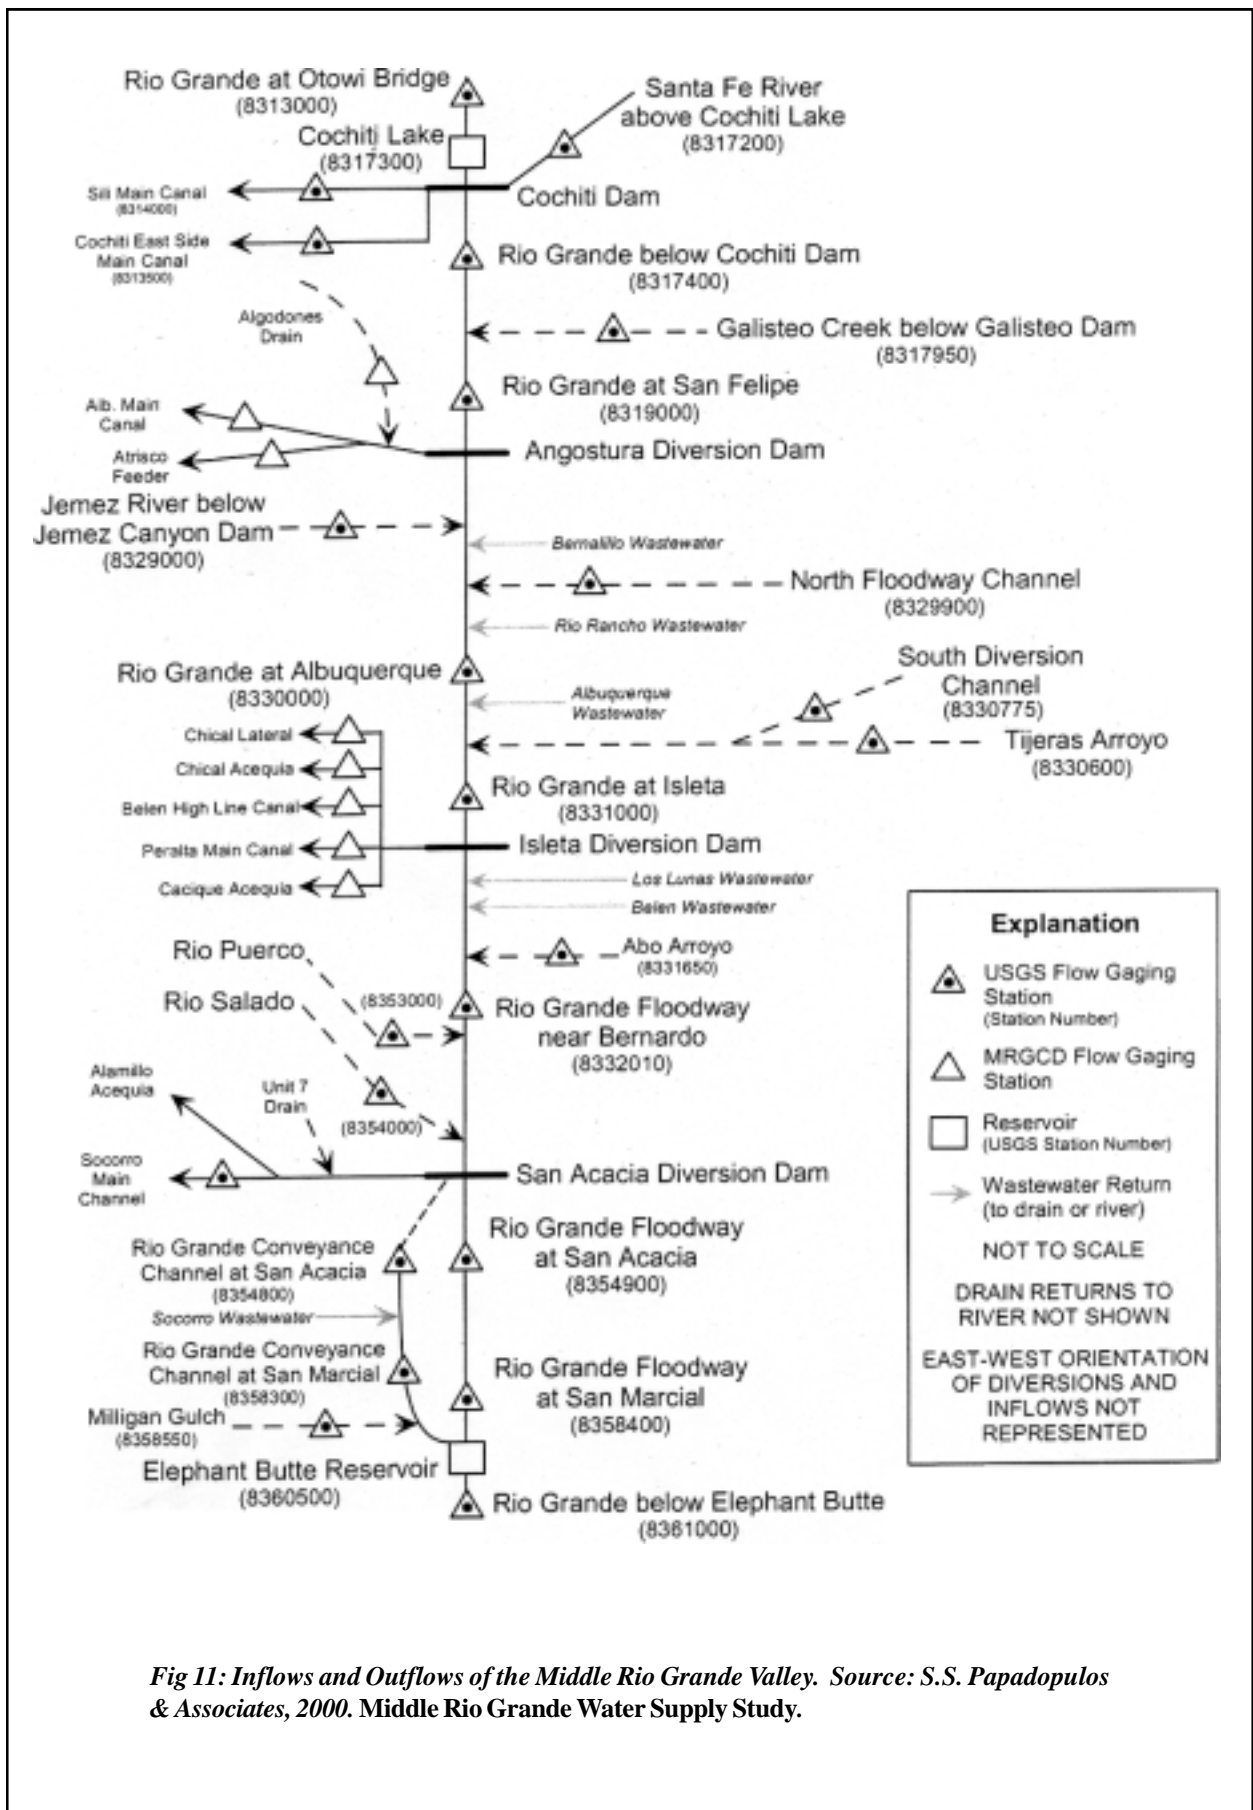
*Fig 11: Inflows and Outflows of the Middle Rio Grande Valley. Source: S.S. Papadopoulos & Associates, 2000. Middle Rio Grande Water Supply Study.*

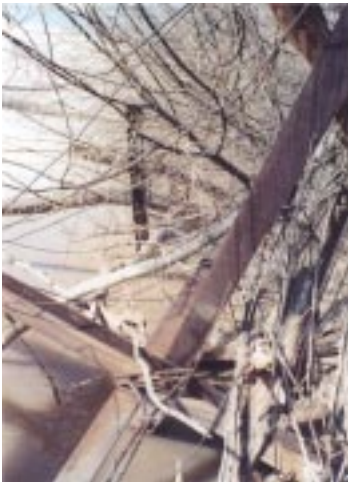
*Fig. 14: The MRGCD wants riverbank jacks to stay in place for levee protection*

Photographs below (see Figures 14, 15 and 16) of the present condition of random jacks in the Middle Valley indicate that Lagasse's calculation that then existing lines could be undercut and buried has been borne out.

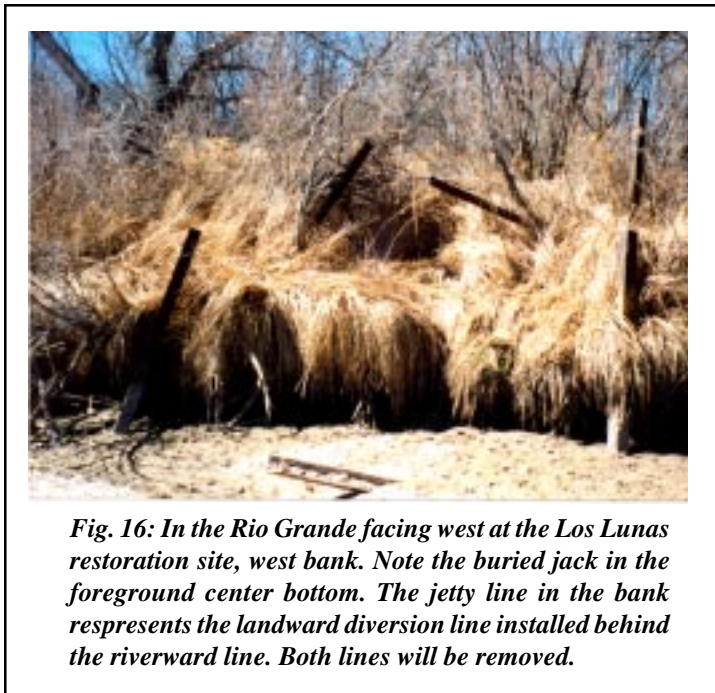
What can be found in common among these interests is a desire to protect the levees, which means that in areas where levees and jetty jack co-exist, jetty jacks are the first and second lines of defense. Much of the discussion of which jetty jacks the bosque and river can live without is driven by

this exigency. This means, just as in real estate, only three things are important when designing a removal plan: location, location, and location.

As noted above, the jacks were placed to establish a bank and as a buffer to protect the levees. As lowering riverbanks and cutting channels into the area may be the only way to reconnect the river to the bosque, removal of the jacks holding those banks is the first step. Unlike in the Cochiti area below the dam where the paucity of sediment supply has caused erosion behind the jetty lines and rendered them useless, the second tier of jacks in the Los Lunas area has maintained the bank line. The vegetation built up behind the bank line provides a buffer between the river and the levee (see Fig. 16 above).

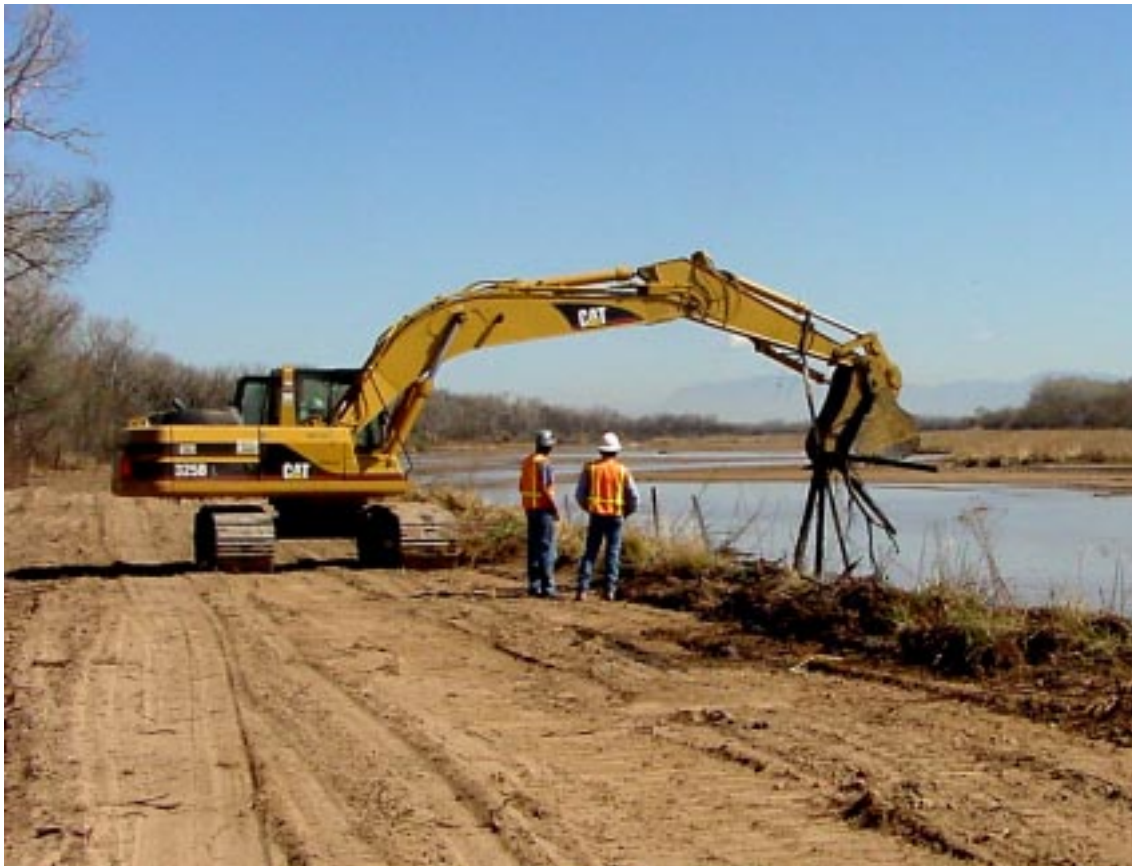
*Fig. 17: Los Lunas, west bank. The first day of jetty jack removal, Apr. 9, 2002. Bankline jacks are the first to be removed. The job of removing 1,355 jacks is expected to take one to several months. Photo by Mark Horner, U.S. Army Corps of Engineers.*

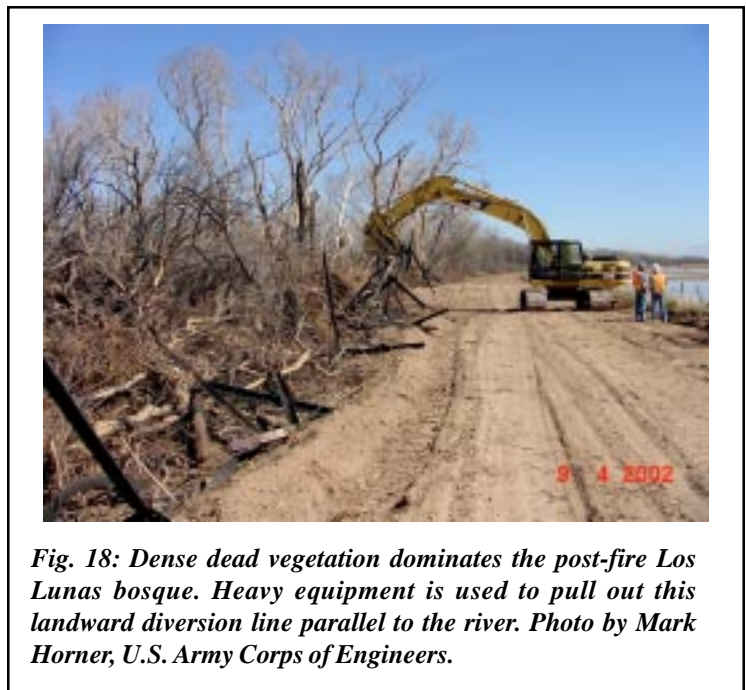
While this much is known, no analysis was conducted to assess feasibility of removal or to predict the effects of removal of the jetties. The mostly buried river jacks were expected to crumble when pressure was applied to extract them, but the jacks came out much easier than expected (Tashjian, pers. com.). The tieback lines are expected to come out fairly easily, even though interspersed with dense vegetation.

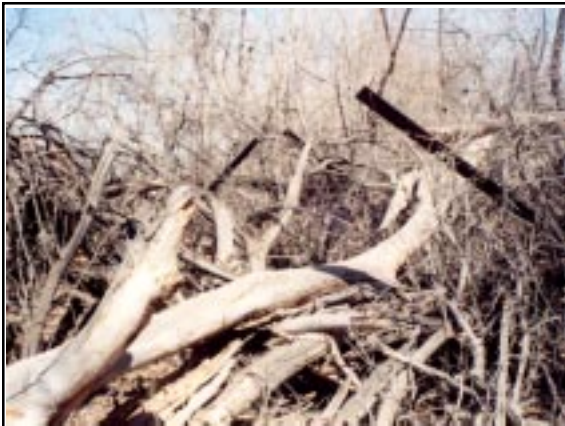
*Fig. 19: Dead and down wood tangled in jetty jacks in the bosque, slated for removal as part of the Rio Grande Valley State Park restoration project. Jetty jacks armor the river banks and prevent overbank flooding, so wood litter can't decompose, making it ready fuel for fires.*

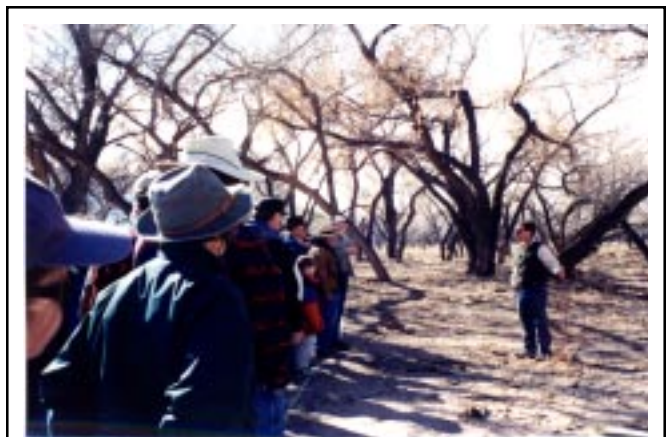
*Fig. 22: Results of jetty jack removal and exotic vegetation removal. Todd Caplan, project engineer for the Pueblo and the Bureau of Reclamation, gives a tour in the cottonwood bosque at Santa Ana restoration project area, 1999.*

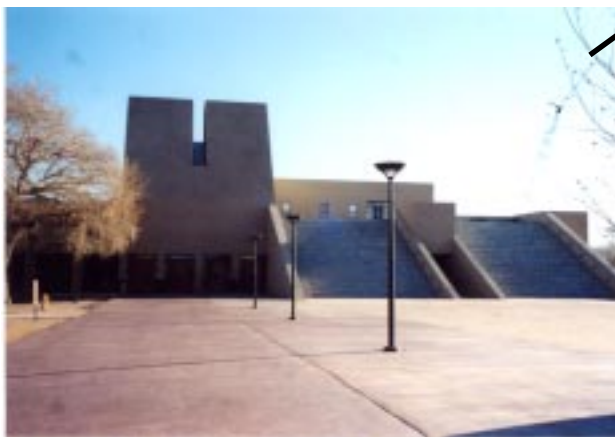
*Fig. 21: Barelas Bridge bosque will be cleaned up to adjoin the National Hispanic Cultural Center.*

Restoration in the bosque across from the National Hispanic Cultural Center also includes jetty jack removal.

- 34.....Fig. 21: Barelvas Bridge bosque will be cleaned up to adjoin the National Hispanic Cultural Center.
- 35.....Figures 23-24: Before and After: At left is a jetty jack installation at Santa Ana, photo 1974 (Lagasse 1980). Below is the result of bank restoration using bio-engineering methods and native willow planting.

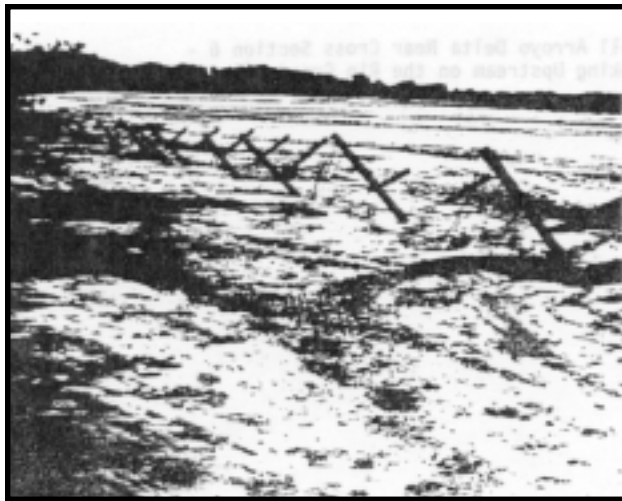
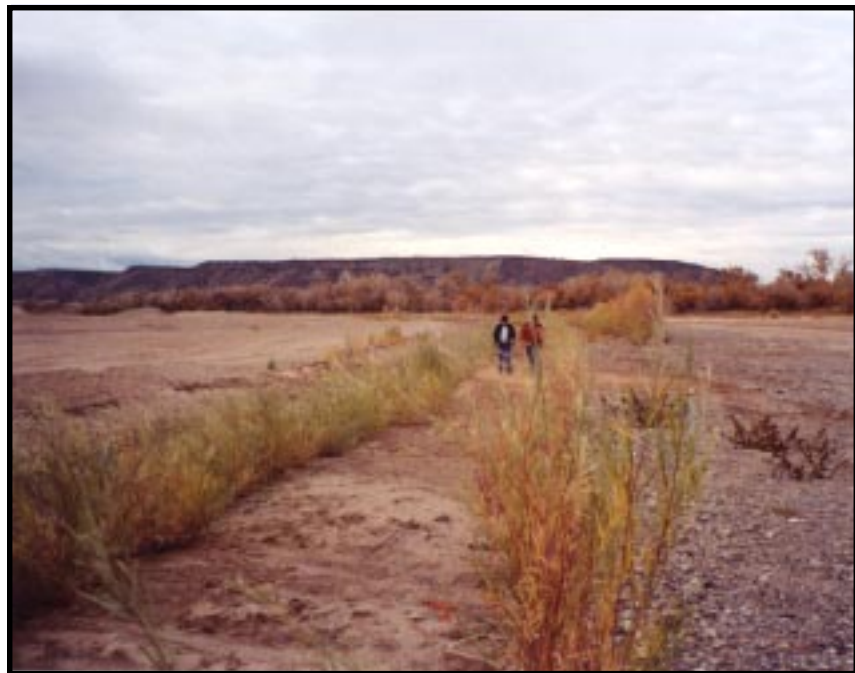
*Figures 23-24: Before and After: At left is a jetty jack installation at Santa Ana, photo 1974 (Lagasse 1980). Below is the result of bank restoration using bio-engineering methods and native willow planting.*

initiated in 1996 a restoration plan covering 1,200 acres of riparian land. The results have been impressive. The project is ongoing; so far 480 acres has been cleared of salt cedar and Russian olive (see Fig. 22 below). Revegetation with native trees and shrubs is completed on 30 acres to be expanded to additional acreage over the next several years. Soil remediation of 115 acres of saline soils had to be done before planting of native grassland. Finally, the Pueblo removed 1,600 jetty jacks from the abandoned floodplain adjacent to the river (see Fig. 23). Following clearing, part the channel was rebuilt to redirect flow away from a Bureau levee and bioengineering techniques were employed to build a new bank (see Fig. 24). The project is ongoing, well-funded, and successful.
