# Open Reduction and Internal Fixation for Treating Pertrochanteric Femoral Fracture Below a Hip-Resurfacing Implant in a 65-Year-Old Man: A Case Report

Department of Orthopaedics & Rehabilitation, The University of New Mexico Health Sciences Center, Albuquerque, New Mexico

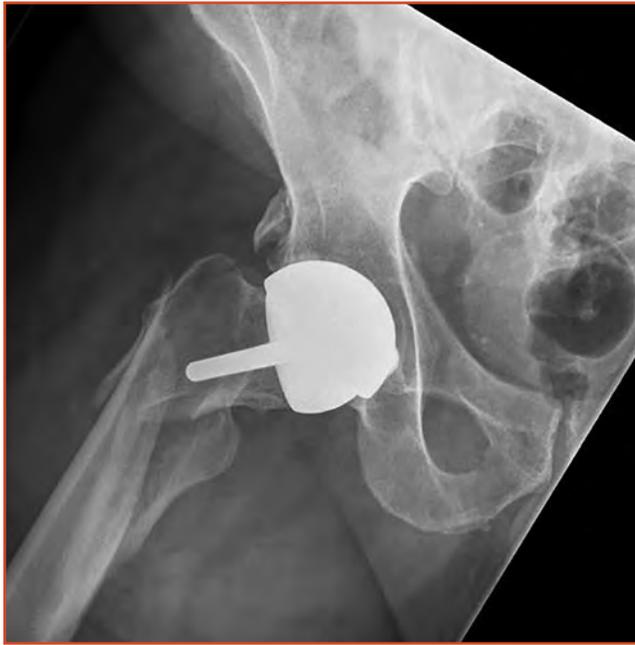
**Figure 1.** Anteroposterior radiograph of a right hip obtained at an outside facility, showing a displaced pertrochanteric femoral fracture distal to a well-fixed, hip-resurfacing implant.

A 65-year-old man presented to our emergency department with a right-sided pertrochanteric femoral fracture. The patient struck a tree while skiing and was initially evaluated at an outside facility. Findings of radiographs revealed a pertrochanteric femoral fracture beneath the implant used in a prior hip resurfacing (Figure 1). He was transferred to our level 1 regional trauma center for definitive treatment. Before the ski-related injury, the patient's pain had improved since his index procedure. Normal findings of motor and sensory neurological functions were noted. He had returned to all activities, including skiing and riding his motorcycle. Regarding the patient's index hip resurfacing, no radiographs of his pre-, intra-, and postoperative treatment were available.

neurological functions were intact, and findings of vascular examination were normal. Radiographs revealed an unstable intertrochanteric femoral fracture, involving the lateral cortex and the lesser tuberosity, with the degree of comminution somewhat appreciated. The hip resurfacing implant was well aligned, with a slight level of valgus noted.

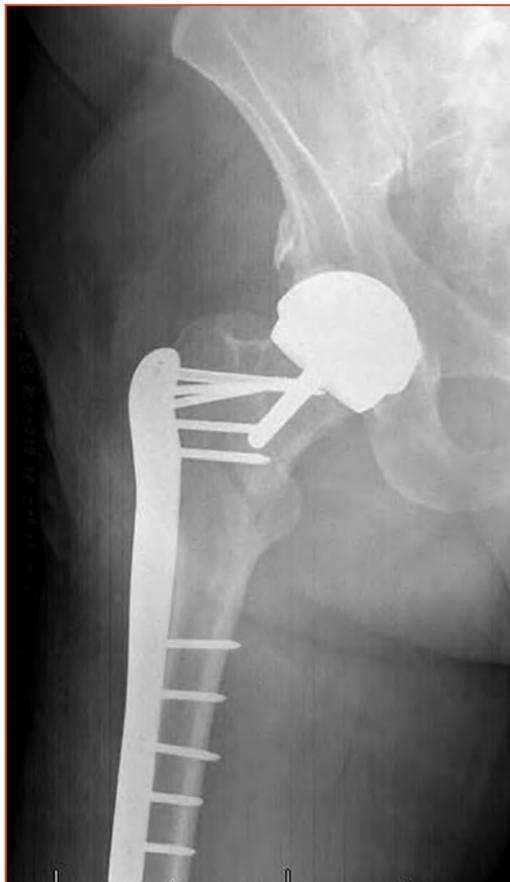
**Figure 2.** Immediate postoperative anteroposterior radiograph of the right femur, showing a well-reduced fracture with a lateral proximal femoral locking plate in place.

The patient was taken to the operating room and underwent ORIF in the lateral position. Fluoroscopy-assisted manipulation of the hip was used to ensure no loosening or instability of the hip-resurfacing implant. The hip was extended by pulling manually on the leg. The hip-resurfacing implant did not reveal any subluxation, dislocation, or play within the proximal femur. A standard lateral approach to the femur was used to ensure the hip capsule was not violated. Near-anatomical fixation was achieved by using a proximal femoral locking plate.

Because the hip-resurfacing implant was not loose and the patient was happy with his prior level of function, extramedullary fixation was performed to treat the fracture. Owing to the presence of the hip-resurfacing implant, intramedullary and cephalomedullary nailing or other fixation techniques placing large diameter fixed angle implants into the femoral neck were not possible. Total hip arthroplasty was not recommended because the patient functioned well after his prior fracture and the implant did not appear loose. The most proximal screws were drilled and placed free-handedly with nonlocking screws to avoid the hip-resurfacing implant (Figures 2 and 3). Postoperatively, the patient was discharged with posterior hip precautions and no weight bearing on his right leg.

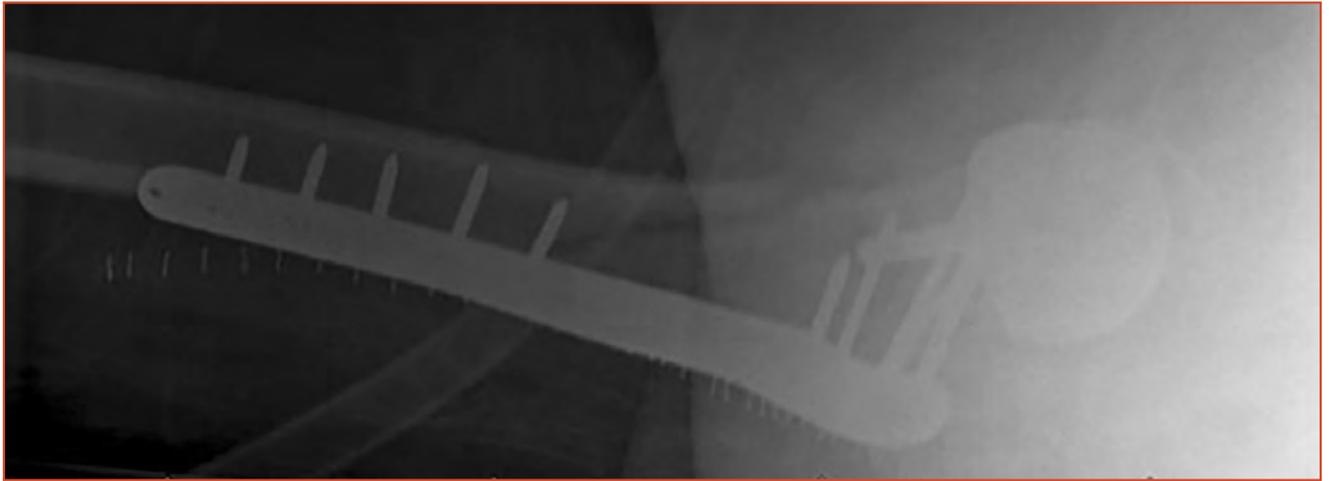
**Figure 3.** Immediate postoperative lateral radiograph of the right femur, showing a well-reduced fracture with a lateral proximal femoral locking plate in place.

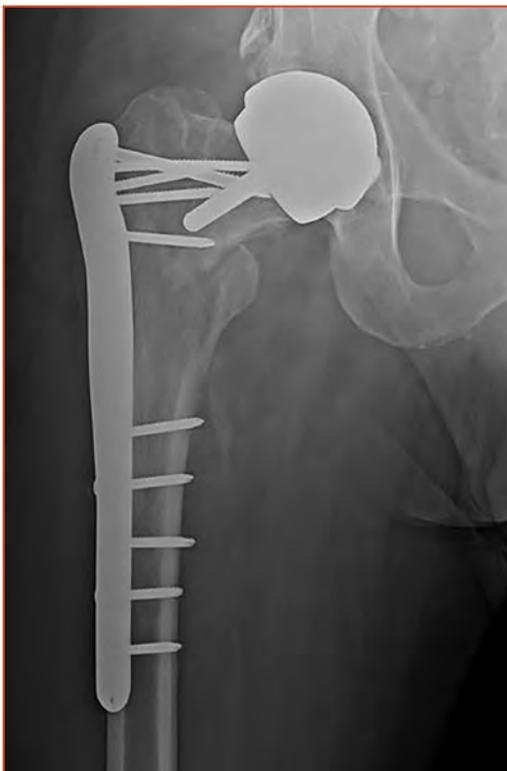
**Figure 4.** At 6 weeks postoperatively, anteroposterior radiograph of the right femur shows mild varus collapse of the fracture without implant complications.

At 2-week follow-up, he reported that he was doing well and radiographic findings were promising. His weight bearing progressed to touch down. At his 6-week follow-up, he reported he was still doing well, with no falls or complications at home. Findings of radiographs revealed mild varus collapse of his fracture without evidence of the hip-resurfacing implant loosening or dislocating (Figure 4). The patient maintained touch-down weight bearing until his 3-month follow-up, at which time the radiograph findings revealed a stabilized fracture. He also reported that he had been putting full weight on his leg. As such, he was progressed to full weight bearing. At 5-month follow-up, the patient had returned to all activities, including riding his motorcycle, and had no concerns. Radiograph findings showed stabilization of his varus collapse, no implant complications, and healing of his fracture (Figure 5).
