An Engineered Fit-For-Purpose Polymer Nanocomposite Seal Repair Material for Wellbores

Civil, Construction & Environmental Engineering

DISSERTATION

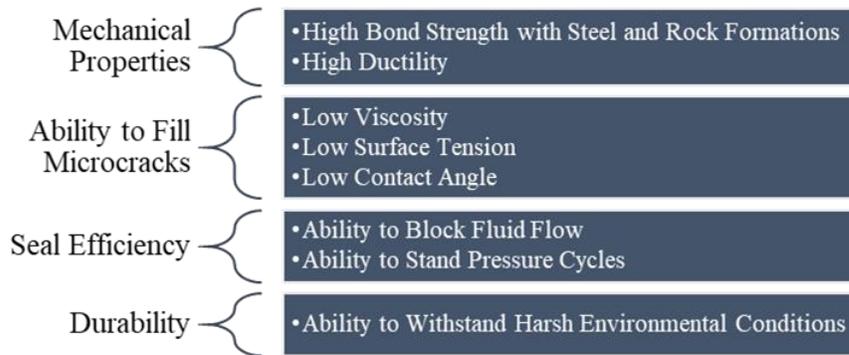
Figure 1.1: Summary of the desired properties of wellbore seal repair material.

The desired properties of wellbore seal repair material are summarized in Figure 1.1. High bond strength and ductility are required to allow the seal repair material to

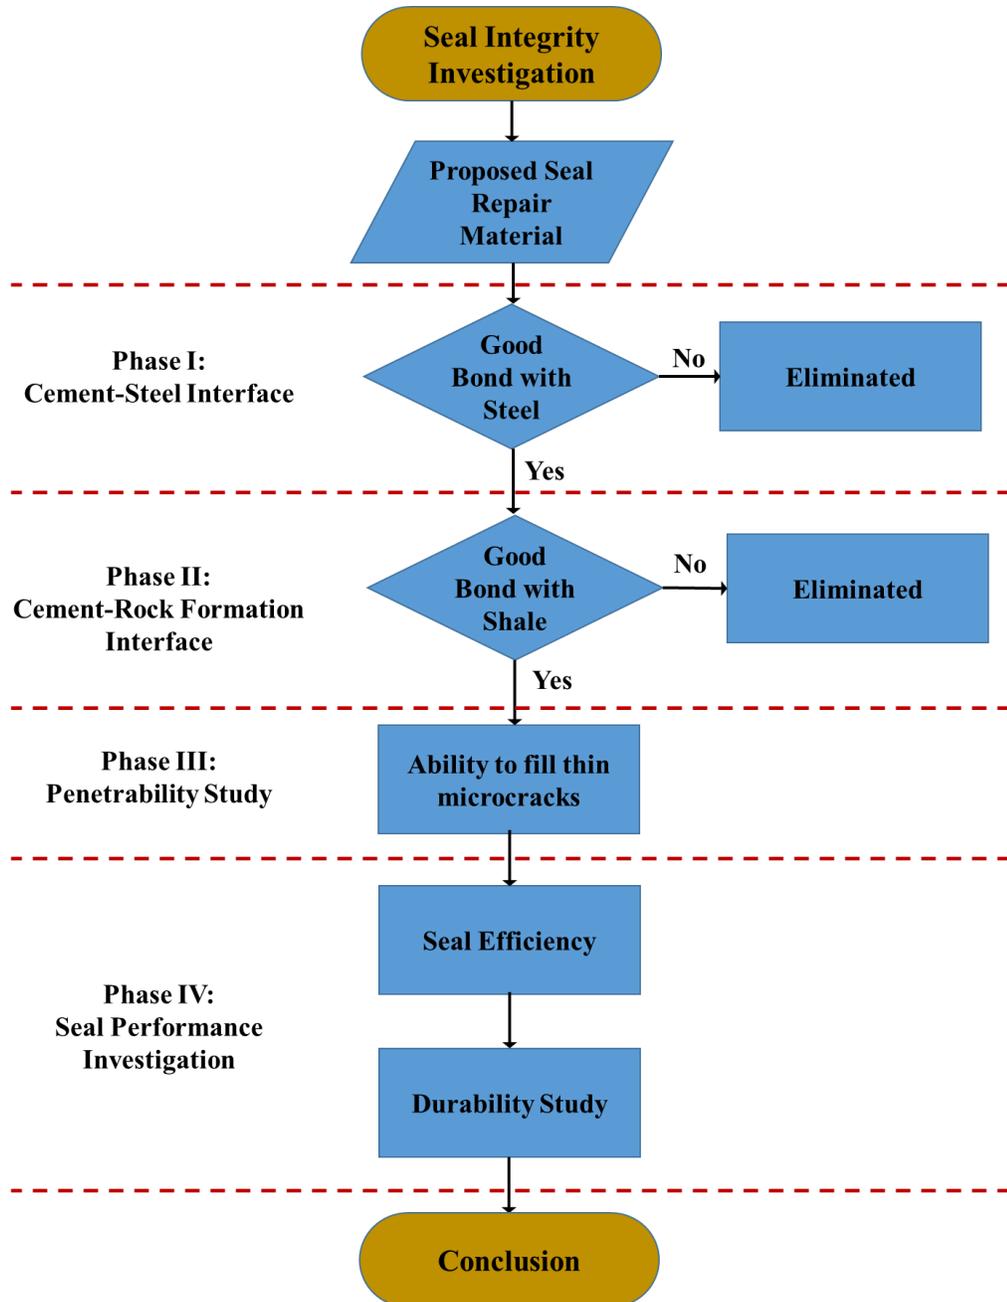
Figure 1.2: Flowchart summarizes the elimination process adopted in the investigation.

The design process of the seal repair material (selection of polymer and incorporated nano particles) follows an elimination process of four phases summarized in Figure 1.2. First, the bond strength with steel, and flowability of the proposed polymer cement nanocomposites (PCNC) were investigated. Next, in Phase II the bond strength with shale of the selected polymer nanocomposites in Phase I was investigated. In Phase III, the ability of selected polymer nanocomposites to fill thin microcracks (30 μm) was then investigated. Finally, a performance study that includes examining the efficiency of seal repair material to the seal cement-steel interface, and the ability to withstand the wellbores' extreme environmental conditions was conducted in Phase IV. In all the

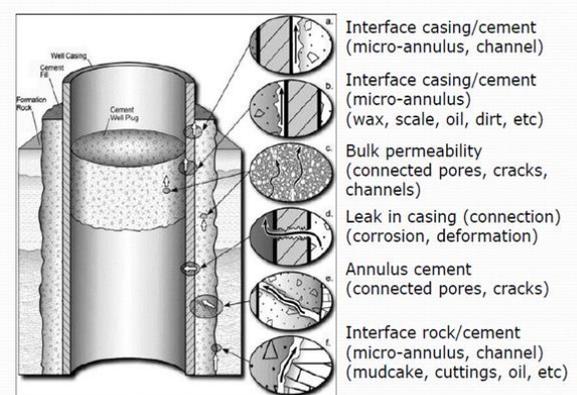
Figure 2.1: Schematic representation of zonal isolation and potential leakage pathways (Celia et al. 2005).

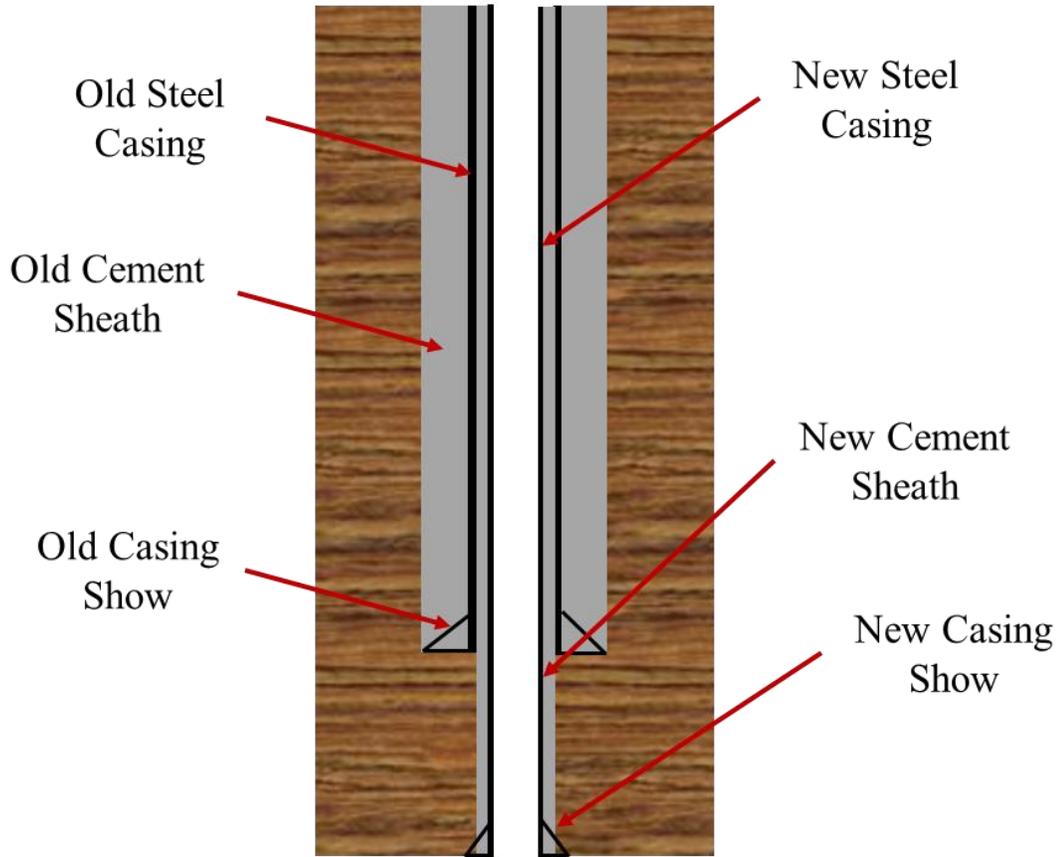
Figure 2.2: Restoring wellbore integrity by installing an additional casing.

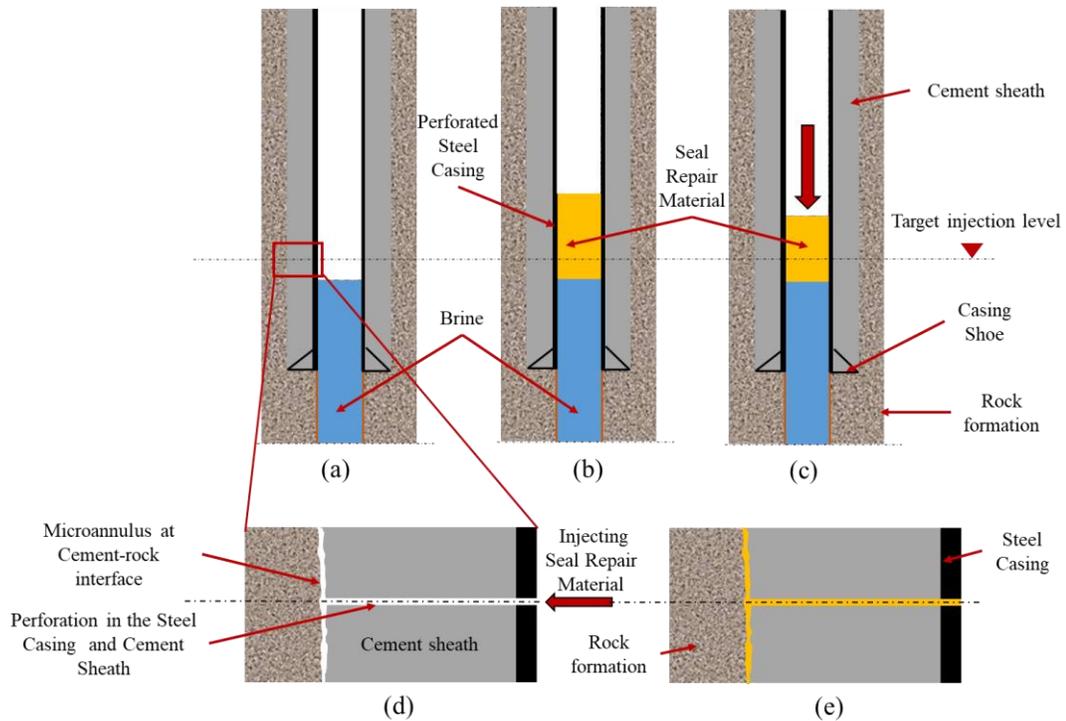
Figure 2.3: Injection process of seal repair material: (a) fill bottom hole with high density brine up to 2-3 m below the injection level, (b) fill 5-10 m of casing with seal repair material, (c) apply pressure to push seal repair material into the microcracks, (d) Microannulus at Cement-rock interface before injecting seal repair material, and (e) Sealed Microannulus at Cement-rock interface.

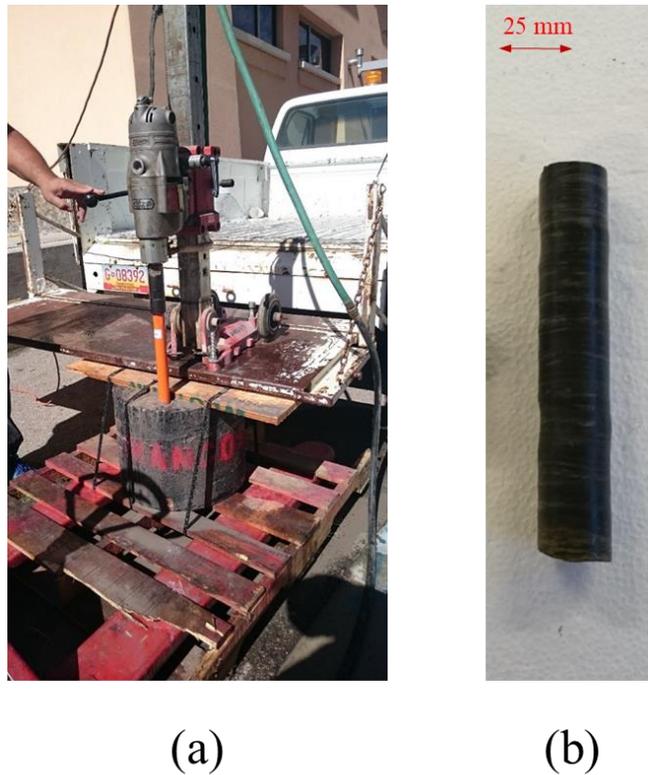
Figure 3.1: (a) Coring process of Mancos shale and (b) Mancos shale core.

The shale used in this investigation is Mancos Shale, sourced from TerraTek shown in Figure (3.1).

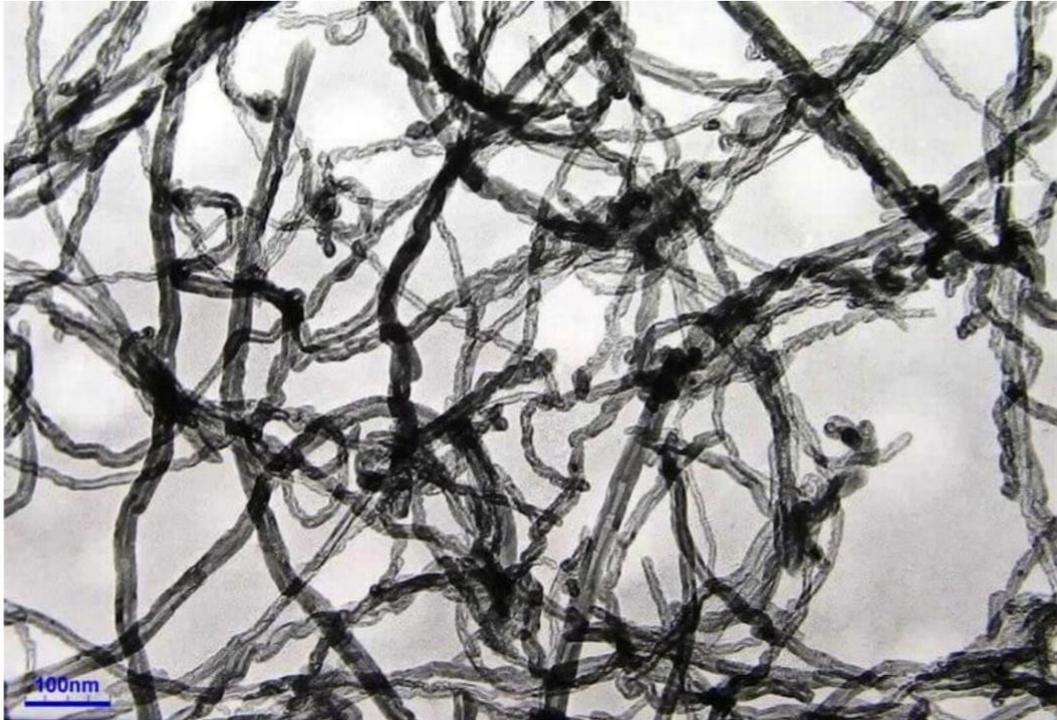
Figure 3.2: Transmission electron microscope (TEM) images of MWCNTs.

Functionalized Multi-Walled Carbon Nano-Tubes (MWCNTs) were added to produce the nanocomposite. The MWCNTs have an outer diameter (OD) of 20–30 nm, inner diameter (ID) of 5–10 nm and length of 10–30 μm . The bulk density of the MWCNTs is 0.21 g/cm^3 and the specific surface area is 110 m^2/g . The functionalization of MWCNTs was performed by the manufacturer. A typical functionalization process is carried out in two steps as reported by Zhu et al. and Osorio et al. (Zhu et al. 2003, Osorio et al. 2008). First, a mixture of nonorganic acids such as sulfuric, nitric, and/or hydrochloric acids is added and stirred with the nanotubes under elevated temperature. The role of the aggressive mixture of acids is to create a defect on the surface of the nanotubes. The acids addition is followed by base such as ammonium hydroxide. The base is expected to neutralize the acidity and impregnate the carboxylic functional group on the nanotubes. Figure 3.2 shows Transmission electron microscope (TEM) images of MWCNTs.

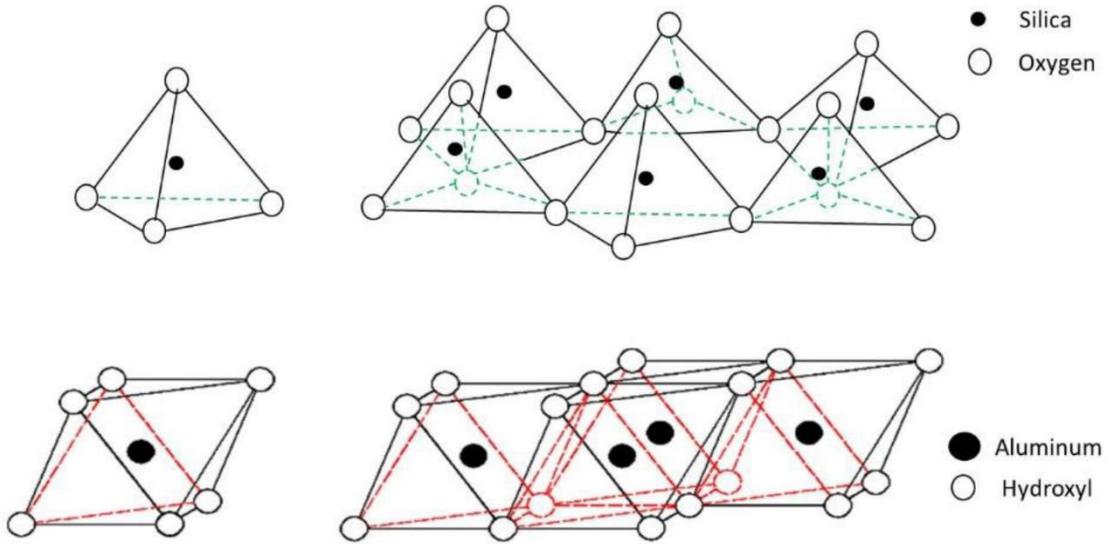
Figure 3.3: Structure of a silica tetrahedral sheet (up), and an alumina octahedral sheet (down) (McLaren and Cameron 1996).

$\text{Al}(\text{OH})_3$ - sheets (McLaren and Cameron 1996) as shown in Figure 3.3. In montmorillonite (2:1 type phyllosilicates), each layer is composed of one octahedral alumina sheet sandwiched between two tetrahedral silica sheets (Uddin 2008).

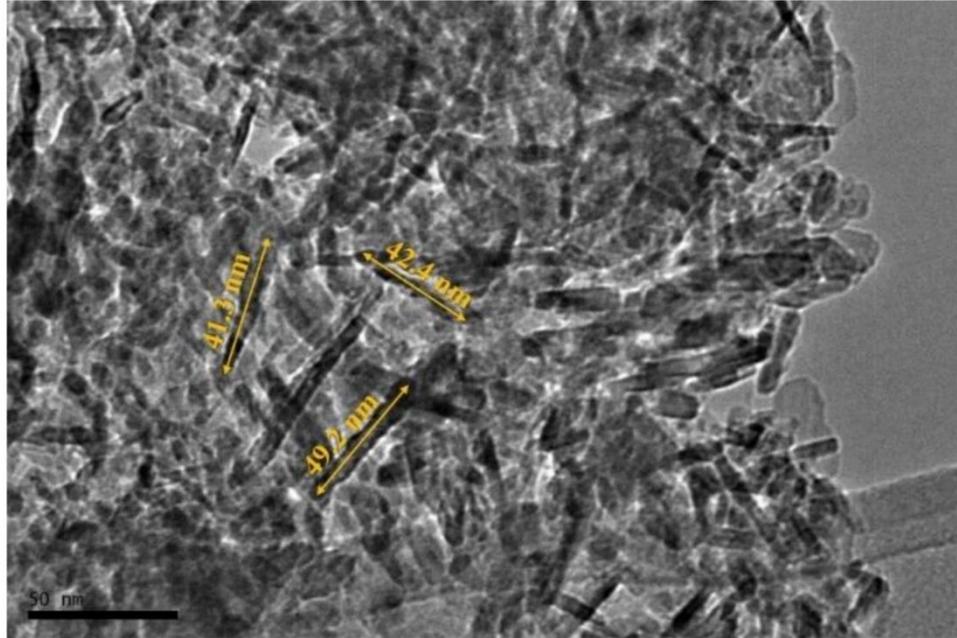
Figure 3.4: Transmission electron microscope (TEM) images of ANPs.

The nanoalumina used is aluminum oxide (Al_2O_3) nano- particles manufactured by Sigma Aldrich, Inc. and has a maximum particle size of 50 nm. Figure 3.4 shows Transmission electron microscope (TEM) images of ANPs.

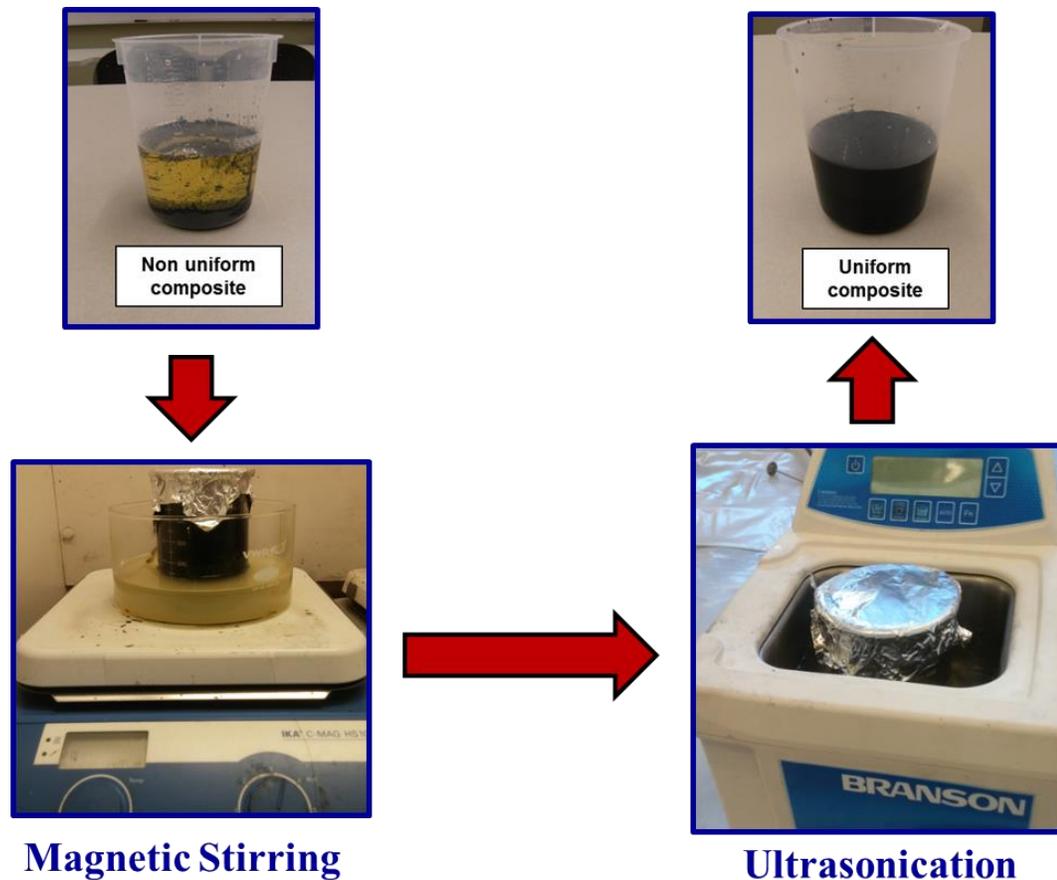
Figure 3.5: Schematic showing the steps to prepare polymer nanocomposites.

To prepare Novolac epoxy and polymer nanocomposite, the nanomaterial was added to the required amount of the resin, and the mix was stirred for 2 hours at 110 °C using. This relatively high mixing temperature was used to reduce the resin viscosity and improve the dispersion of nanomaterial. The mix was then sonicated for 2 additional hours at 65 °C using an ultrasonic homogenizer. For MMA PNCs, the magnetic stirring temperature was reduced to 80 °C due to its low evaporation temperature. The polymer resin nanocomposite was left to cool and reach room temperature. After the polymer resin nanocomposites reach the room temperature, it was mixed with the required amount of hardener. Figure 3.5 summarizes the polymer nanocomposites preparation process.

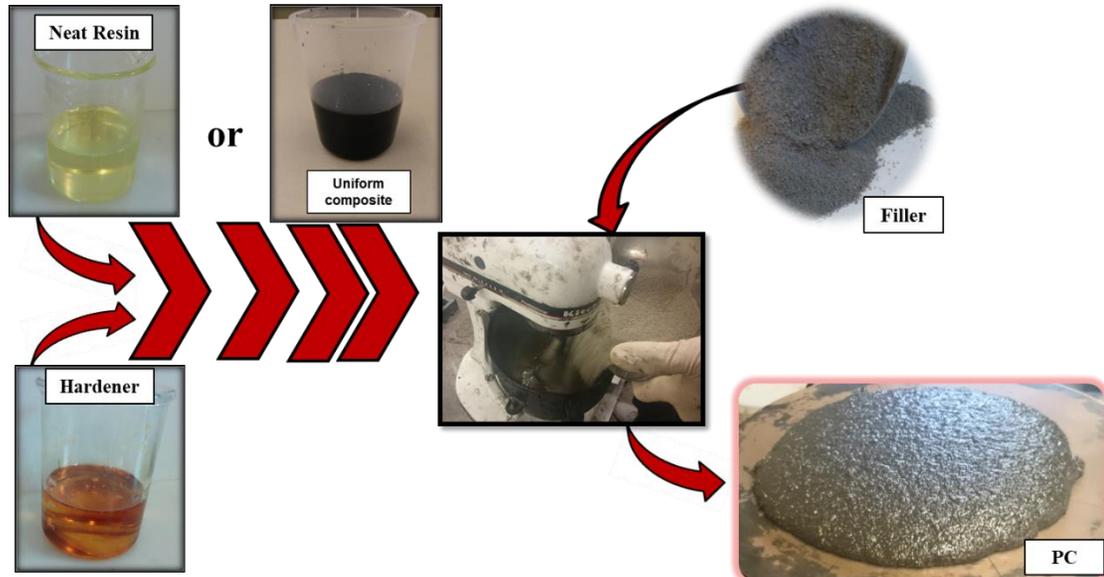
Figure 3.6: Schematic of mixing procedure of polymer-cement nanocomposites.

In order to prepare polymer cement nanocomposite (PCNC) of Novolac epoxy and polysulfide siloxane epoxy, the polymer resin nanocomposites were mixed with the required amount of hardener for 2-3 minutes using a low speed mixer, after which silica filling powder were added. Mixing continued for 2-3 minutes until the mixture was uniform. Schematic of mixing procedure is shown in Figure 3.6. Table (3.1) shows the list of PCNCs used in this study. The mix proportions for all Polysulfide siloxane epoxy and Novolac epoxy PCNC are presented in Tables 3.2 and 3.3 respectively.

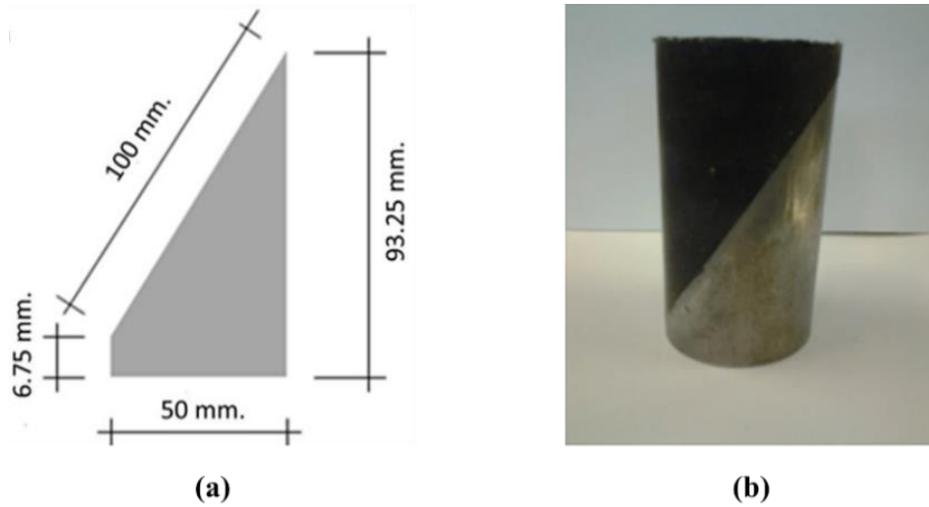
Figure 3.7: (a) Steel part dimensions (b) composite cylinder for slant shear test

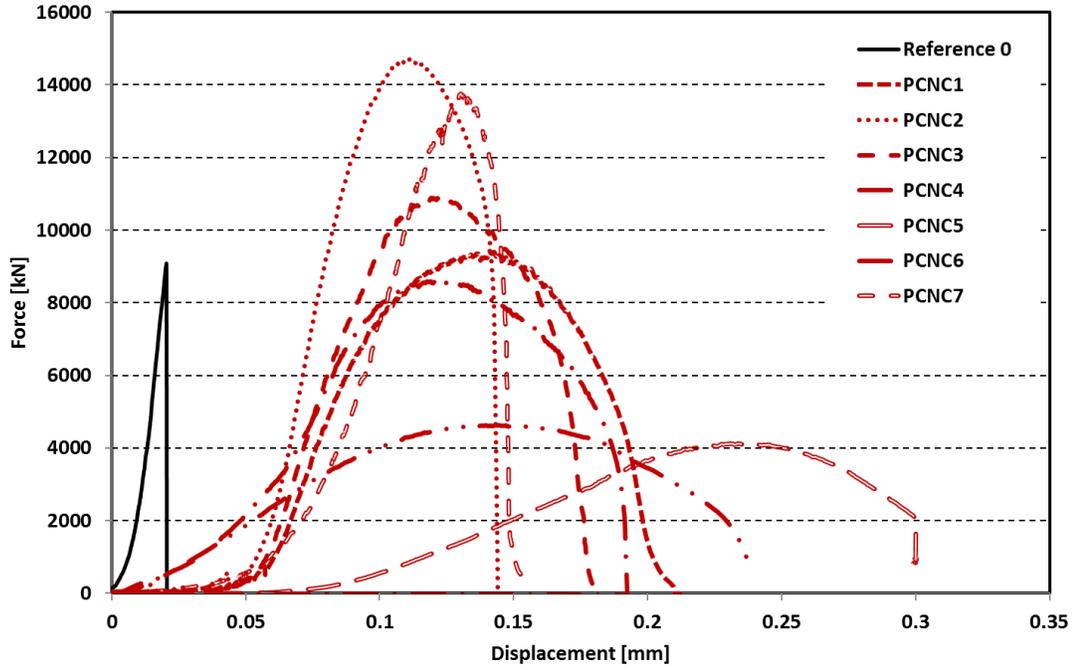
Figure 3.9: Load-displacement curves of reference microfine cement material and Polysulfide Siloxane epoxy cement nanocomposites

Load-displacement data from the slant shear tests for the Polysulfide Siloxane epoxy cement nanocomposites in Figure 3.9 and Novolac epoxy cement nanocomposites in Figure 3.10. Load-displacement response of the reference microfine cement material is also shown in Figure 3.9 and Figure 3.10.

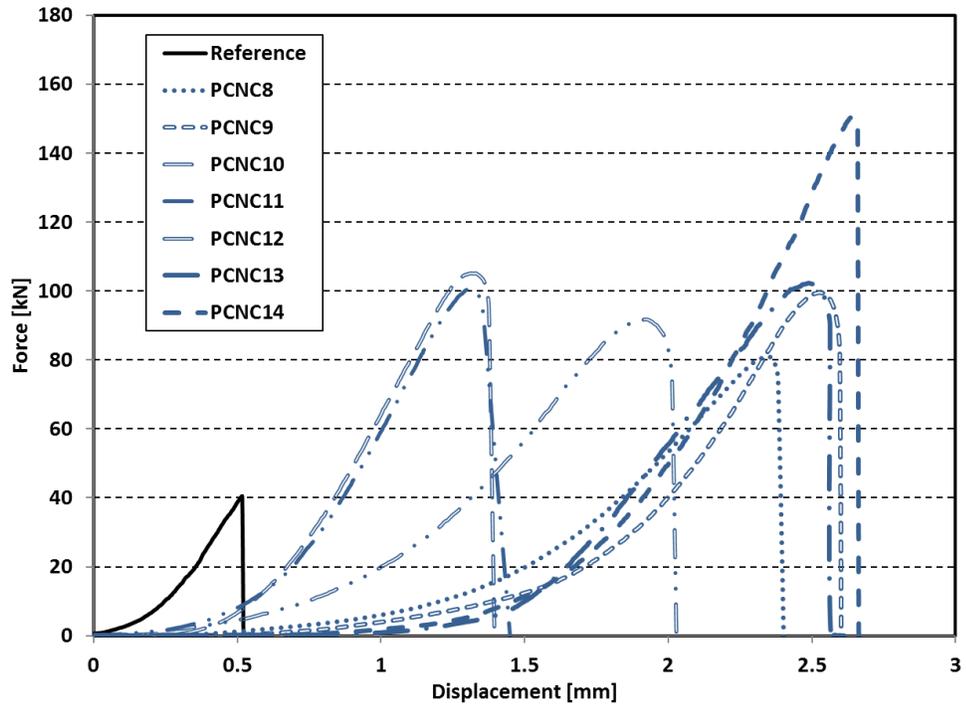
Figure 3.10: Load-displacement curves of reference microfine cement material and Novolac epoxy cement nanocomposites.

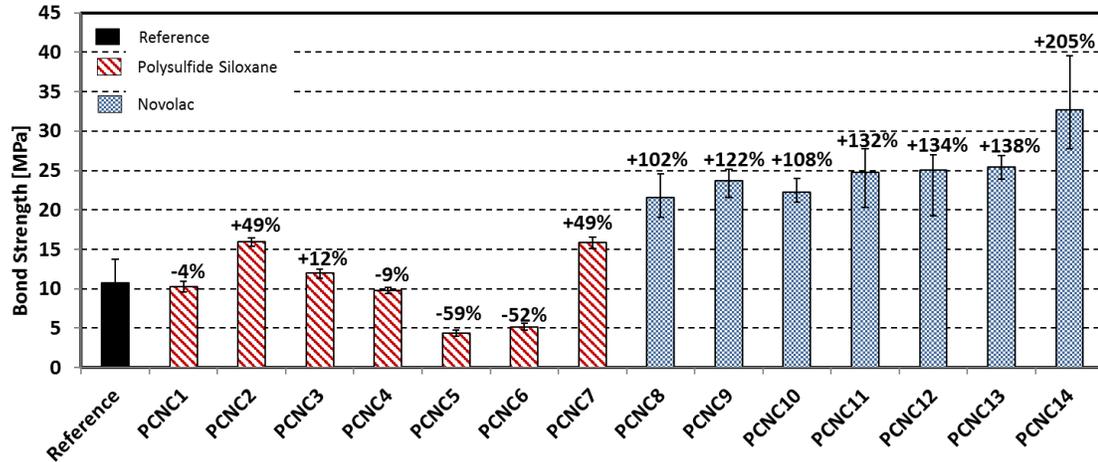
Figure 3.11: Mean bond strength for reference microfine cement material and all fourteen polymer cement nanocomposites.

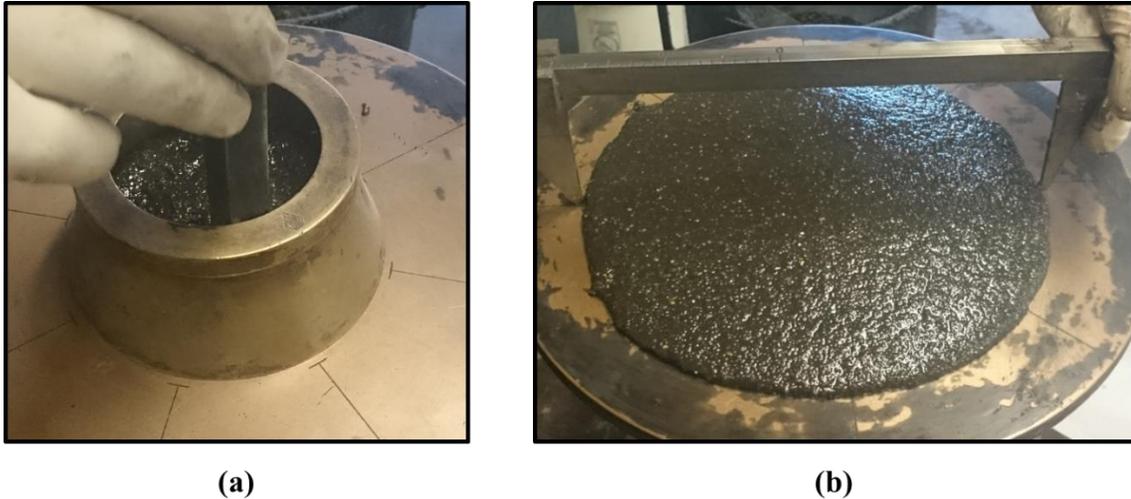
Figure 3.12: (a) Filling the flowability cone (b) taking readings using test caliber.

the flowability of the slurry. Figure 3.12 shows filling of the flowability cone and reading of flowability with the test caliber.

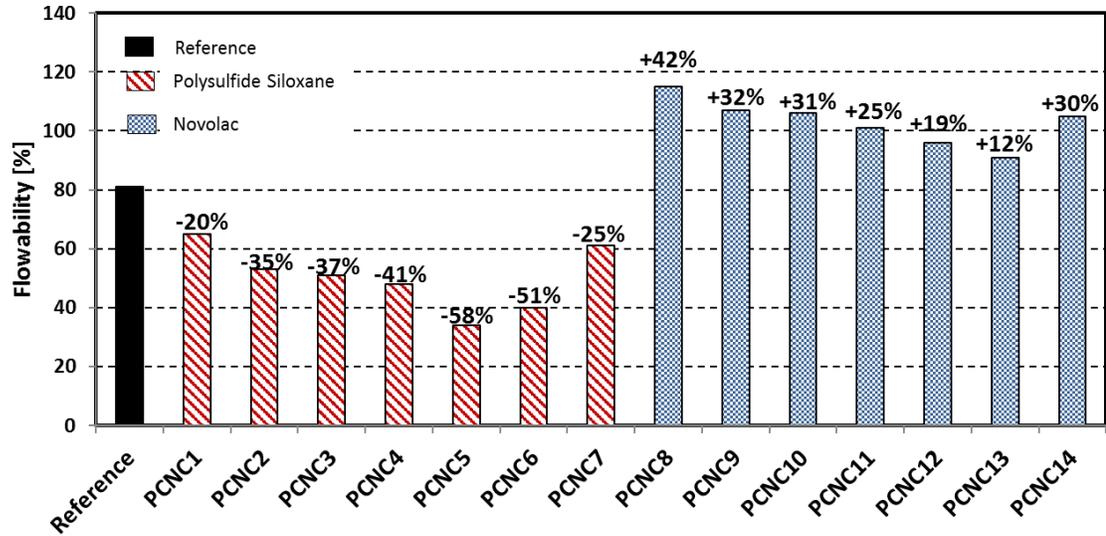
Figure 3.13: Flowability results for the reference microfine cement material and all fourteen polymer nanocomposites.

Flowability results for reference microfine cement material and all fourteen PCNCs tested are shown in Figure 3.13. The flowability of all polysulfide siloxane cement nanocomposites were less than the reference cement materials. In contrast, the flowability of all Novolac epoxy cement nanocomposites were greater than the reference cement material. The results indicate that mixtures that included nanoparticles had a reduced flowability compared to the neat epoxy cement nanocomposites. Incorporating 0.5% MWCNTs and 2.0% nanoalumina had the least effect on flowability of polymer cement nanocomposites for both types of epoxies while 4.0% nanoclay and 1.0% nanosilica decreased the flowability the most.

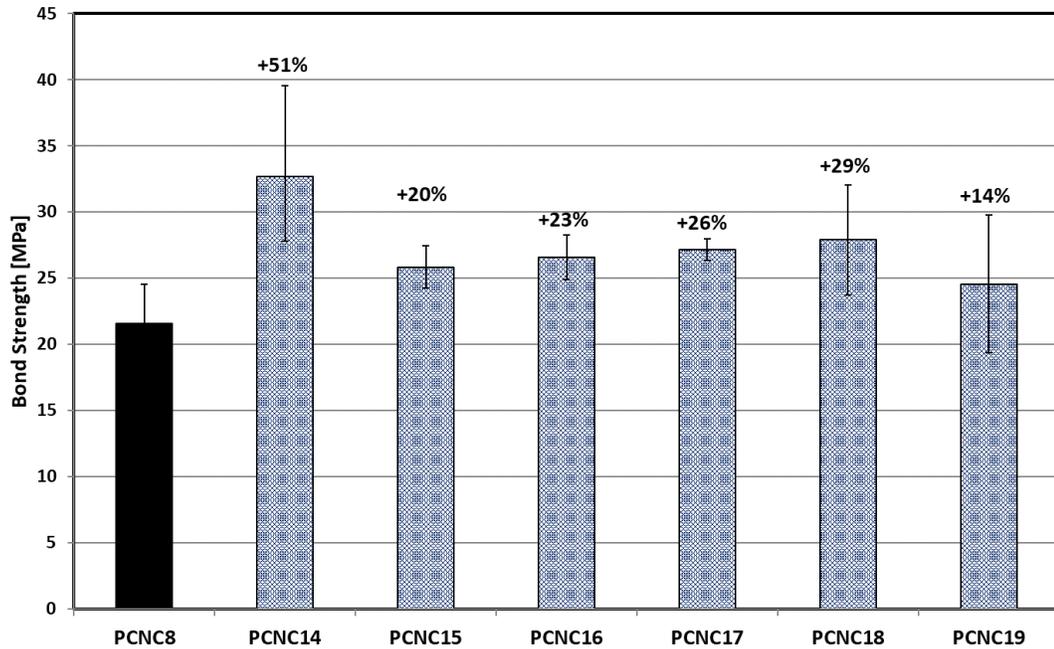
Figure 3.14: Mean bond strength for all Novolac epoxy PCNC.

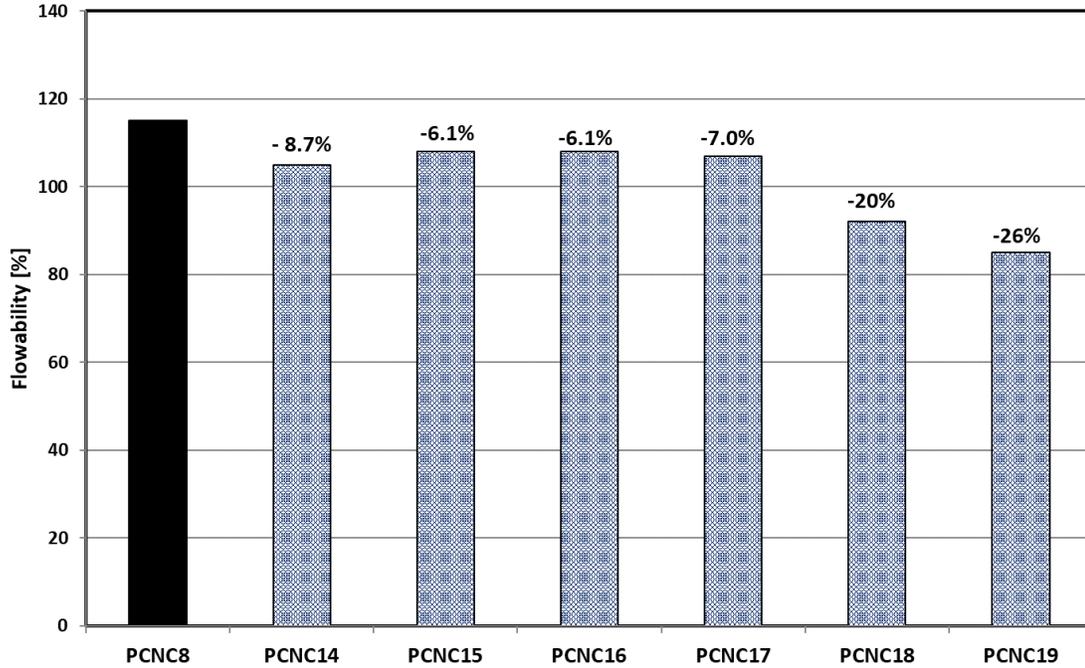
Figure 3.15: Flowability results for all Novolac epoxy PCNC.

Figure 3.15 shows the flowability results of all Novolac epoxy PCNC incorporating ANPs compared to neat Novolac epoxy PCNC. Flowability results show that the higher content of nanoparticles incorporated the lower the flowability of PCNCs. However, this relationship is not linear for all ANPs content. As shown in Figure 3.15, incorporating low content of ANPs in Novolac PCNC (from 0.5% to 2.0%) results in less than 9% reduction in the flowability of PCNC. On the other hand, incorporating higher content on ANPs (3.0% and 4.0%) results in 20% to 26% reduction in the flowability of PCNCs. This can also be explained by the agglomerations of nanoparticles that results from dispersing such a high content of ANPs.

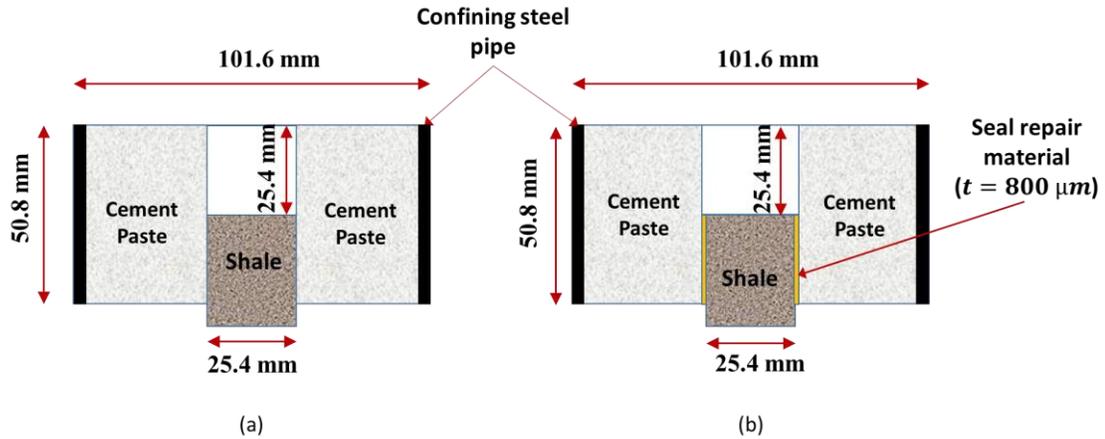
Figure 3.16: Schematic of the push-out test specimens for (a) first set of specimens and (b) second set of specimens.

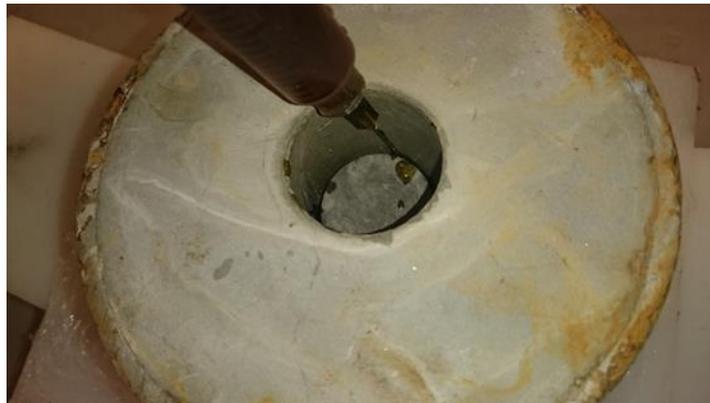
Figure 3.17: Placing seal repair material at the cement-shale microannulus.

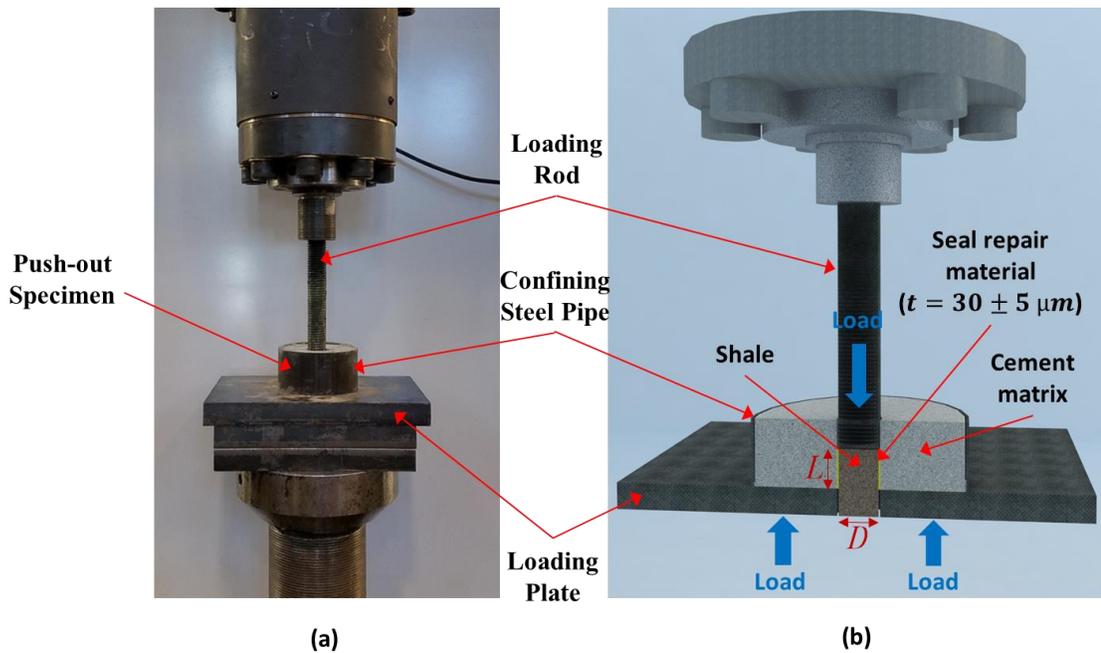
Figure 3.18: (a) Push-out test setup and (b) Push-out test schematic.

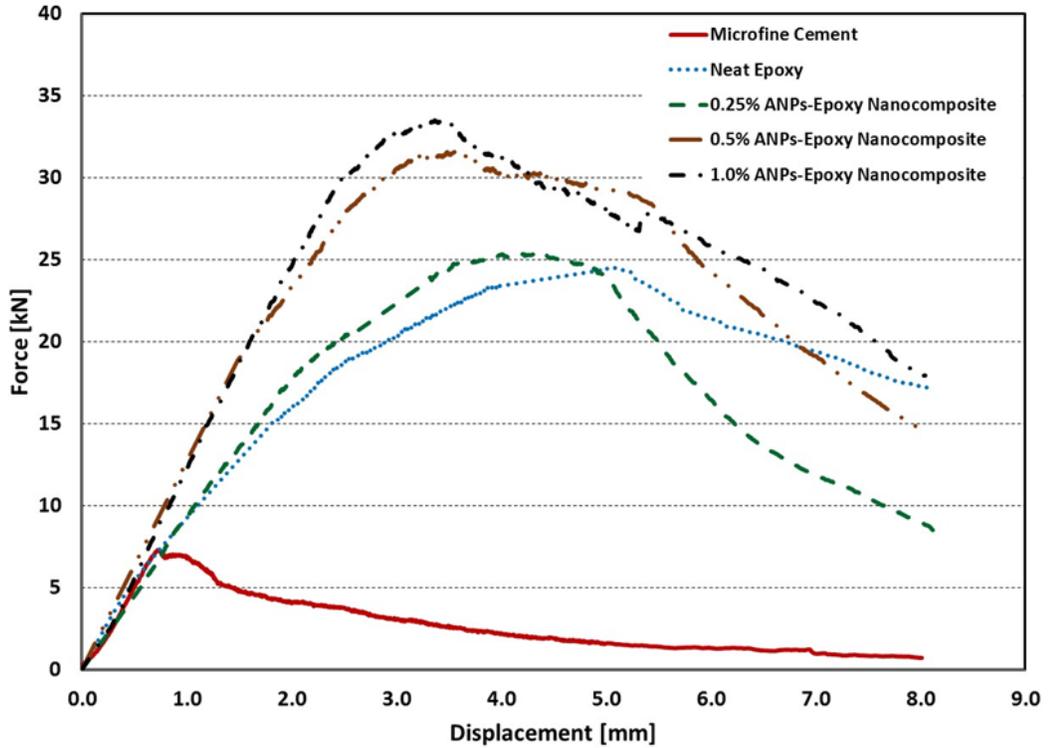
Figure 3.19: Median load-displacement curves of specimens sealed with microfine cement and epoxy-based materials.

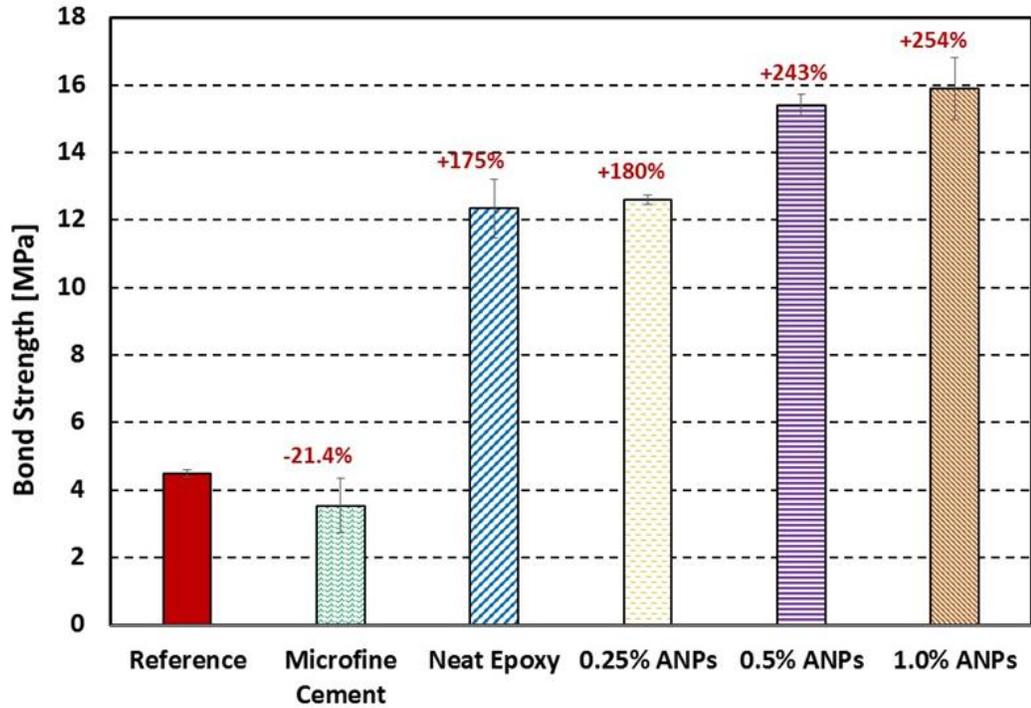
Figure 3.20: The bond strength of the reference case and all seal repair materials.

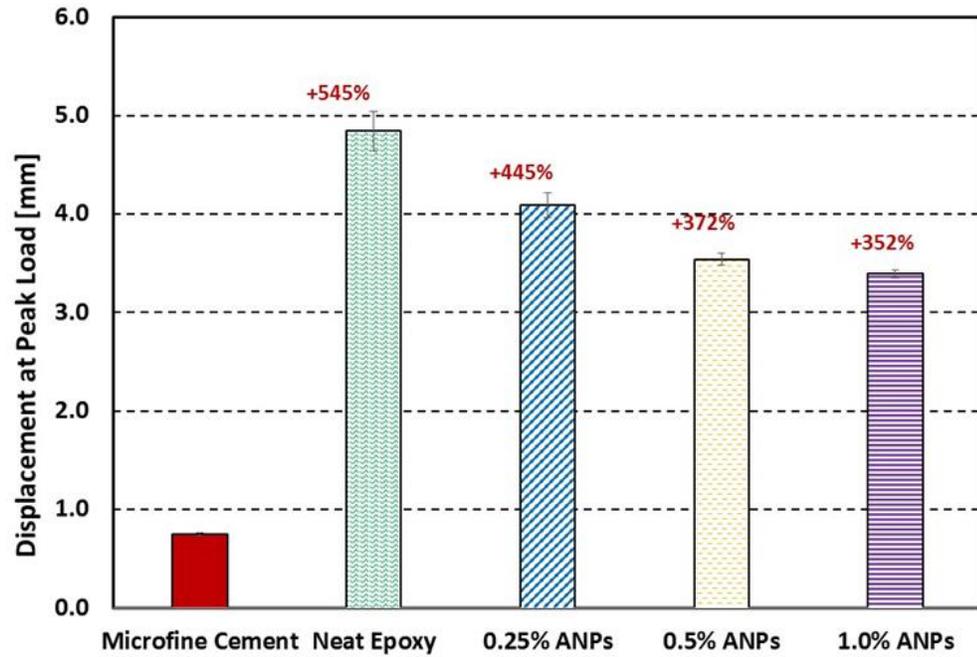
Figure 3.21: Displacement at peak load of the microfine cement and all ANPs-epoxy nanocomposites

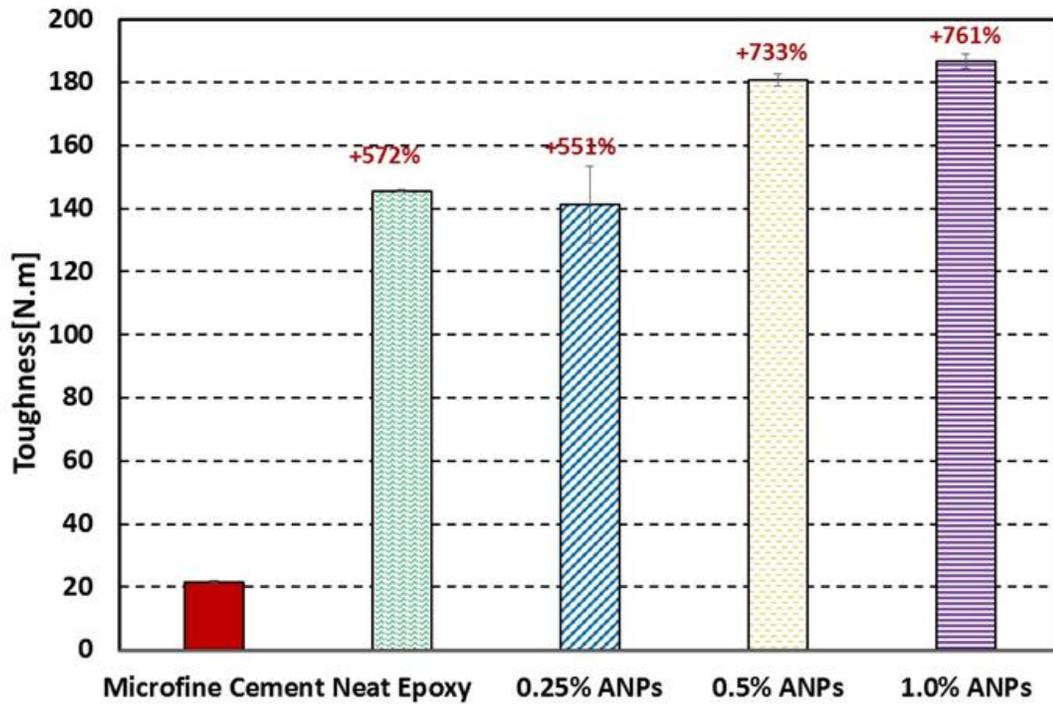
Figure 3.22: Toughness for the microfine cement and all ANPs-epoxy nanocomposites

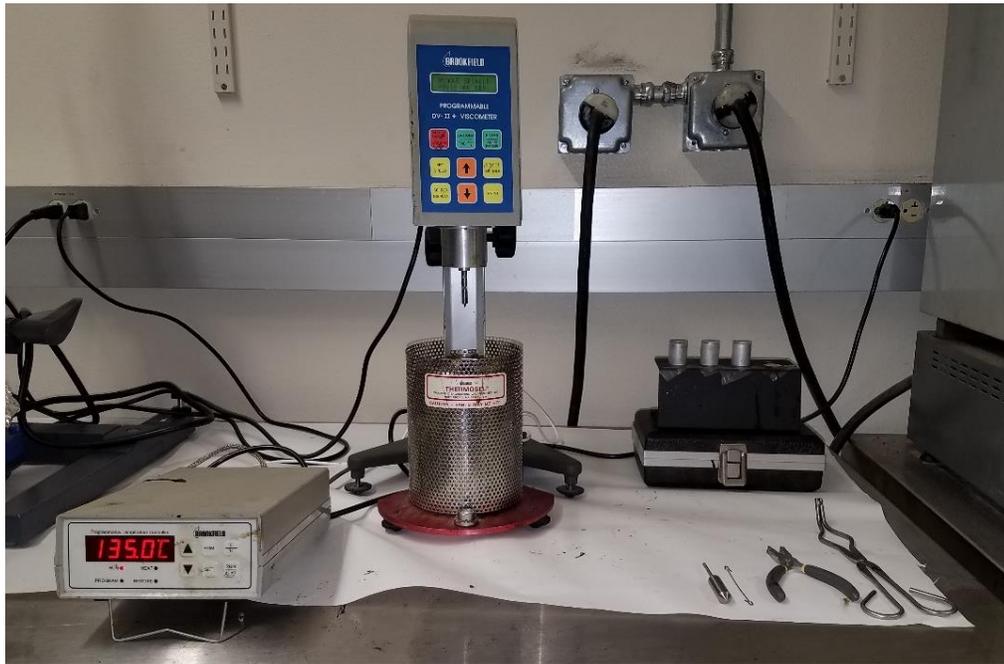
Figure 3.23: Rotational Viscometer.

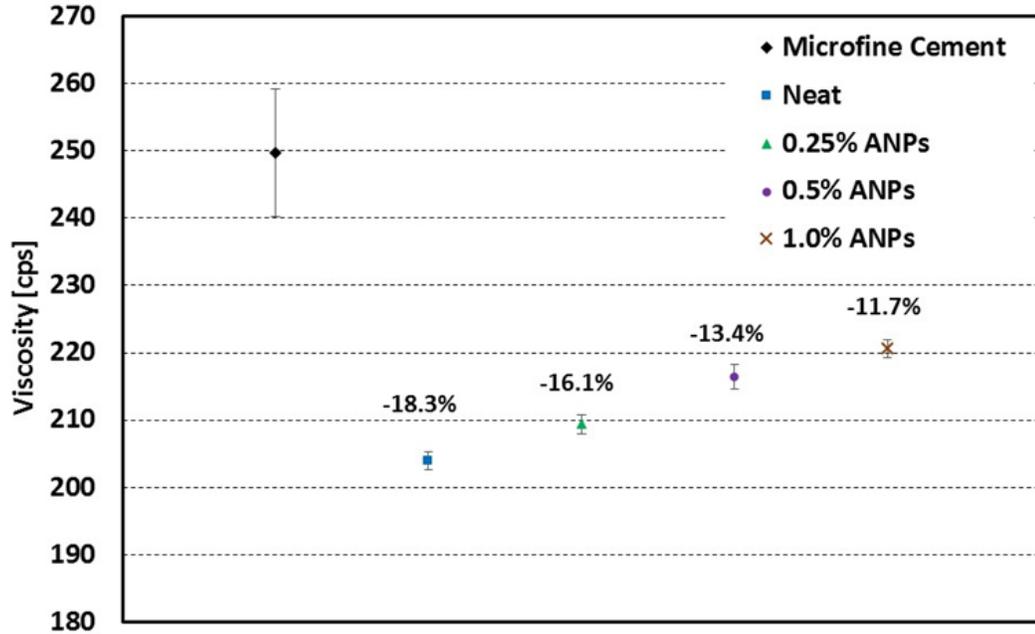
Figure 3.24: Comparison of the viscosity between polymer nanocomposites incorporating 0% (Neat) 0.25%, 0.5%, and 1.0% ANPs and microfine cement.

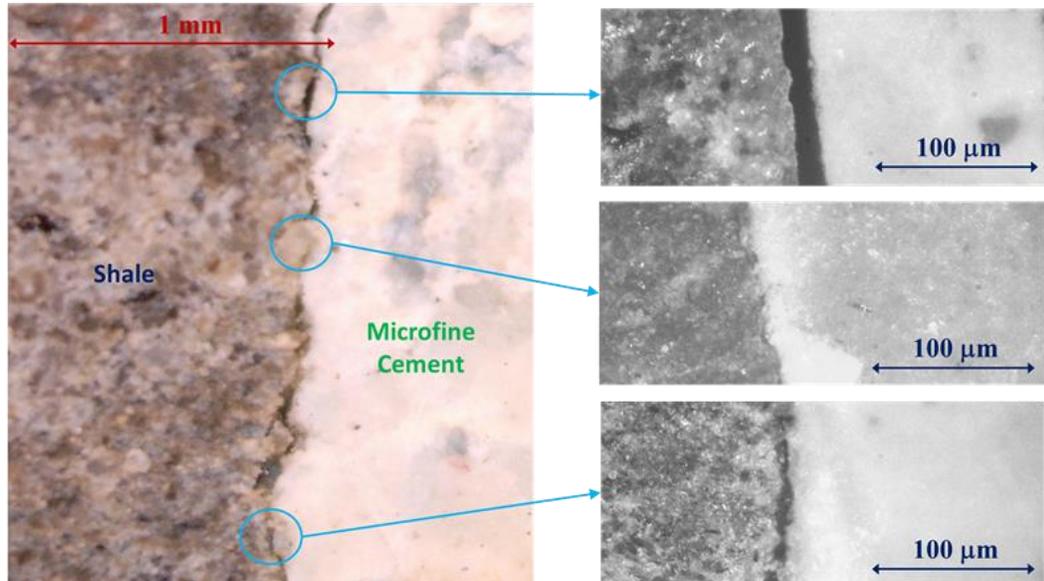
Figure 3.25: Microscopic images of shale-microfine cement interface with two different levels of magnification showing areas with gap between microfine cement and shale.

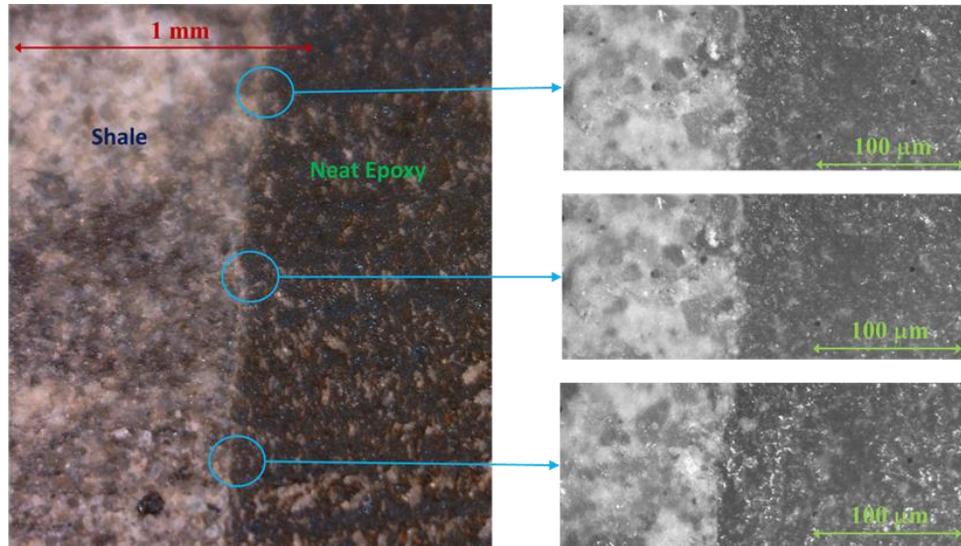
Figure 3.26: Microscopic images of shale-neat epoxy interface with two different levels of magnification showing the ability of the neat epoxy seal repair material to completely fill the gap at the shale-cement interface.

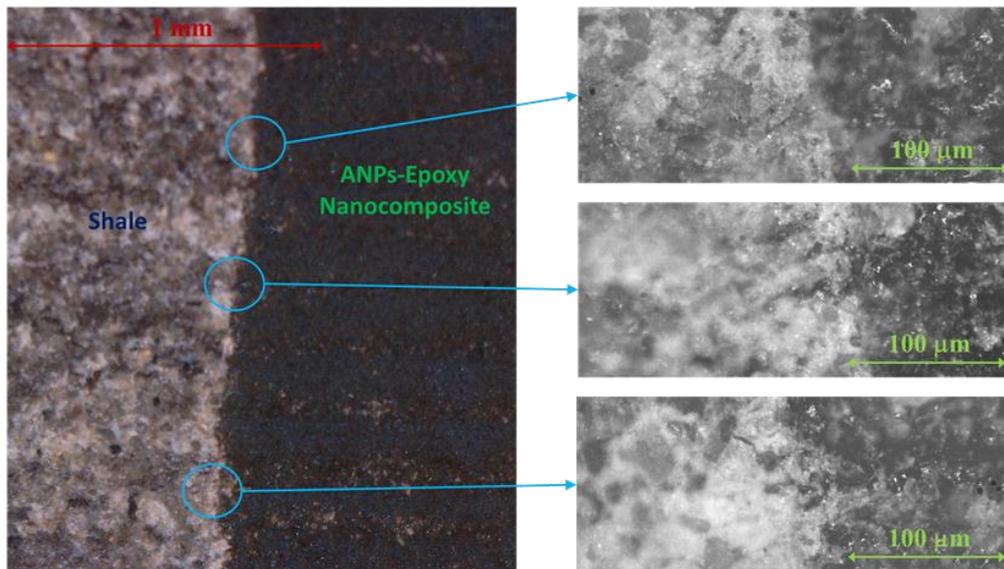
Figure 3.27: Microscopic images of shale-1.0% ANPs-epoxy polymer nanocomposite interface with two different levels of magnification showing the ability of the epoxy seal repair material to completely fill the gap at the shale-cement interface.
