An Engineered Fit-For-Purpose Polymer Nanocomposite Seal Repair Material for Wellbores

Civil, Construction & Environmental Engineering

DISSERTATION

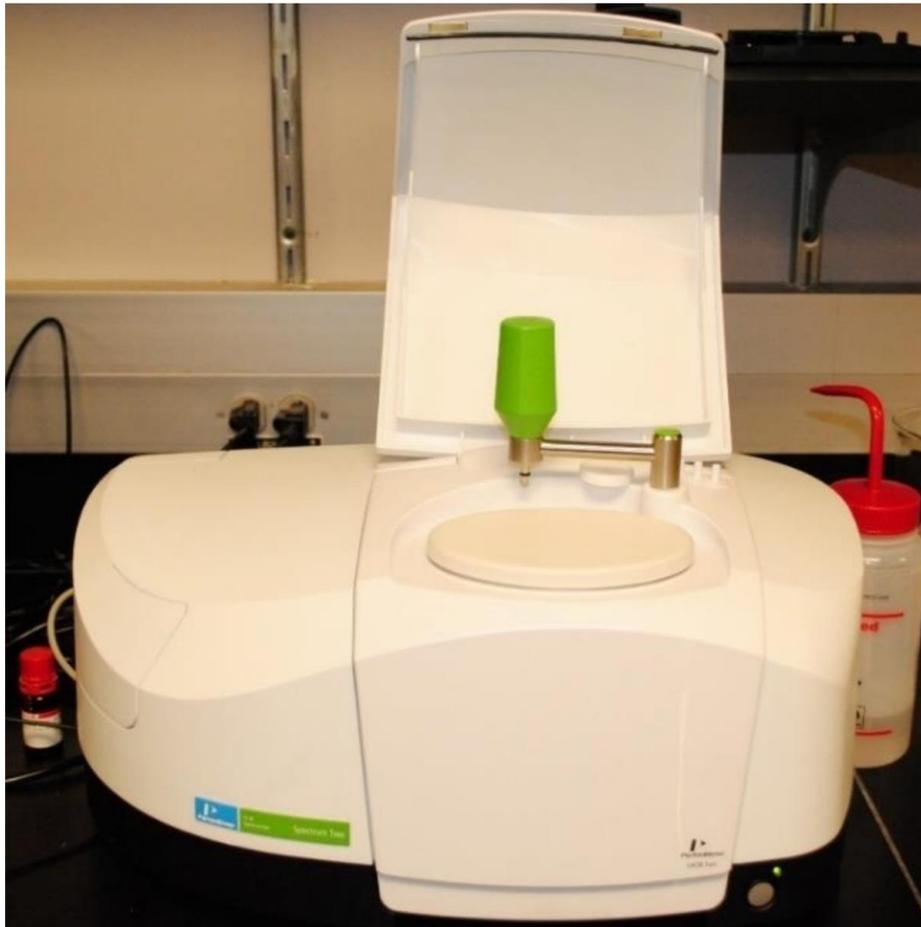
Figure 3.28: PerkinElmer FTIR machine.

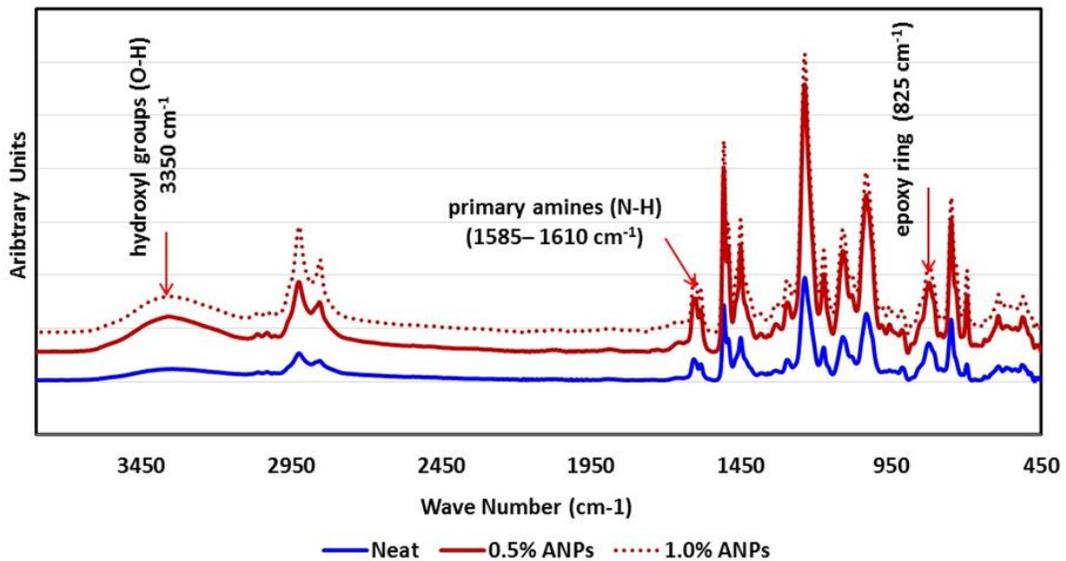
Figure 3.29: FTIR spectra of neat epoxy and epoxy incorporating 0.5 and 1.0 % ANPs showing the significant changes appearing in the spectra using ANPs compared to the neat epoxy.

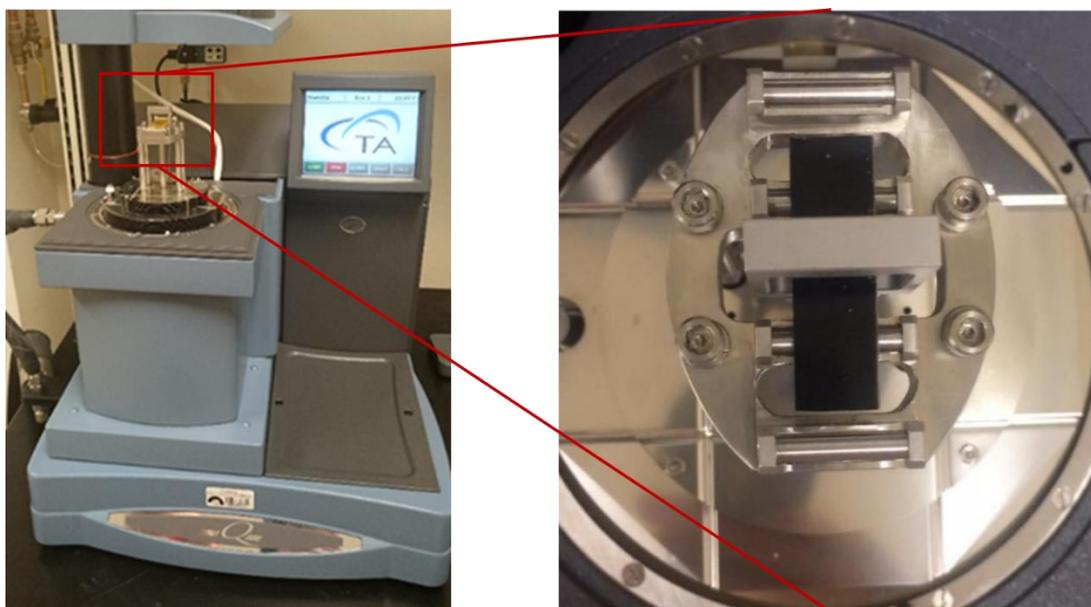
Figure 3.30: DMA Q800 with 3-point bending clamp.

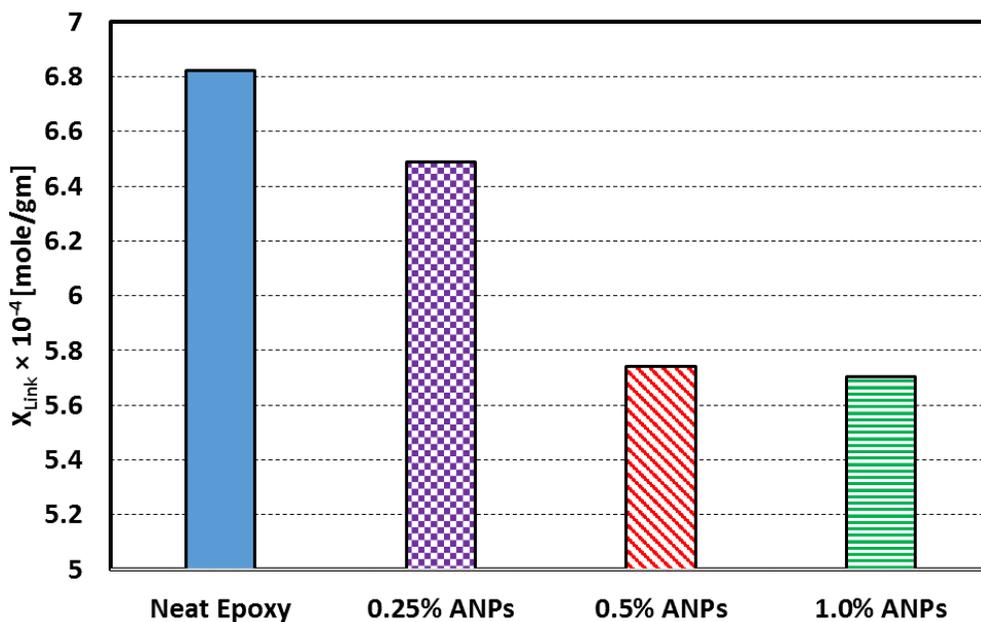
Figure 3.31: X_{link} : A measure of the degree of crosslinking for neat epoxy, 0.25% ANPs-epoxy nanocomposite, 0.5% ANPs-epoxy nanocomposite, and 1.0% ANPs-epoxy nanocomposite.

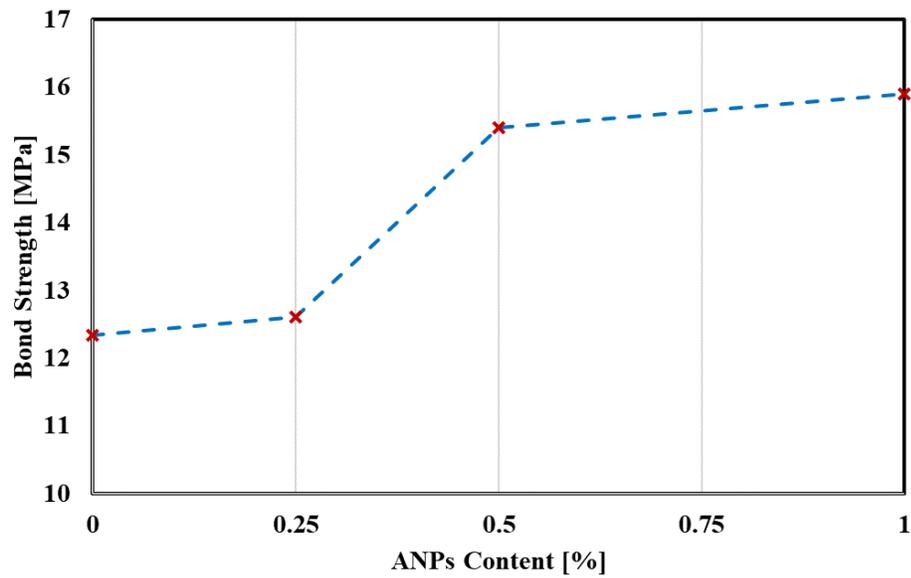
Figure 3.32: The relation between the bond strength and the content of ANPs in polymer nanocomposites.

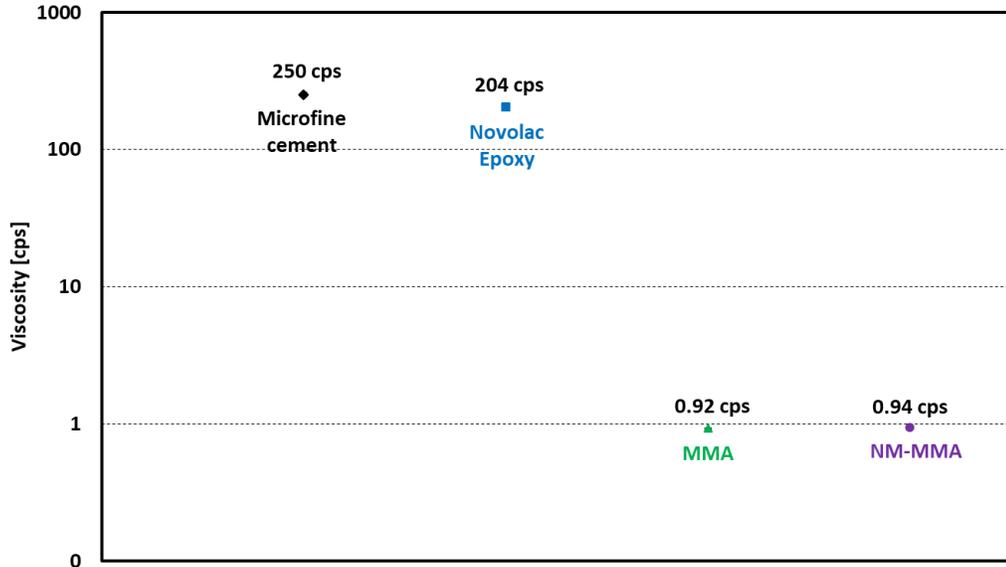
Figure 3.33: Viscosity measurements of all seal repair materials: Log scale is used to enable display with order of magnitude change in viscosity.

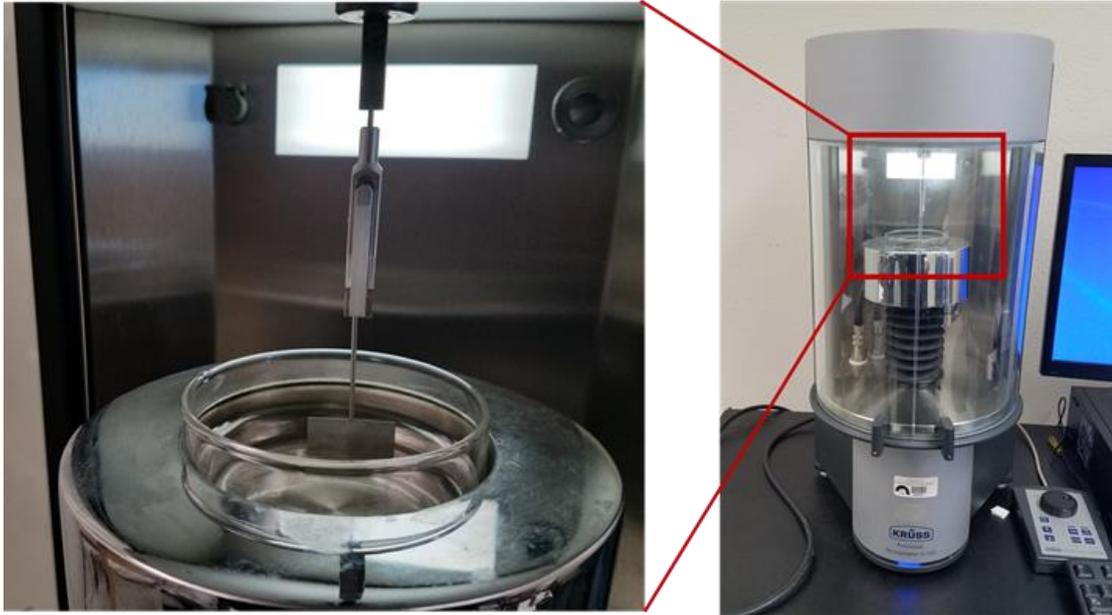
Figure 3.34: KRUSS force tensiometer K100 machine.

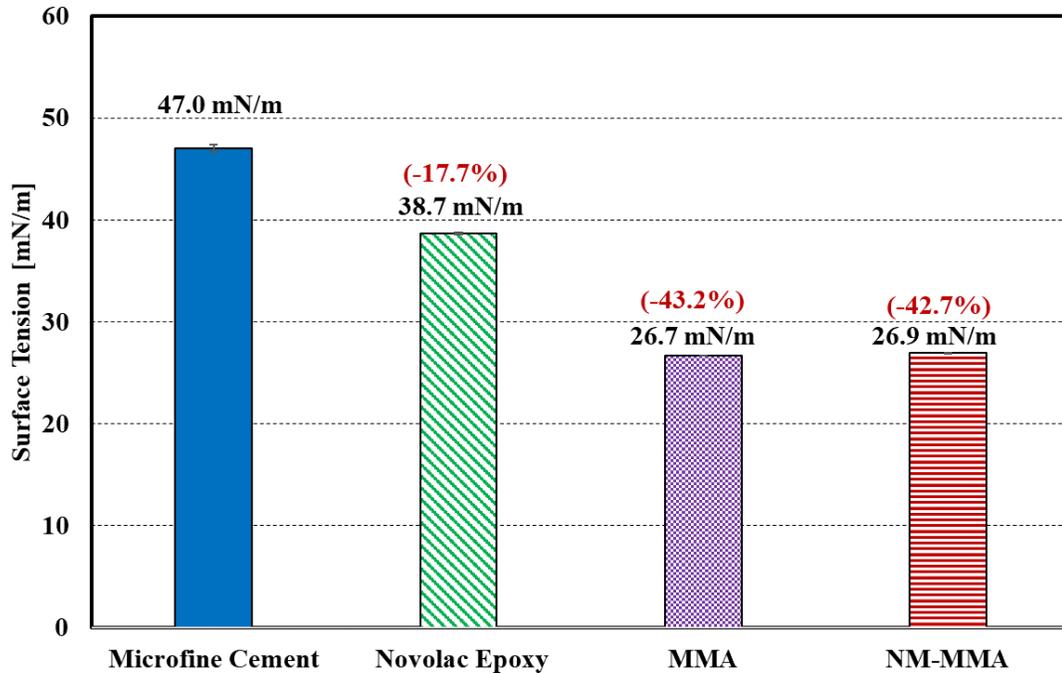
Figure 3.35: Surface tension seal repair materials: % above the bars represents the difference of Penetrability Index of seal repair material compared with microfine cement.

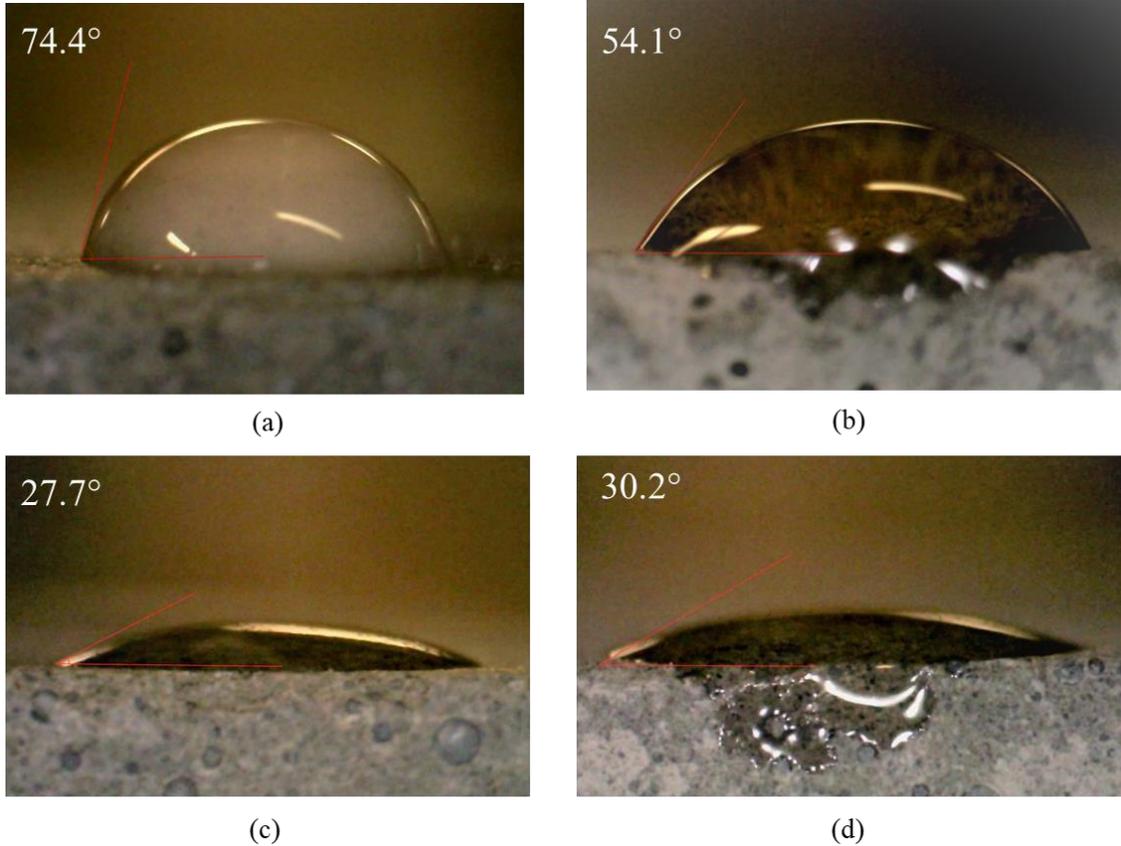
Figure 3.36: Contact angle measurements for (a) Microfine cement, (b) Novolac epoxy, (c) MMA, and (d) NM-MMA.

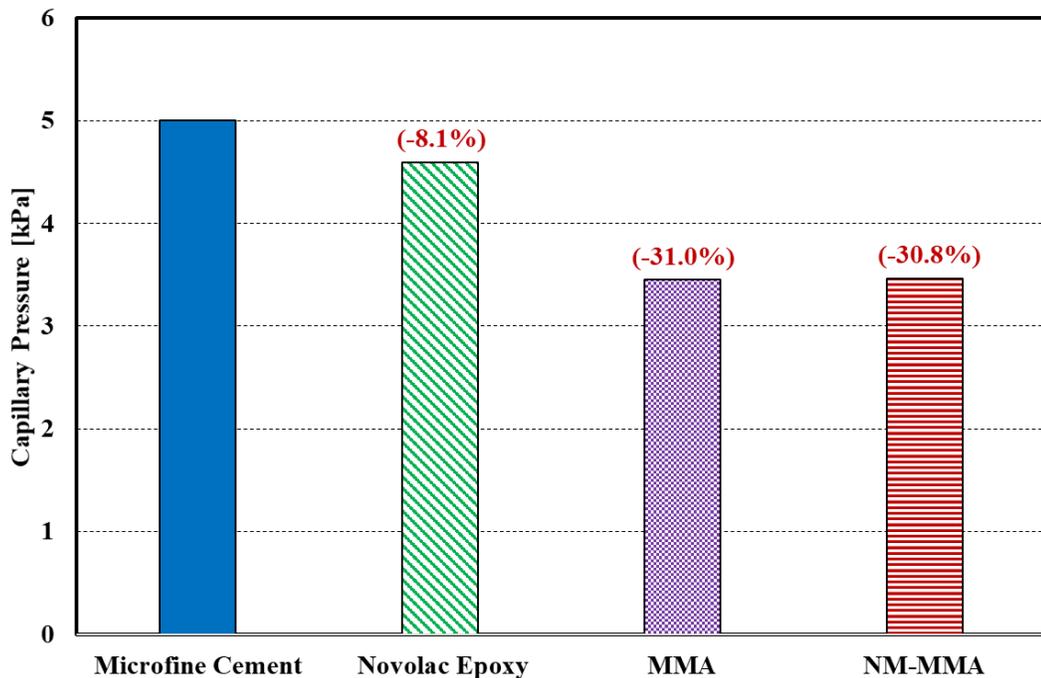
Figure 3.37: Capillary Pressure of all seal repair materials in a 30 μm microcrack; % above the bars represents the difference of Capillary Pressure of seal repair material compared with microfine cement.

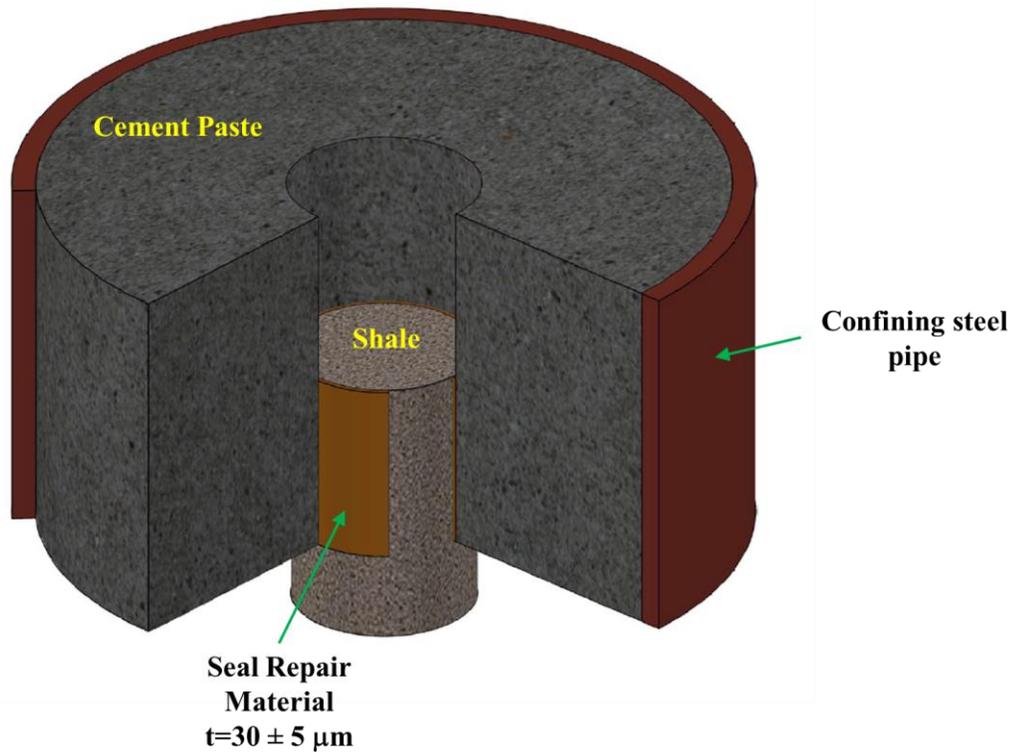
Figure 3.38: Schematic of push-out test specimen for 30 μm microcracks.

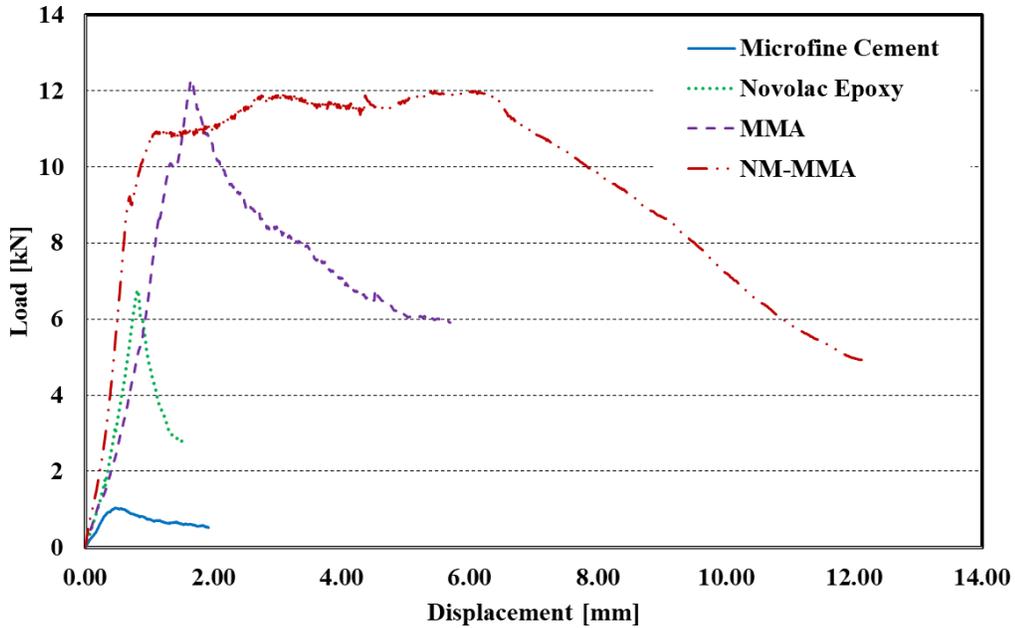
Figure 3.39: Median load-displacement curves of specimens sealed with microfine cement, Novolac epoxy, MMA, and NM-MMA polymer nanocomposite.

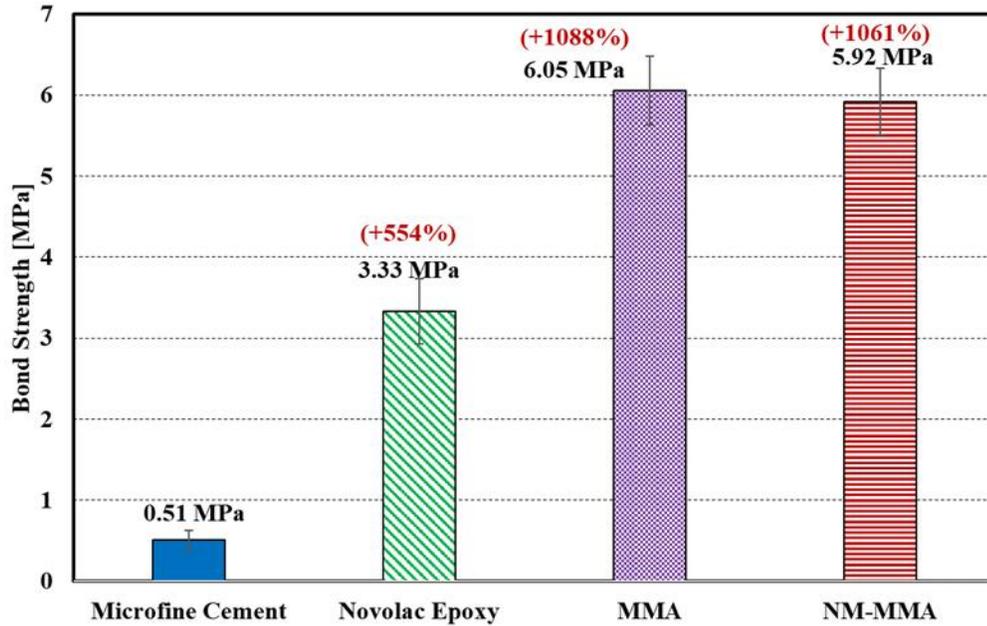
Figure 3.40: The apparent bond strength of all seal repair materials; % above the bars represents the difference of bond strength of seal repair material compared with microfine cement currently used in the field.

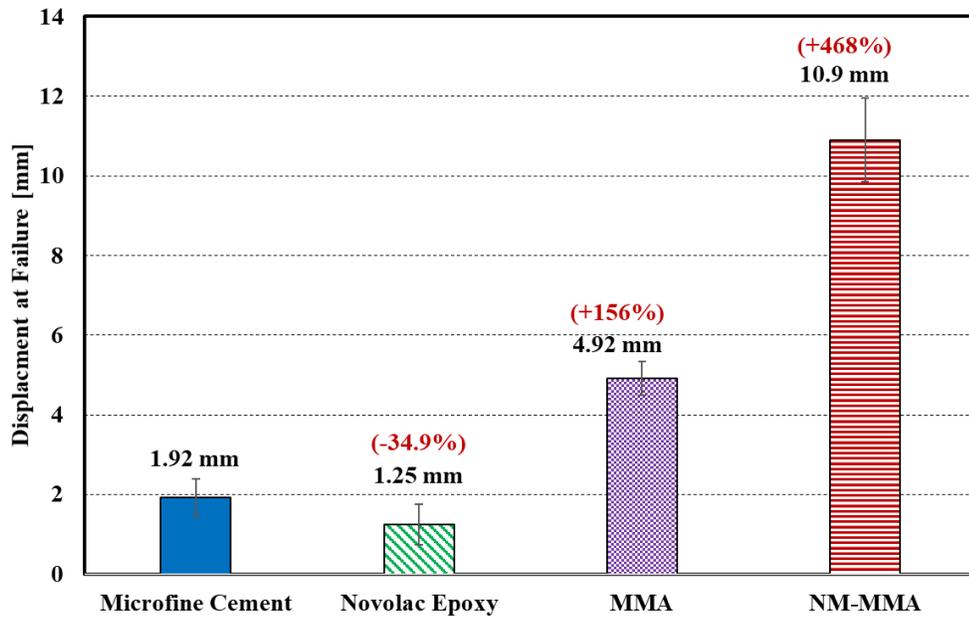
Figure 3.41: Displacement at failure of all seal repair materials; % above the bars represents the difference of bond strength of seal repair material compared with microfine cement.

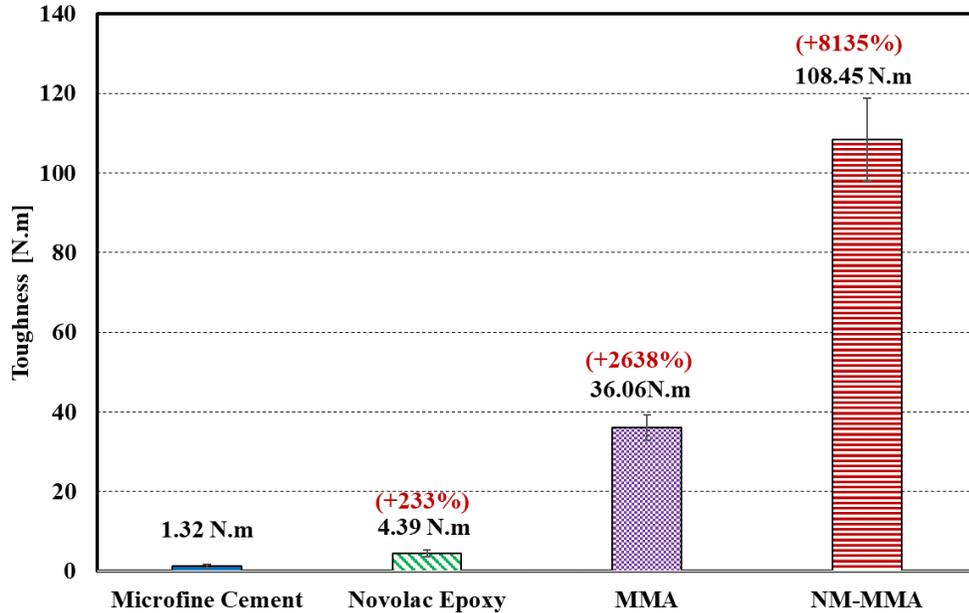
Figure 3.42: Toughness of all seal repair materials; % above the bars represents the difference of bond strength of seal repair material compared with microfine cement.

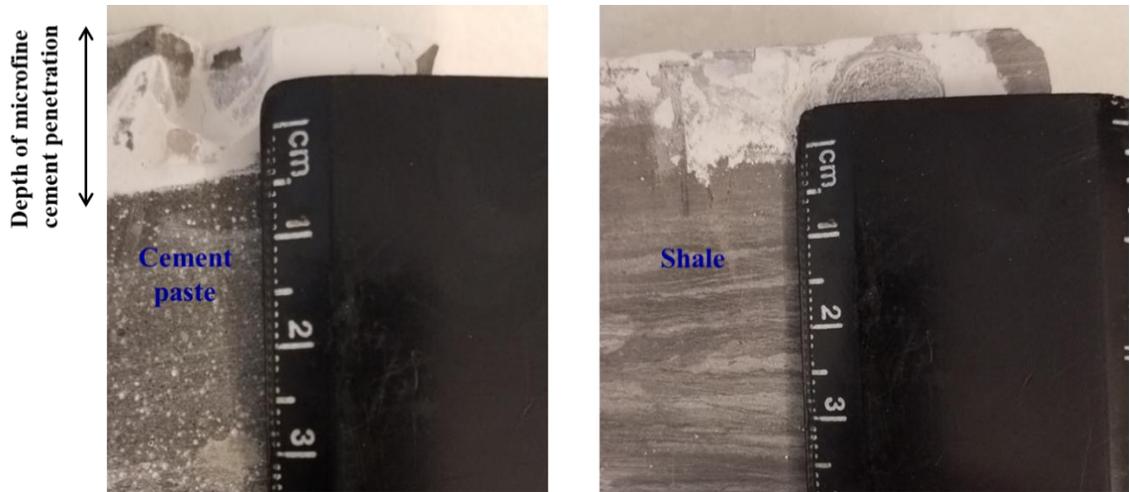
Figure 3.43: Microscopic images of cement-shale interface sealed with microfine cement with two different sides showing depth of microfine cement penetration of cement paste and shale sides.

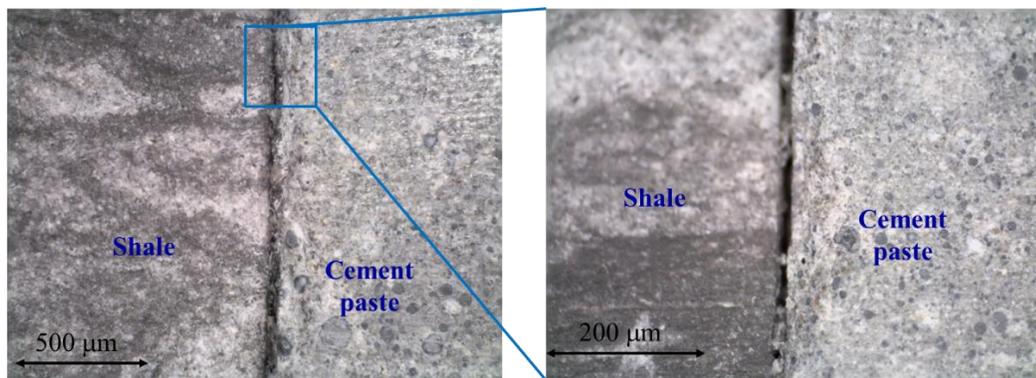
Figure 3.44: Microscopic images of cement-shale interface sealed with Novolac epoxy with two different levels of magnification showing gaps in sealed interface. Right photo at high magnification shows the inability of epoxy to penetrate 30 μm microcracks.

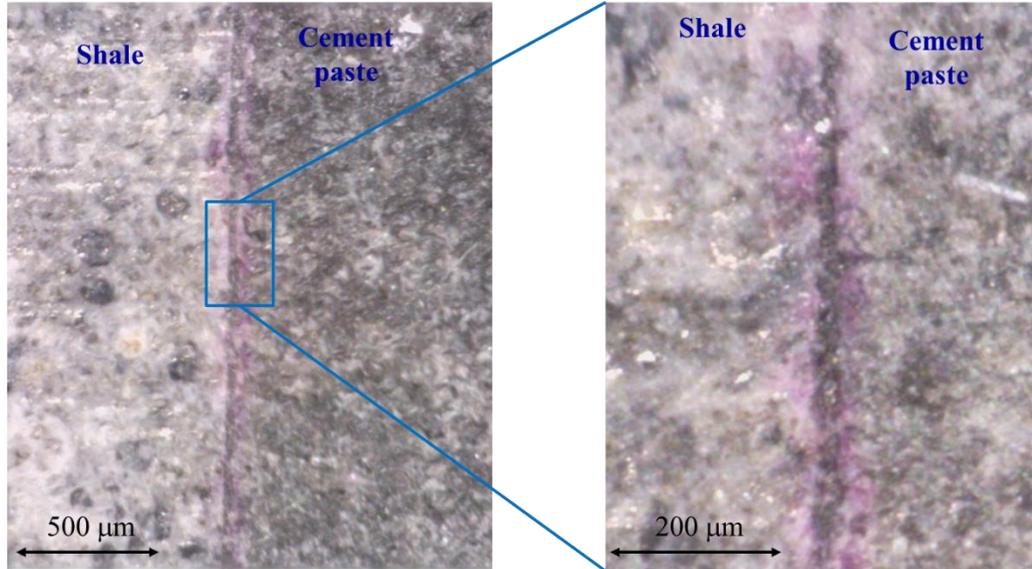
Figure 3.45: Microscopic images of cement-shale interface sealed with NM-MMA with two different levels of magnification showing the ability of the NM-MMA seal repair material to completely fill the gap at the shale-cement interface. Right photo proves the ability of NM-MMA to fill the microcracks and infiltrate both shale and cement paste sides.

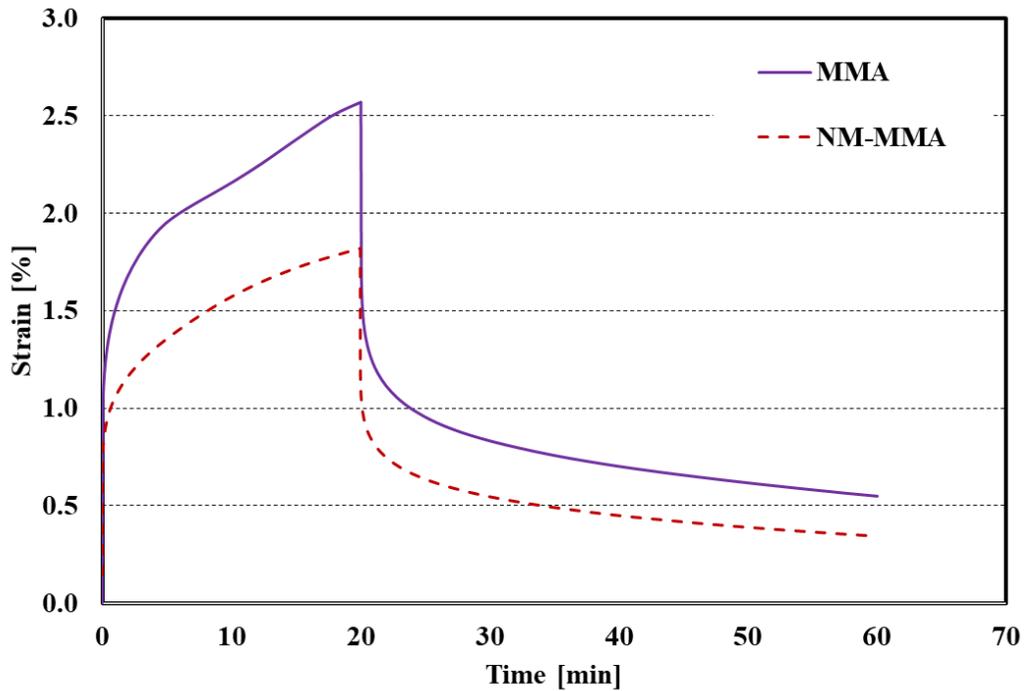
Figure 3.46: The viscoelastic behavior of MMA and NM-MMA obtained from creep test.

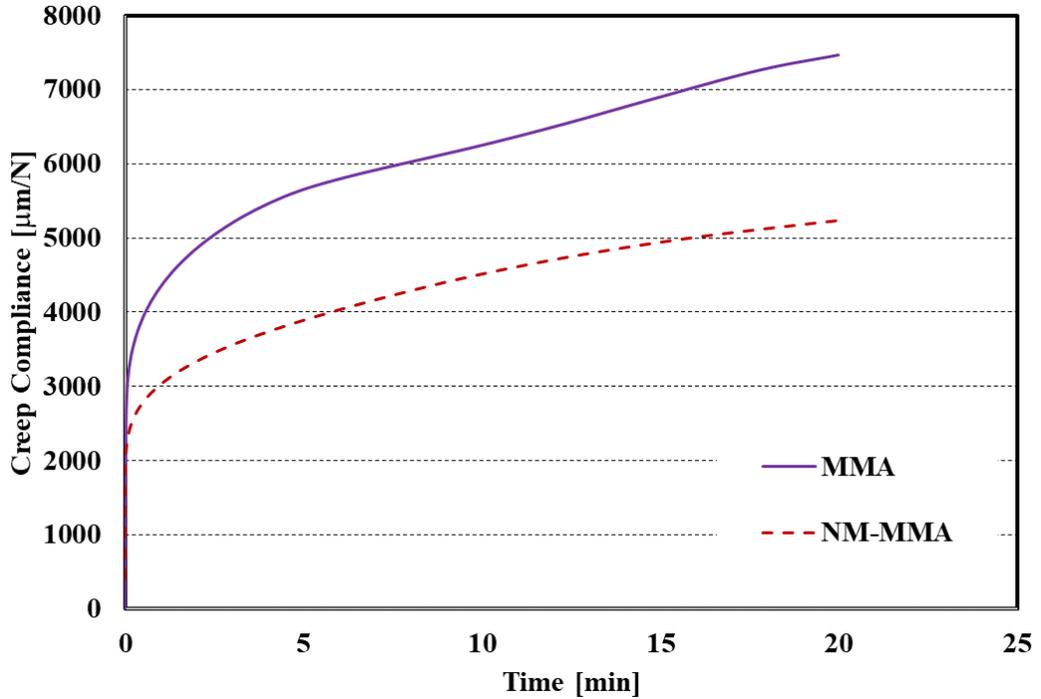
Figure 3.47: Creep Compliance of MMA and NM-MMA calculated from equation 3.7.

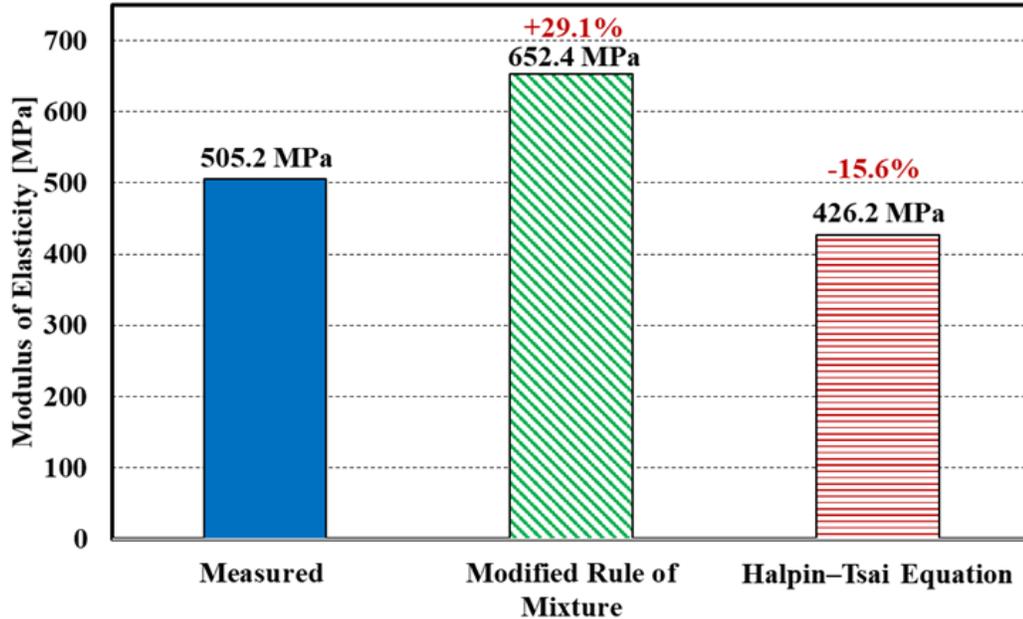
Figure 3.48: The estimated modulus of elasticity of NM-MMA using modified rule of mixture and Halpin-Tsai method compared to the measured value; % above the bars represents the difference of estimated modulus of elasticity compared with measured value..

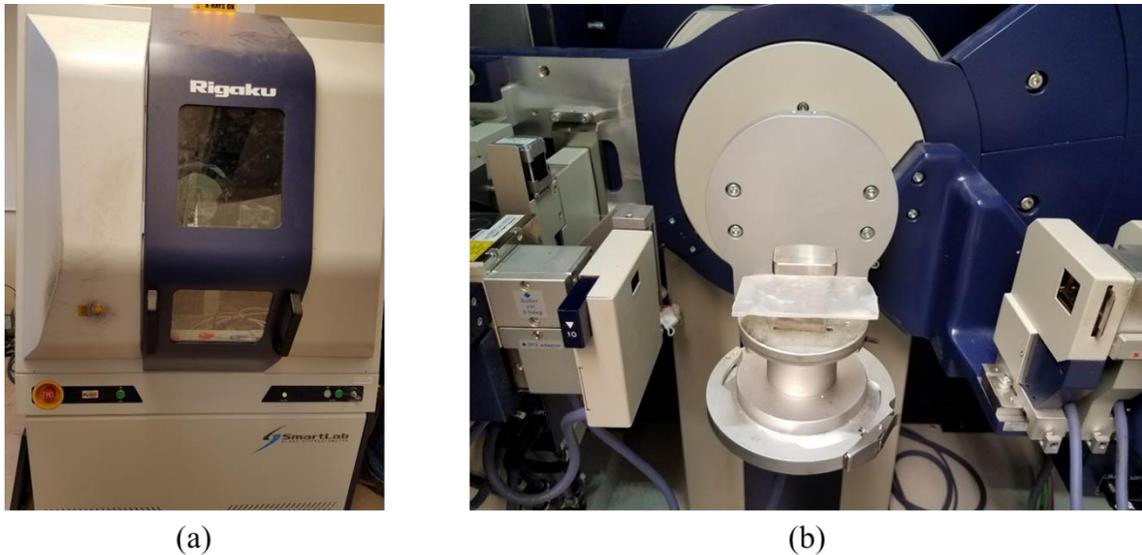
Figure 3.49: (a) Rigaku SmartLab XRD machine and (b) MMA sample on XRD sample holder.

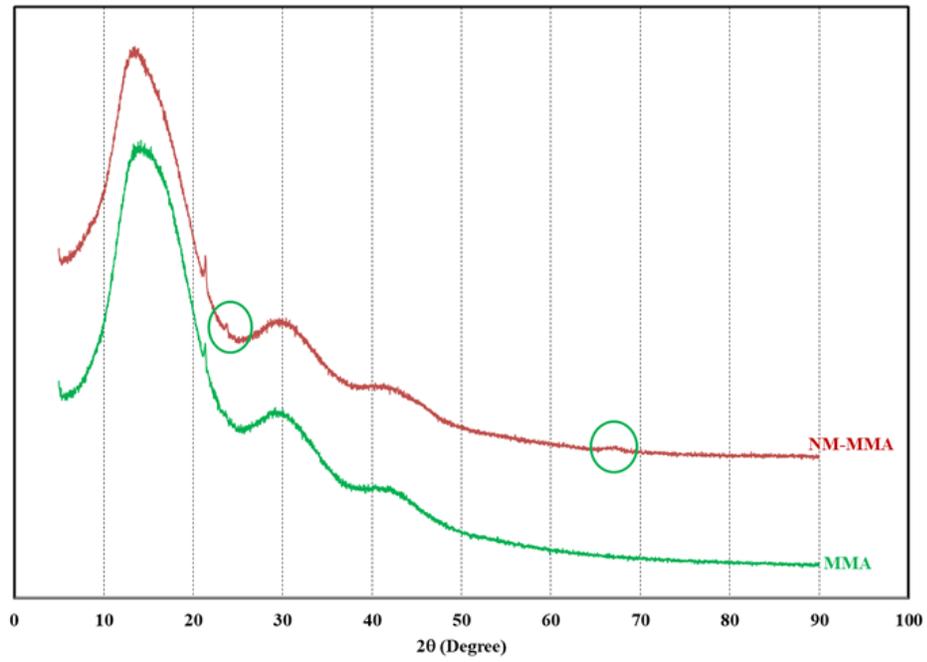
Figure 3.50: XRD scans for both MMA and NM-MMA specimens.

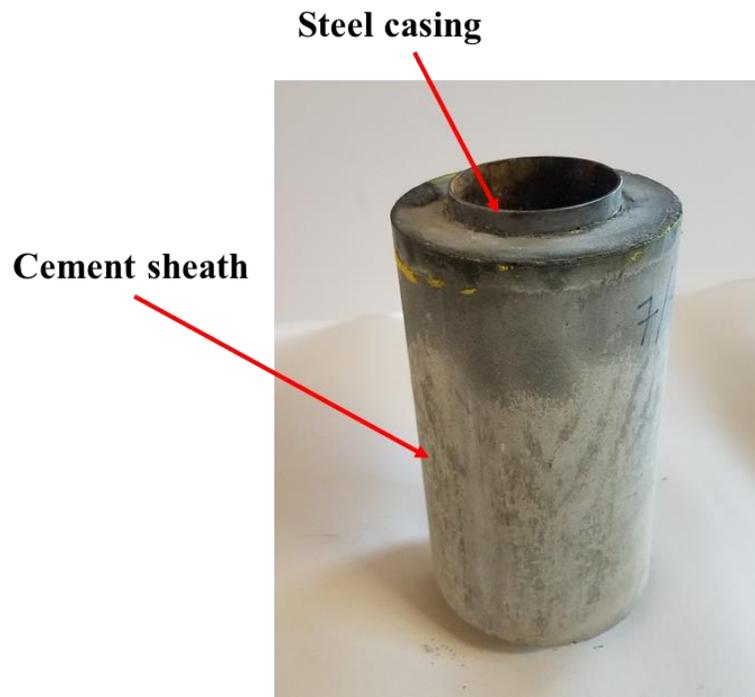
Figure 3.51: Integrated seal test specimen.

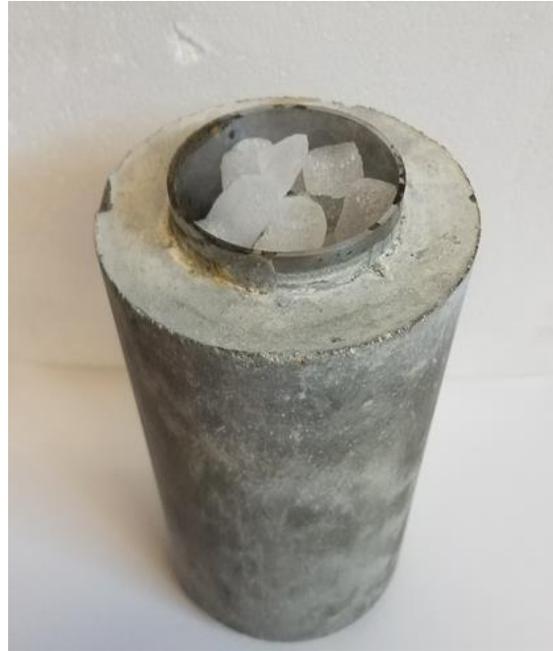
Figure 3.52: Debonding steel casing from the cement sheath using dry ice.

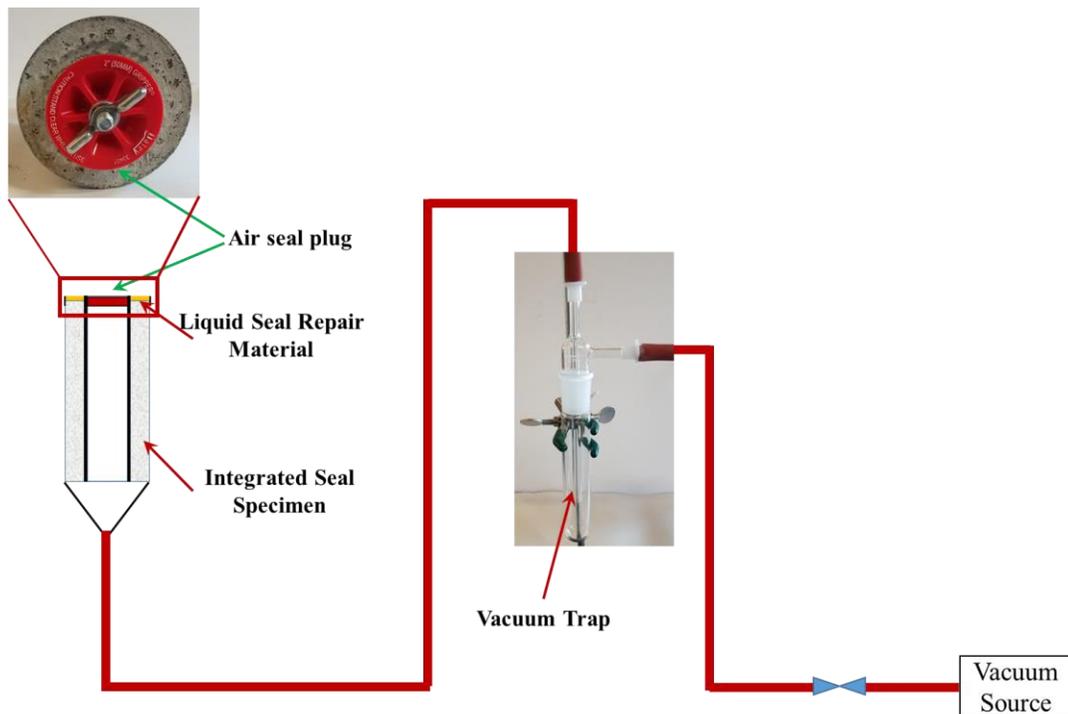
Figure 3.53: Schematic of seal repair material injection setup.

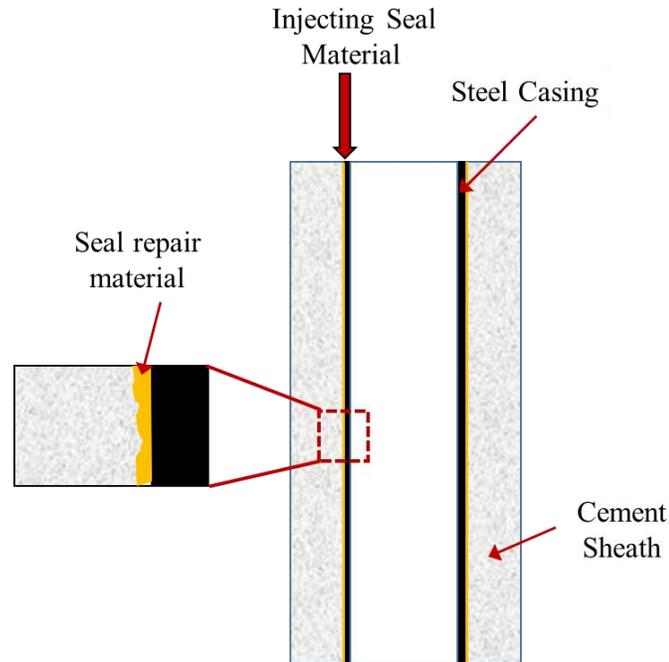
Figure 3.54: Schematic of integrated seal test specimen.

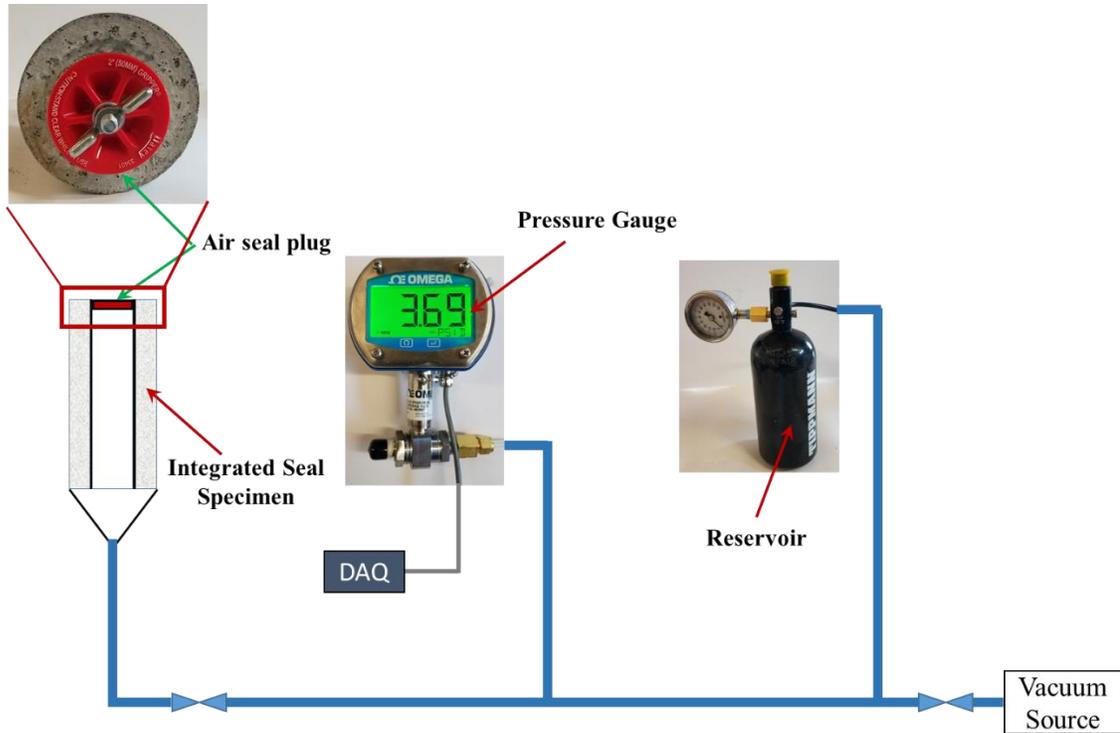
Figure 3.55: Schematic of the cement-steel interface characterization setup.

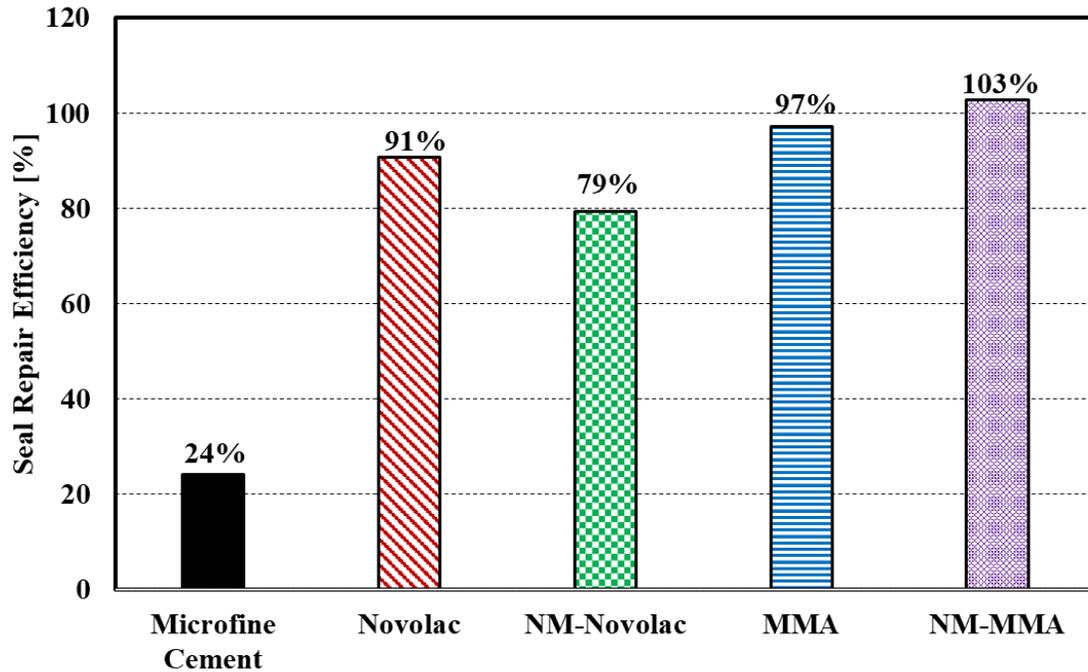
Figure 3.56: Seal efficiency of different seal repair materials used for restoring wellbore seal integrity.

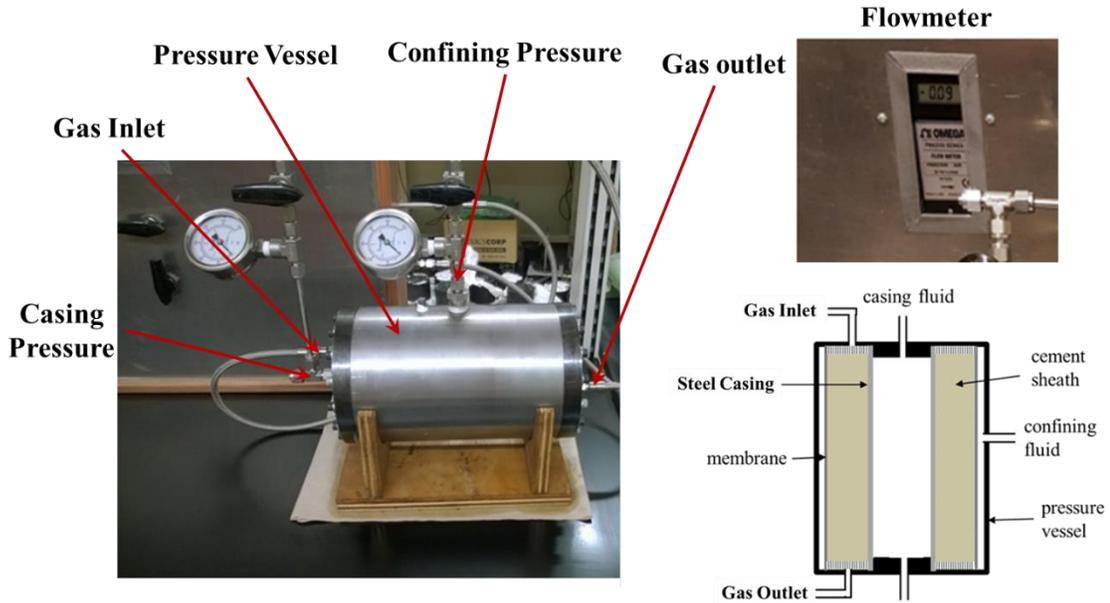
Figure 3.57: Integrated seal test setup.

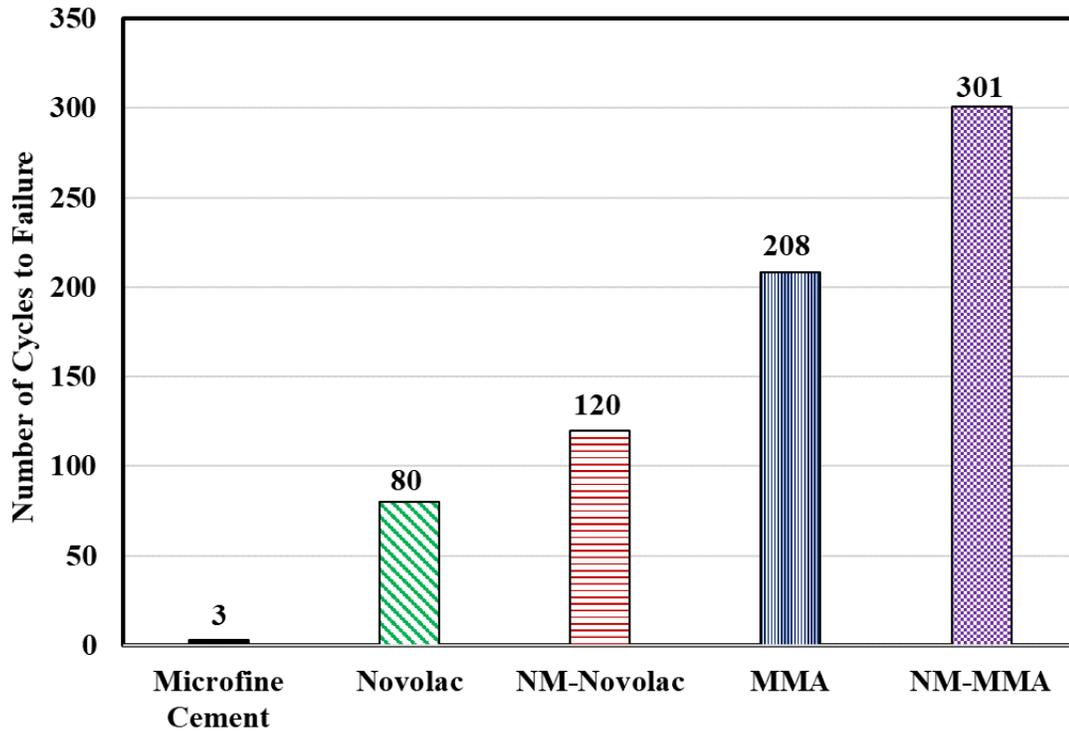
Figure 3.58: Number of casing pressure cycles applied until failure of seal integrity of sealed specimens.

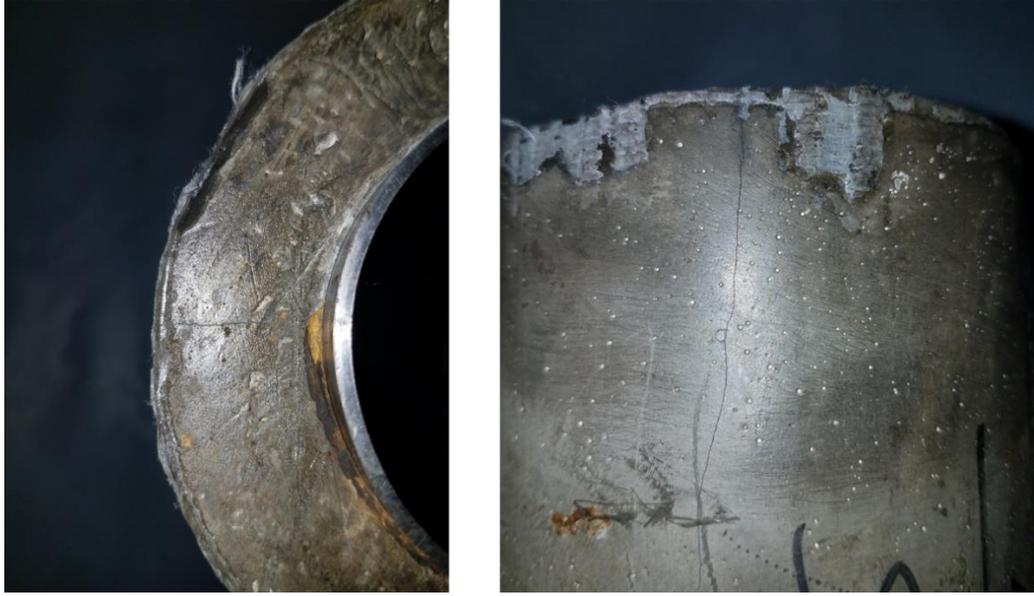
Figure 3.59: Post cyclic test integrated seal specimen sealed with MMA showing a single longitudinal crack in the cement sheath.

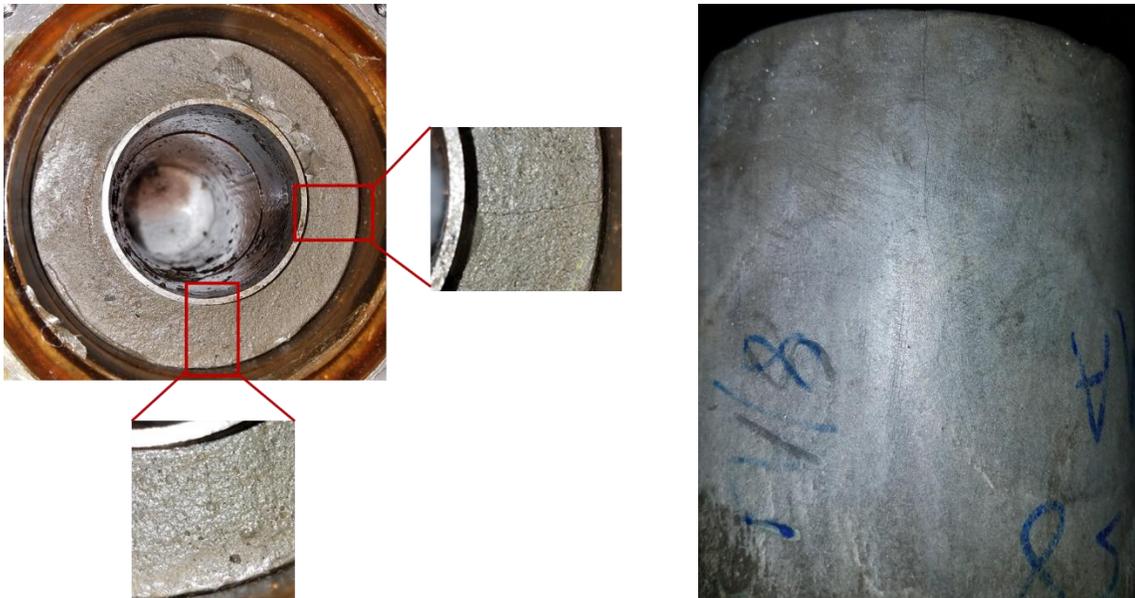
Figure 3.60: Post cyclic test integrated seal specimen sealed with NM-MMA showing two longitudinal cracks in the cement sheath.

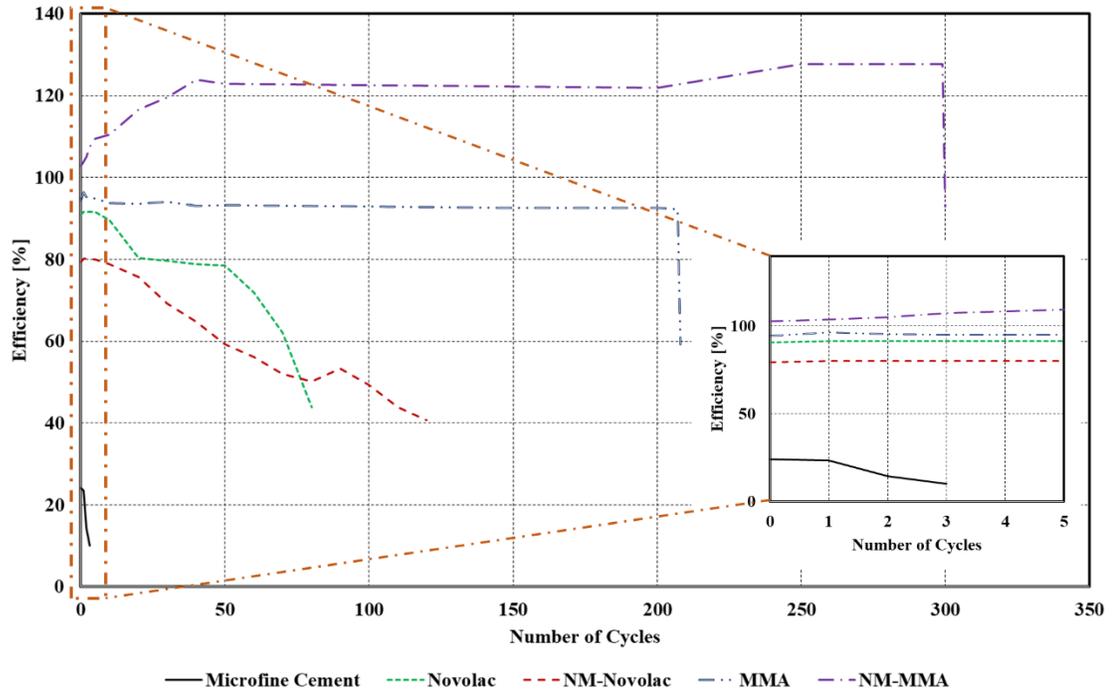
Figure 3.61: Change of seal efficiency of seal repair materials with number of casing pressure cycles.
