An Engineered Fit-For-Purpose Polymer Nanocomposite Seal Repair Material for Wellbores

Civil, Construction & Environmental Engineering

DISSERTATION

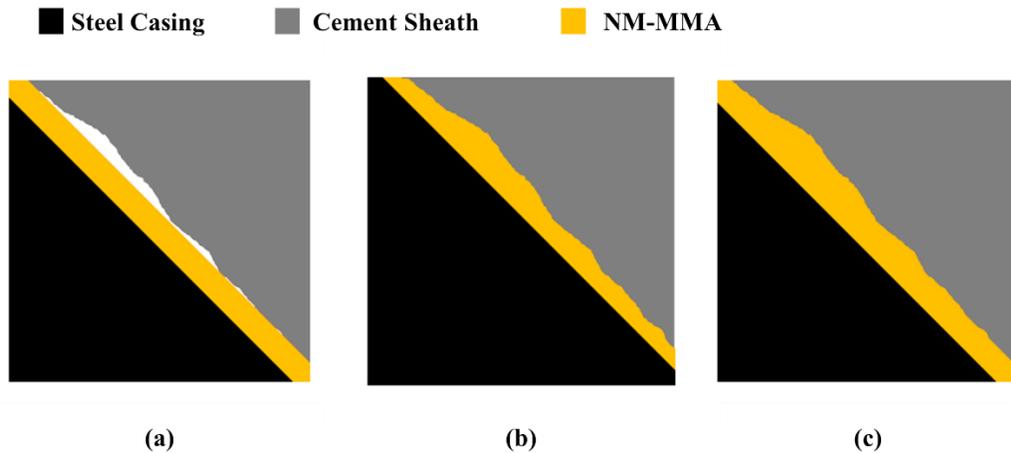
Figure 3.62: Effect of casing pressure cycles on cement-steel interface sealed with NM-MMA: (a) Prior to applying casing pressure, (b) Maximum casing pressure applied, and (c) Casing pressure released.

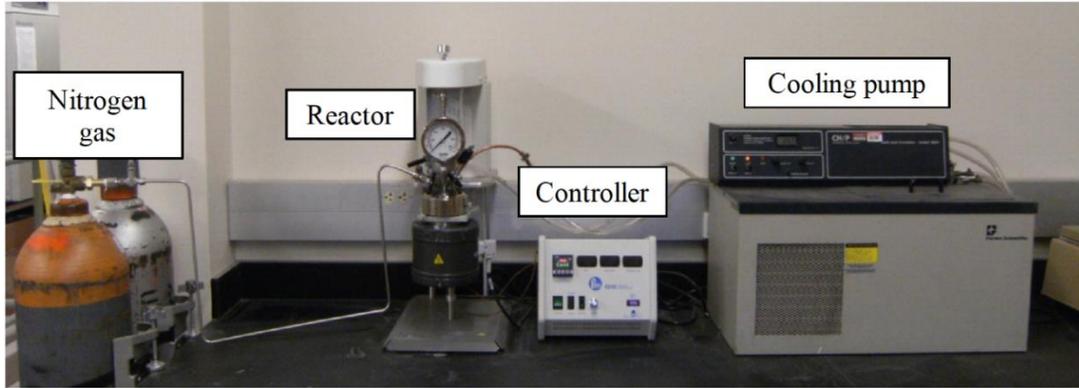
Figure 3.64: High temperature and pressure reactor setup.

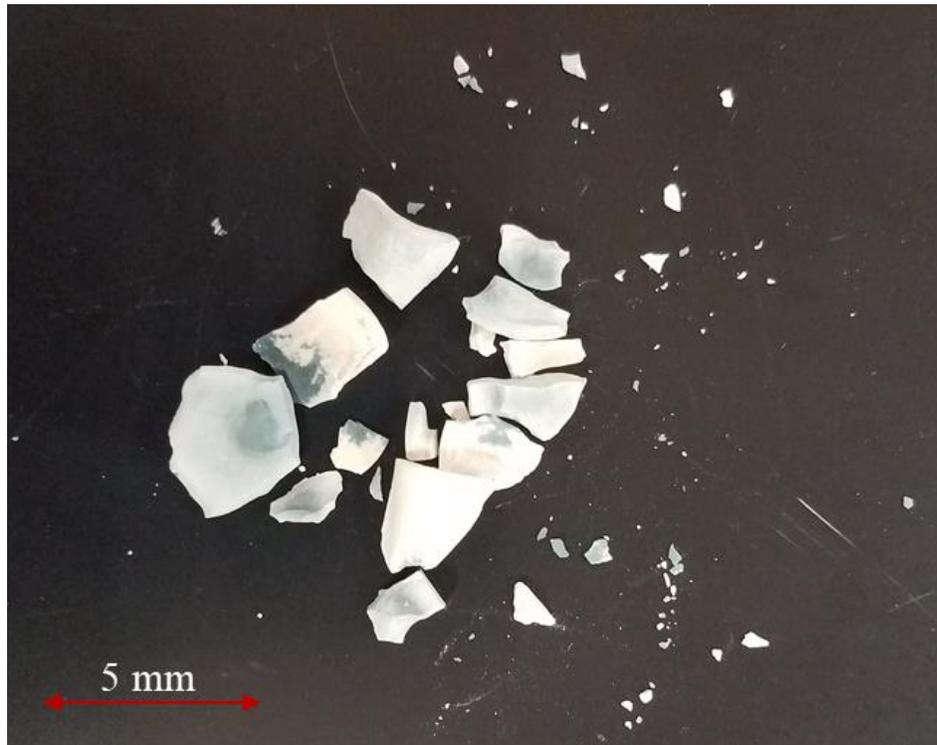
Figure 3.65: Microfine cement fractions falling apart due to harsh environmental conditions.

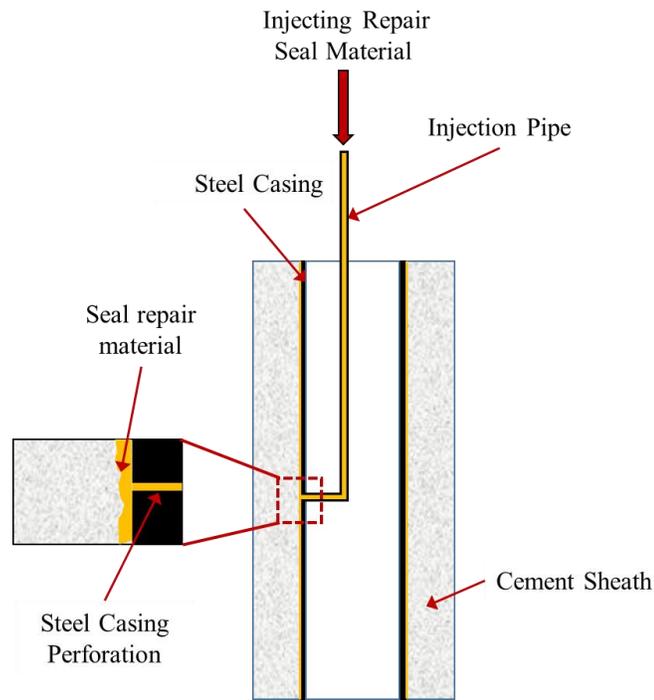
Figure 4.1: Schematic of sealing integrated seal specimen through perforation in the steel casing.

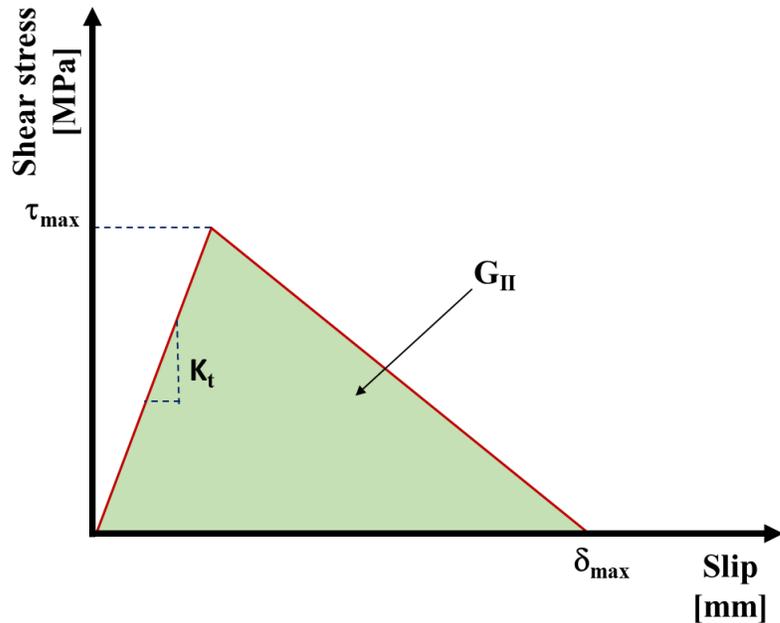
Figure 4.2: Bilinear shear stress-slip interface interaction model.
