### Analysis Of Ternary Chloride Salt Corrosion In High Nickel Alloys

Dimitri Madden

THESIS

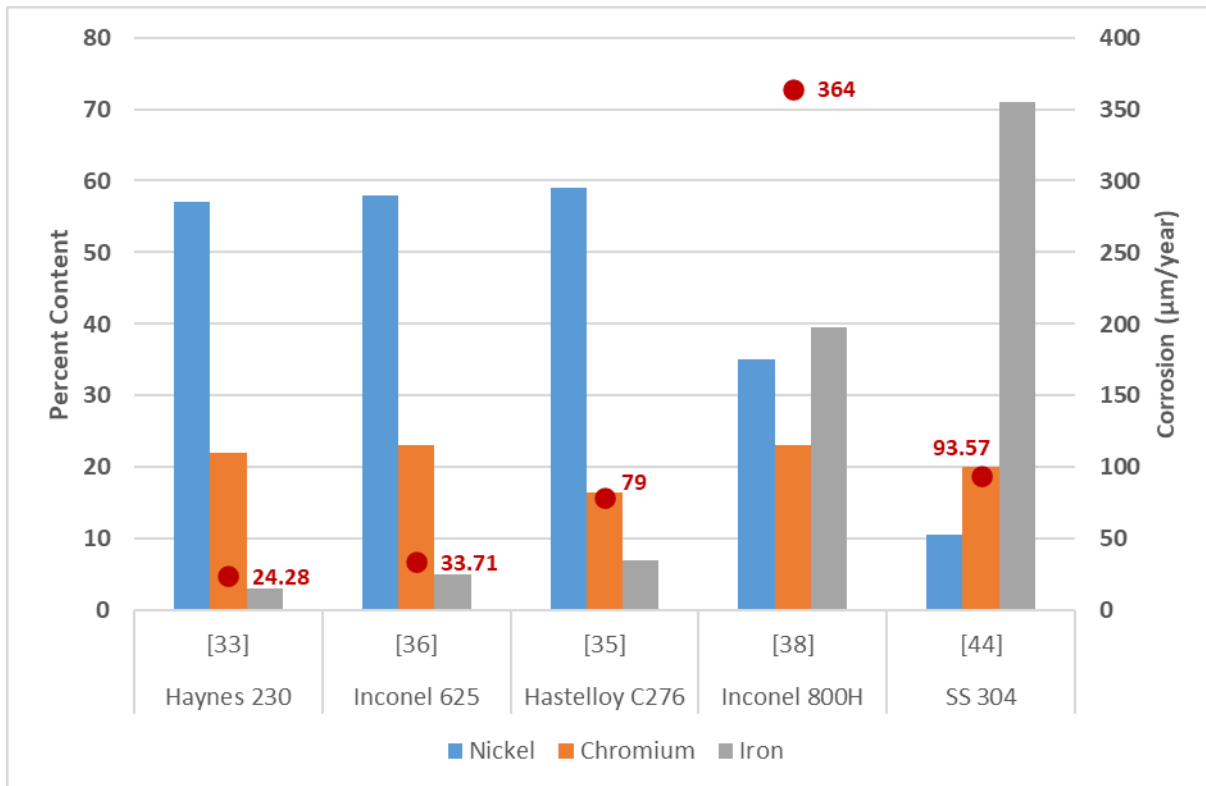
**Figure 3: Alloy Composition vs. Corrosion Rate**

When considering the composition, it is not surprising that alloys like Haynes 230, Hastelloy C276, and Inconel 625 have such good corrosion resistance. Figure 3 plots nickel, chromium, and iron content of some alloys considered against corrosion rates reported after 500–1000-hour exposures to 700-750°C chloride salts. As previously discussed, iron and chromium are correlated with high corrosion in chlorides, while nickel is correlated with corrosion resistance. Haynes 230, Hastelloy C276, and Inconel 625 all have high nickel content. Inconel 800H has the lowest nickel content and highest iron content of any of researched alloys, and had reported corrosion rates of 364 μm/year at 750 °C. This was the highest corrosion rate of any nickel alloy under a vacuum or argon cover gas. The austenitic stainless steels all have low nickel content and high iron, and all three had high corrosion and mass loss rates at high

temperatures. Haynes 230, Hastelloy C276, and Inconel 625 likely outperform Inconel 800H and austenitic stainless steels due to high nickel content and low iron content. However, Inconel 600 has the highest nickel content of any alloy considered, and yet reported Inconel 600 corrosion is significant. Inconel 600 showed 200-700  $\mu\text{m}$  corrosion depth in NaCl-KCl between 700-900  $^{\circ}\text{C}$ , by Salinas-Solano et al and Grégoire et al [52],[58]. One possible explanation is the presence of beneficial alloying elements. As previously mentioned Oryschich and Kostyrko [32] found that the presence of cobalt, molybdenum, and tungsten increase corrosion resistance of nickel alloys. Increased nickel content for higher dissolution of alloying elements into the metal [31]. In Haynes 230, Hastelloy C276, and Inconel 625 all have refractory metals and cobalt, while Inconel 600 has none. Similarly, Inconel 800H lacks refractory metals or cobalt.

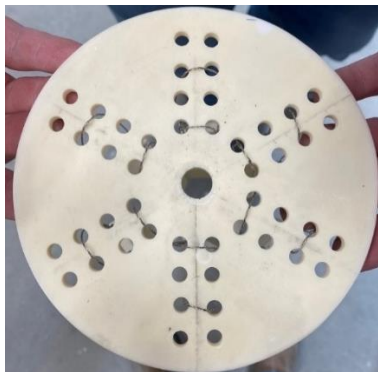
The strings of samples were then hung from an alumina plate, referred to as the chandelier. The samples were hung from an alumina plate to prevent galvanic coupling which could occur if two strings of samples were in contact with the same piece of metal, allowing for ion transfer. The alumina plate was a corrosion resistant and temperature rated alternative to hanging the samples from a metal hanger. Holes were drilled in the alumina plate to allow for hanging of samples in the pattern shown below.

**Figure 7: Alumina Disk for Hanging Samples**

Pairs of holes were drilled in 6 columns, each column with 4 rows. This orientation allowed for up to 12 strings of samples to be hung from the plate. The other 12 rows were for hanging alumina spacers between rows of samples, as shown in the images below. These spacers prevented strings of dissimilar material from contacting each other, again resulting in galvanic corrosion.

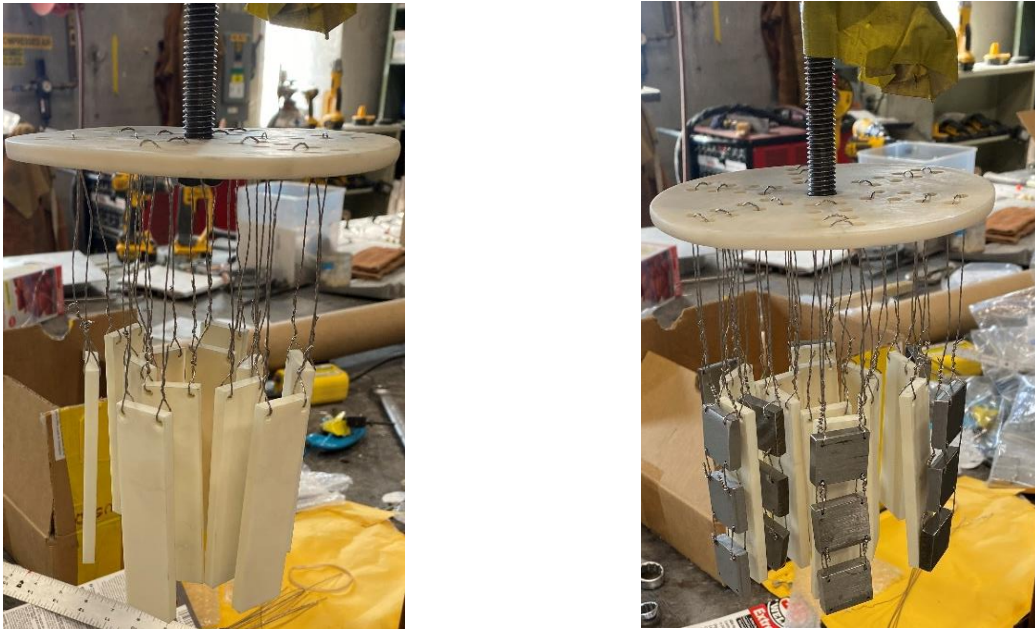
**Figure 8: Coupon Sample "Chandelier" with Alumina Spacers, with and without Coupons**

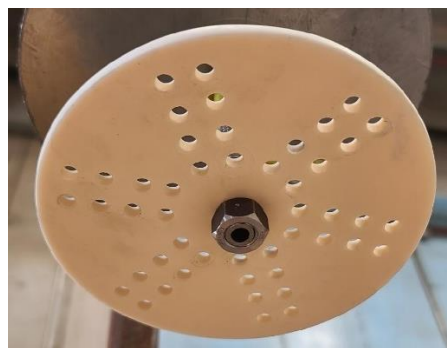
The alumina plate also had a 1/2" hole in the center. A threaded C276 rod passes through this hole and the alumina plate was fixed in place with a C276 nut.

**Figure 9: Alumina Coupon Disk Mounted on Threaded C276 Rod**

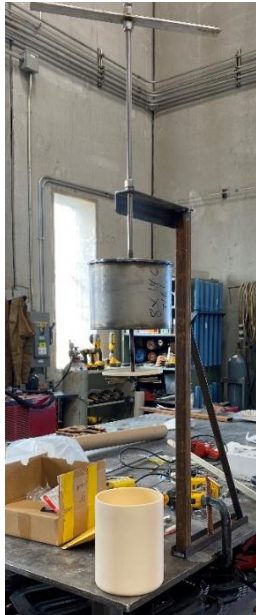
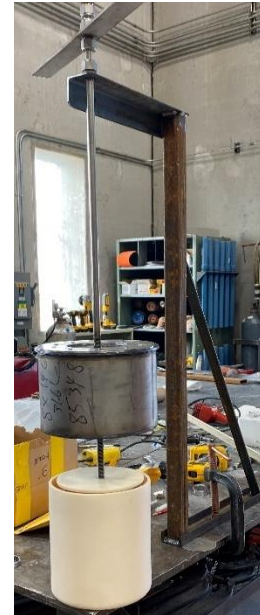
Figure 11 shows the sliding tube system, the crucible, and the sample tree chandelier outside the test pot. The tube is positioned above one of the alumina crucibles used for corrosion testing and is fixed in a makeshift stand with a Swagelok reducing union on top to allow for raising and lowering of the tube. The image shows the chandelier in the raised and lowered position. The alumina plate at the end of the slide tube is the chandelier used for hanging samples.

**Figure 11: Sliding Rod and Coupon Holder Raised Above and Lowered into Alumina Crucible**

As can be seen in Figure 11 above, there was a large metal cylinder along the length of the slide tube. This cylinder was a thermal insulator used to protect the top of the flange from test temperatures. The Teflon ferrules used in some of the fittings on the flange could only operate up to 327 °C, but the salt was to be heated to 750 °C. The system also held pressure and the flange pressure was thermally derated at test temperatures. The insulating barrier was a hollow container of 316SS, filled with Microtherm pourable insulation. It protected the flange and Teflon ferrules from the extreme temperatures at the bottom of the vessel where the salt-filled alumina crucible rested. A graphite ring at the top of the thermal barrier was used as a scrubber to maintain a tight seal between the thermal barrier and the inner diameter of the test pot.

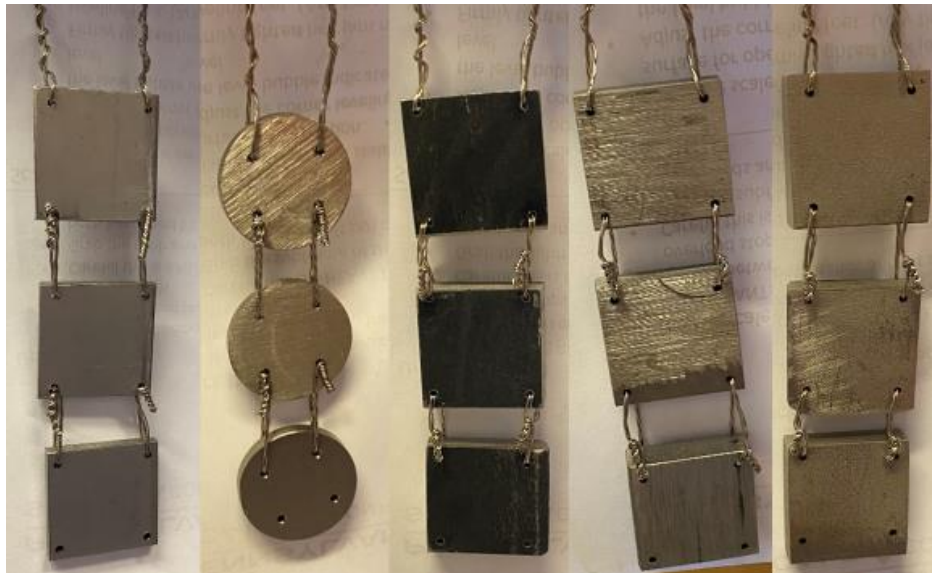
For corrosion testing of the five nickel alloys, three coupon-type samples of each material were used, suspended in chains with pure nickel wire.

**Figure 17: Pre-Test Nickel Alloy Samples left to right: Haynes 230, Haynes 282, Inconel 740H, Inconel 625, Inconel 800H**

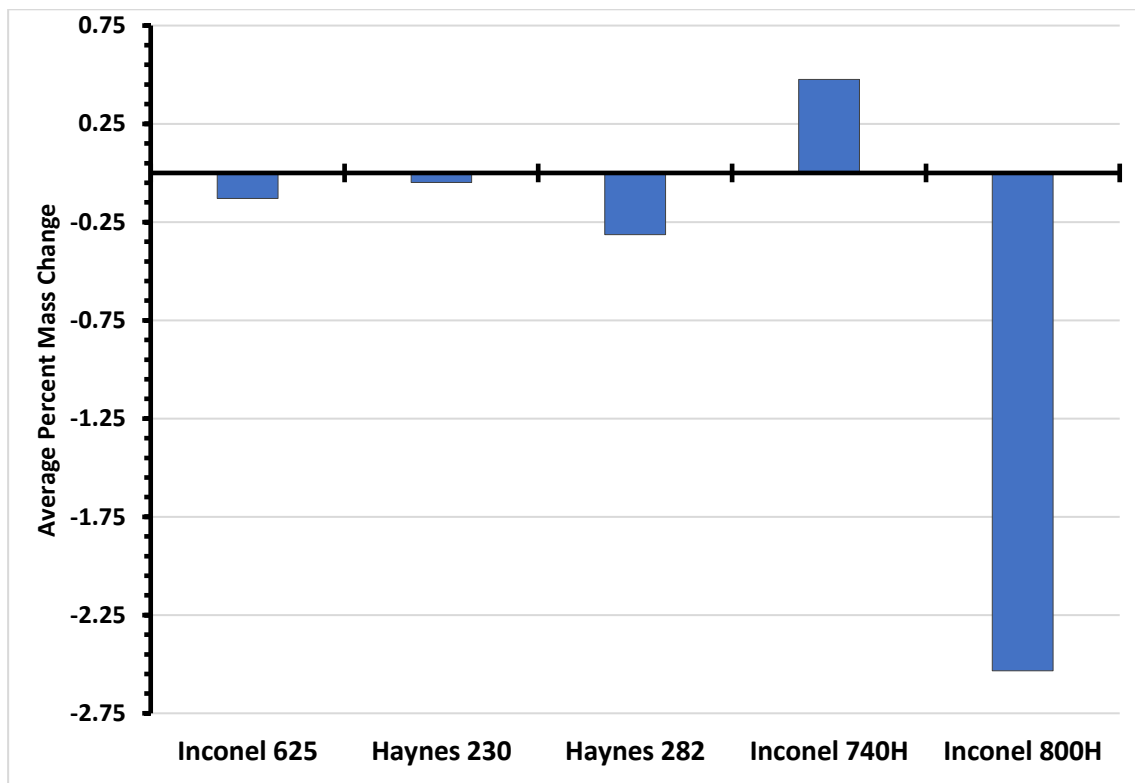
All samples in this test lost mass except for Inconel 740H, for which all samples gained mass, a phenomenon which will be evaluated further. Overall, the lowest mass loss was in Haynes 230, with an average percentage loss of 0.05%. The most significant loss was in Inconel 800H, which lost over 2.5%.

**Figure 19: Average Percent Mass Change of Alloys After 500 hours of Molten Chloride Salt Exposure**

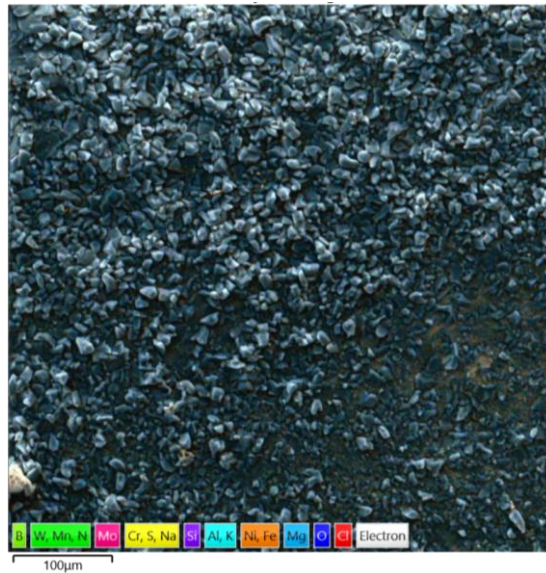
However, the third sample, imaged with the replacement EDS equipment, showed a significant amount of salt residue. EDS analysis revealed the salt residue was almost completely magnesium oxide. The magnesium oxide did not contain any dissolved alloying elements from the Haynes 230 sample, such as nickel or chromium. It was a layer of pure salt that deposited on the sample surface. The lack of incorporated alloying elements in the salt residue further suggests that the Haynes 230 material had good corrosion resistance. However, it is unclear why such a significant amount of salt was adhered to the sample surface even after multiple washes.

Figure 24: SEM 100  $\mu\text{m}$  magnification surface image of Haynes 282

Figure 25: EDS layered scan of Haynes 230

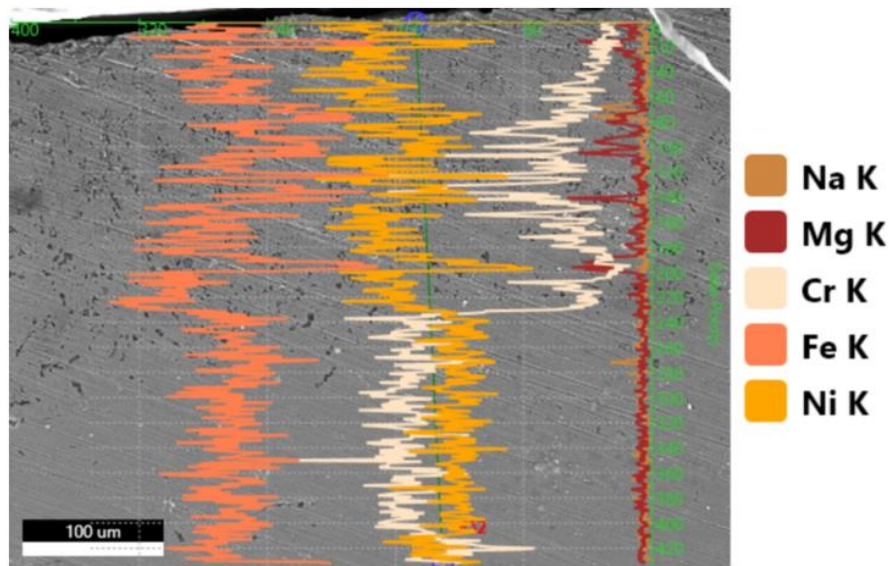
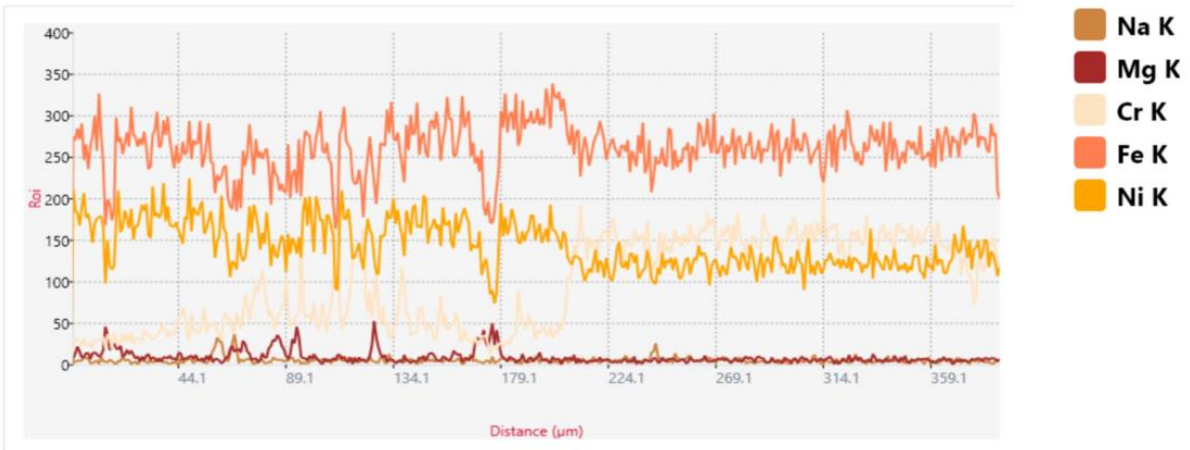
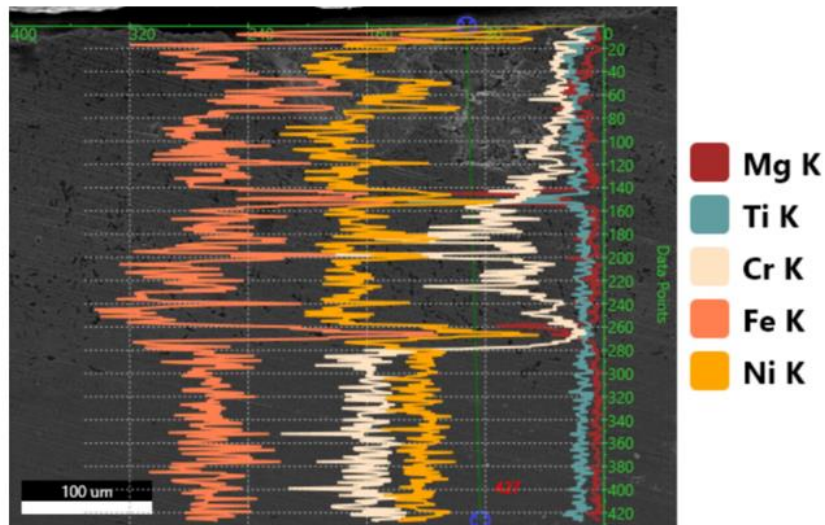
The first cut and polished samples analyzed were of Inconel 800H, shown in Figures 33-36, which show the data from two different EDS imaging procedures. Prior to performing any EDS analysis, clear pitting corrosion was already evident. As can be seen in Figures 33 and 35, significant holes from pitting corrosion were visible from the sample exterior edge down into the sample body. EDS analysis confirmed the pitting was the result of chromium depletion. As can be seen in the line scans taken from the exterior edges into the sample bodies, the chromium content was directly correlated with the visible pitting. At the sample interior chromium, iron, and nickel content levels were all normal. But approaching the exterior edge where the pitting becomes visible, chromium content decreased sharply. This pitting and chromium depletion occurred 200-225  $\mu\text{m}$  into the sample over the 500-hour salt exposure period.

Figure 33: Cross Section EDS Line Scan of Cut Inconel 800H Area 1

Figure 34: Element Map for Cross Section EDS Line Scan of Cut Inconel 800H Area 1

Figure 35: Cross Section EDS Line Scan of Cut Inconel 800H Area 2

Figure 36: Element Map for Cross Section EDS Line Scan of Cut Inconel 800H Area 2

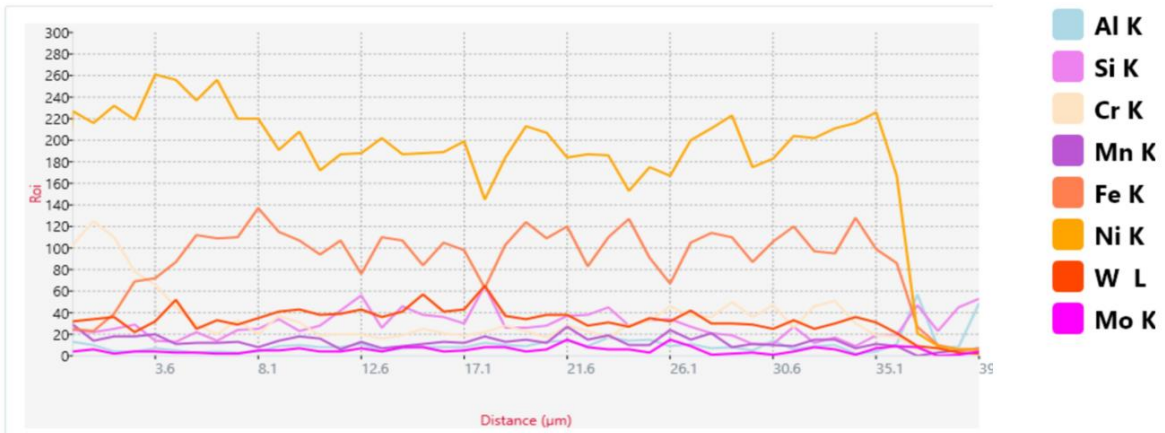
Next, Figures 37-40 provide data from EDS line scan analysis on the cross-section cut faces of Haynes 230 samples. These scans were done at a higher magnification than the previous Inconel 800H imaging as the depth of corrosion was not nearly as extreme. Immediately obvious was the tooling marks on the cut surface, indicating that the polishing quality was not high. However, corrosion analysis was still easily performed with the data obtained. As can be seen in the EDS line scan images Figures 37 and 39, there was some pitting corrosion near the edge of the Haynes 230 samples, in the first ~30  $\mu\text{m}$  from the edge. However, the pitting was not nearly extreme as was seen with Inconel 800H. The worst of the pitting damage was in the first ~10  $\mu\text{m}$ . Pitting on the Haynes 230 sample surface directly correlated with changes in elemental composition. EDS data shows that chromium depletion occurred in the first 20-30  $\mu\text{m}$  along with increased iron content, corresponding with the visible pitting. There was no appreciable change in nickel content in these scans. This analysis clearly indicated corrosion damage through the first 30  $\mu\text{m}$  of Haynes 230, but not further.

Figure 37: Cross Section EDS Line Scan on Cut Face of H230 Area 1

Figure 38: Element Map for Cross Section EDS Line Scan on Cut Face of H230 Area 1

Figure 39: Cross Section EDS Line Scan on Cut Face of H230 Area 2

Figure 40: Element Map for Cross Section EDS Line Scan on Cut Face of H230 Area 2

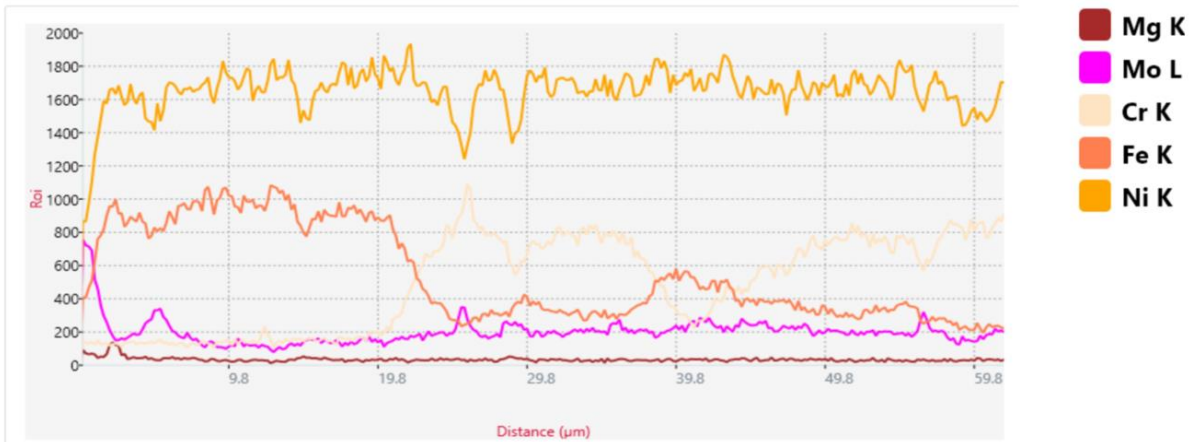
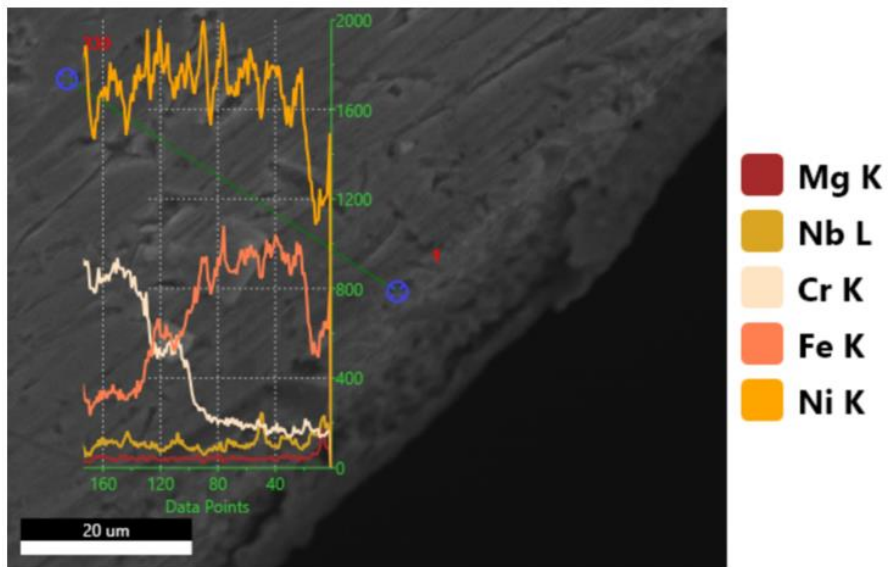
Figures 41-44 show results from EDS line scan analysis on the cross-sectional faces of Inconel 625 samples. Very little pitting corrosion could be seen on these sample surfaces, even at the 20  $\mu\text{m}$  scale. Some possible pitting could be found, but overall there was little visual evidence of corrosion. The only evidence of corrosion was found in the EDS elemental composition imaging. From the exterior edges of the samples to an approximate 20-30  $\mu\text{m}$  depth, there was chromium depletion and increased iron content. Nickel content held consistent throughout the length of the line scan. The data provided by this analysis suggests that Inconel 625 performed well over the 500 hour duration submerged in molten chloride salt.

Figure 41: Cross Section EDS Line Scan of Cut Inconel 625 Area 1

Figure 42: Element Profile of Cross Section EDS Line Scan of Cut Inconel 625 Area 1

Figure 43: Cross Section EDS Line Scan of Cut Inconel 625 Area 2

Figure 44: Element Profile of Cross Section EDS Line Scan of Cut Inconel 625 Area 2

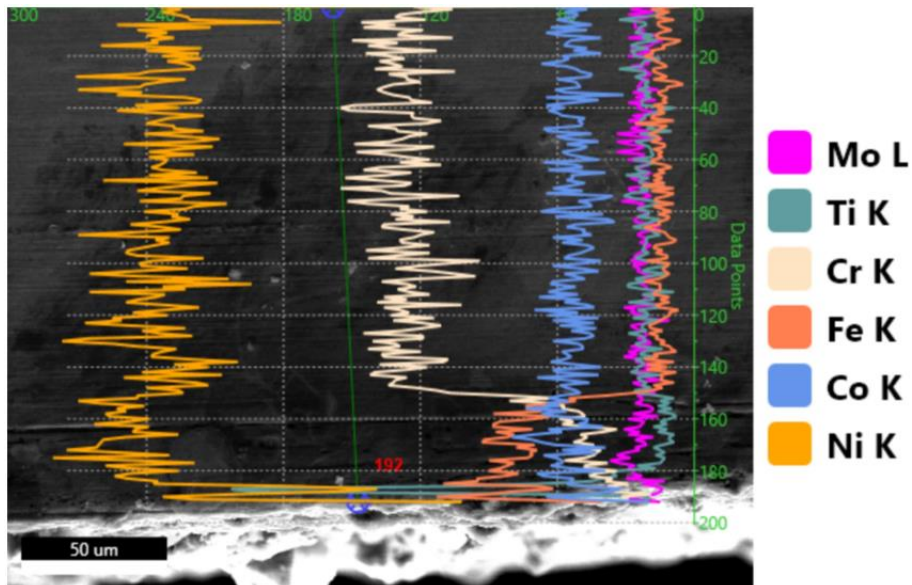
Finally, Hayne 282 samples were imaged last, with Figures 49-52 showing the EDS line scans and element maps. Some damage and possible signs of corrosion could be seen near the edge of the sample. The damage was not as obviously due to corrosion as the pitting seen on previous materials, it is possible the damage was due to cutting and polishing. The cut faces of the Haynes 282 samples were overall in much worse condition than the other materials, with many deformities and significant damage near the edges. However, EDS elemental composition did show clear signs of corrosion. Chromium depletion with elevated iron and cobalt levels was visible in the first ~40  $\mu\text{m}$  of the samples. The decline of chromium content was notably sharp rather than gradual. Though the surfaces were heavily damaged, the chromium depletion did seem to correspond with darkening and damage near the edges. These results indicate Haynes 282 chloride salt corrosion at least to the 40  $\mu\text{m}$  depth. Nickel content held constant throughout the length of the line scans on the cut surface.

Figure 49: Cross Section EDS Line Scan of Haynes 282 Cut Face Area 1

Figure 50: Element Map for Cross Section EDS Line Scan of Haynes 282 Cut Face Area 1

Figure 51: Cross Section EDS Line Scan of Haynes 282 Cut Face Area 2

Figure 52: Element Map for Cross Section EDS Line Scan of Haynes 282 Cut Face Area 2
