Water resources assessment of the Sapello River

Water Resources Assessment of the Sapello River

Editors:
Bruce Thomson
Abdul-Mehdi Ali
Water Resources Program
University of New Mexico
Albuquerque, NM 87131

June 2008

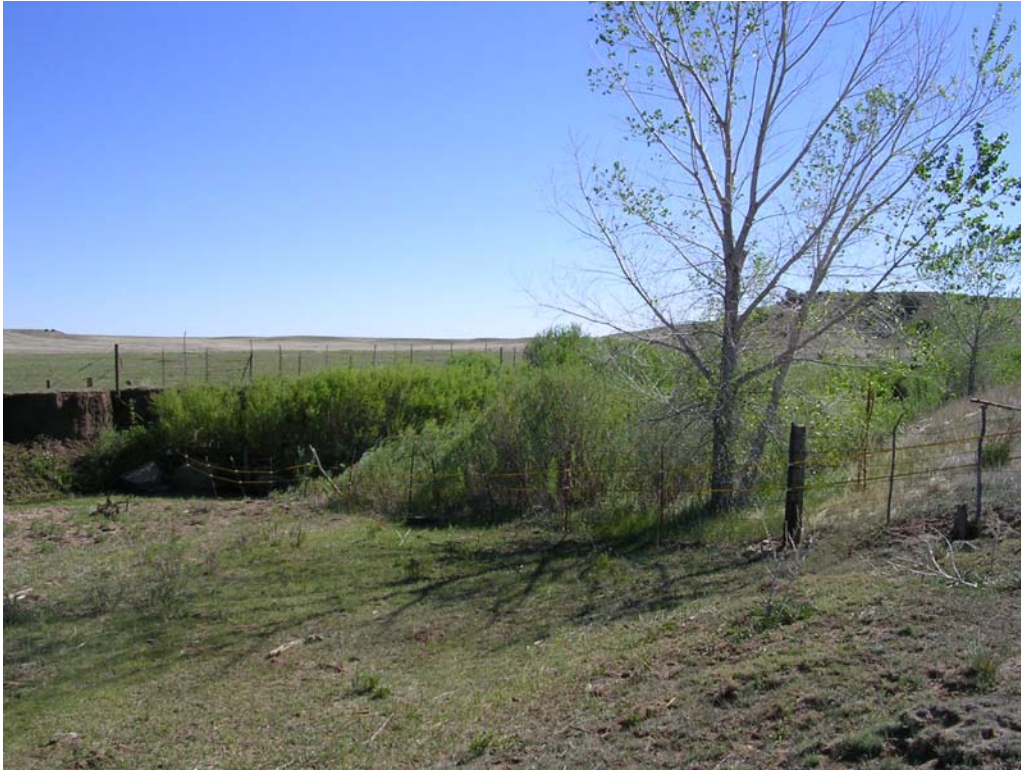
Figure 9. Photograph of the upstream boundary of the Blagg ranch showing the effects of protection of the riparian environment at this site.

The site chosen to represent the lower reaches of the watershed was a ranch owned by David Blagg, where significant restoration techniques have been conducted for the past 16 years. It is important to note that extensive grazing upstream from the Blagg ranch had removed nearly all riparian vegetation on the upstream property (Figure 9). This appears to have caused increased erosion and with subsequent accumulation of a fine grained sediments in beaver ponds and slack water at the Blagg ranch assessment site.

The sample site at the Blagg ranch had recently contained a beaver dam that created a long pool of still water with depths as great as four feet. The dam had washed out a few weeks before the sampling trip. Sample transects were placed 100 feet apart for a total of 400 feet. The average discharge for the Blagg ranch site during the study was measured at 3.52 cfs. The right bank slope averaged between 5 and 30 degrees except where incision was noted at 0.9 feet. The left bank had much higher slopes averaging between 10 and 80 degrees. The thalweg averages 20.95 inches in depth throughout the property. The stream bottom consisted mainly of silt and clay with much of the rock embeddedness ranging from 30 % in the center to 100% along the banks. These findings are consistent with erosion protection provided by dense riparian vegetation and the presence of beaver dams at the site.
