Water resources assessment of the Mora River

WATER RESOURCES ASSESSMENT OF THE MORA RIVER

Water Resources Program
University of New Mexico
Albuquerque, NM 87131

June 2009

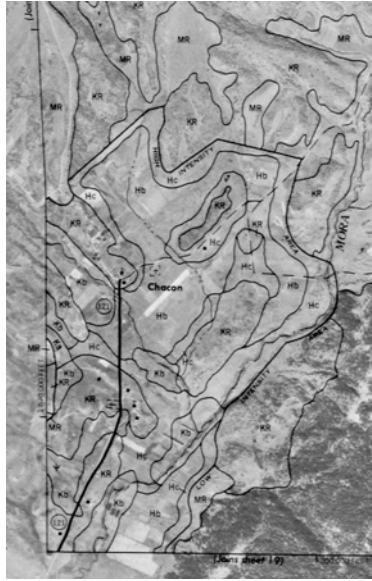
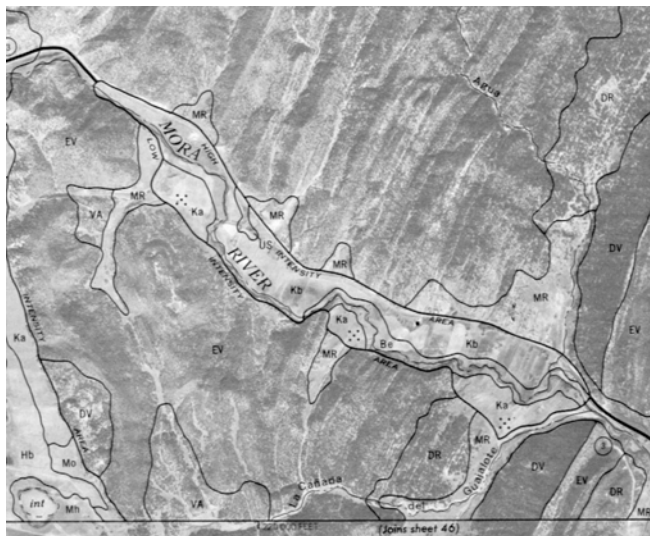
Bd Breece Variant sandy loam 3-8% slope
 Be Brycan loam, 1-3 percent slopes
 DR Dargol-Rocio-Vamer assoc., hilly
 DV Dargol-Rocio-Vamer assoc., very steep
 EV Eutroboralts-Rock outcrop Vamer complex, extremely steep
 FH Firo-Hesperus assoc., hilly
 Hb Hesperus sandy loam 1-3% slopes
 Hc Hesperus sandy loam 3-8% slopes
 Ho Holman complex, 3-5% slopes
 Ka Kinesava sandy loam 3-8% slopes
 Kb Kinesava loam 1-3% slopes
 KR Krakon-Rock outcrop complex, hilly
 MR Moreno-Brycan assoc, sloping
 VA Varner-Rock outcrop- EV complex, hilly

Figure 3 Soil Survey of Mora County (United States Dept. of Ag., Soil Conservation Service, 1981)

The USDA (1981) describes the soils in the Mora region as originating from parent material of metamorphic, igneous and sedimentary rocks. They vary in age from Precambrian to Holocene. Principal soil formation occurred during the Quaternary Period. Broad alluvial deposits occur on the eastern plains. The valleys consist mostly of Mollisols (highly erodible) and are dark colored due to warmer conditions and vegetation, while the higher mountain regions have higher organic matter with non-decomposed leaf litter due to higher precipitation and cooler climates. Soils here tend to have thicker layers and higher occurrence of leached profiles. In the western region, rocks consist of gray and red shale, thin strata of gray limestone and sandstone beds. The Sangre de Cristo Mountains consist of various colored shales, siltstone, arkosic sandstone and clay shale. Climate is the major factor affecting vegetation, parent material, drainage, soil temperatures and precipitation. Figure 3 presents a soil survey of the Mora County region.

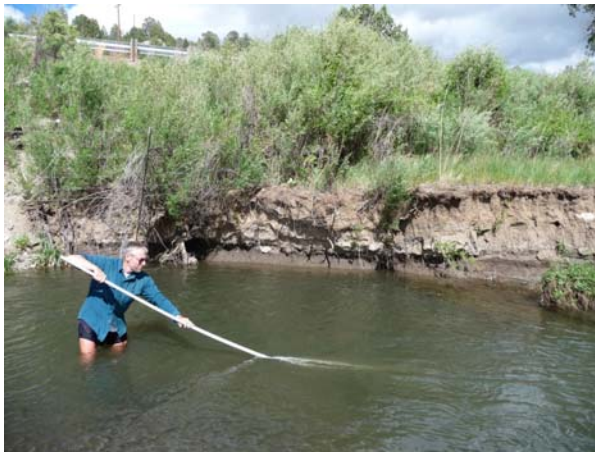
Figure 14. Measurement of thalweg depth at EMAP site number 2 downstream from the community of Mora.

- The thalweg depth (the deepest point in the stream's cross section) was measured every ten feet for 400 feet centered on the baseline transect using a surveyor's rod (Figure 14).
- At each transect, bank-full height and bank-full width (i.e., river height and width at a nominal two-year maximum flow) were identified and measured, as was the wetted-width (i.e., current width of river). Bank angle was recorded. An undercut bank was noted as having a negative bank angle.
- River bottom composition was characterized by selecting locations at each bank and at 25%, 50% and 75% across each transect. The surveyor's rod was placed at each location and the underlying substrate was estimated by determining the size of the particle(s) directly beneath the rod and the fractional embeddedness of the particle using EMAP criteria.

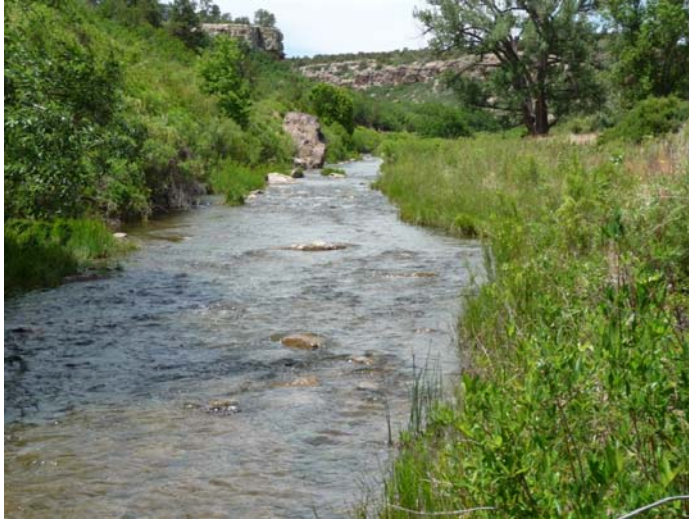
Figure 27. Photograph of the Mora River at the Wind River Ranch (EMAP site number 3).

Site #17 on the lower Mora River, is located at the Wind River Ranch at an elevation of 6600 ft. The river in this section was previously straightened to maximize the area of an adjacent hay meadow, approximately 100 years ago (Wind River Ranch Foundation, 2008), although visual assessments show that the riparian vegetation has grown back, and the river is surrounded by small rocky cliffs and open grassland. The substrate is embedded between 30 - 90%, with a composition of small boulders, fine gravel, and mud/clay. This site was not analyzed by the rapid assessment protocol.
