# The impact of dams, droughts, and tributary drainages on channel form and process : Rio Grande and Rio Chama, NM

**THE IMPACT OF DAMS, DROUGHTS, AND TRIBUTARY DRAINAGES ON  
CHANNEL FORM AND PROCESS: RIO GRANDE AND RIO CHAMA, NM**

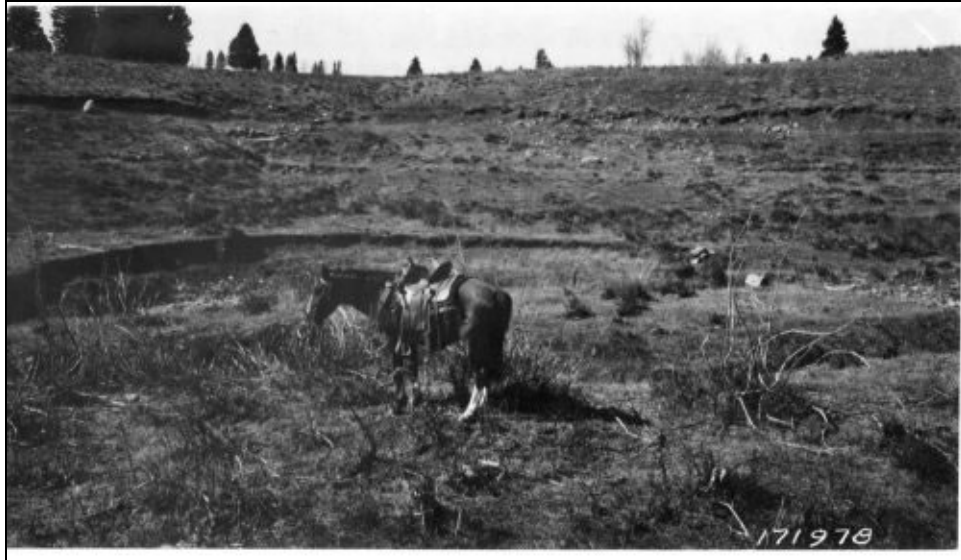
**Figure 16.** Historic photograph depicting land use in the upper Rio Chama watershed from the Carson National Forest (<http://www.fs.fed.us/r3/about/history/carson/>). “Overgrazed range near Tierra Amarilla Grant. This range was typical of much of the range on the Carson at the time” Photo by J. T. Jardine; FS #171978; 1922)

The relative lack of trend in streamflow data for the upstream reach, especially compared to the Rio Grande, suggests that sediment loads likely play a large role in the observed channel adjustments along the Rio Chama, especially upstream. Although there is no direct evidence for an increased sediment supply or channel widening and aggradation along the Rio Chama prior to 1935, land use practices that accelerated hillslope and tributary erosion (e.g., arroyo cutting; Fig. 16) could have contributed to the state of the channel during the early part of the study period. Photographic evidence for a decrease in sediment delivery to the Rio Chama channel after 1935 include the construction of numerous check dams on tributaries to the upstream reach, and reduction in braiding and distributary channels

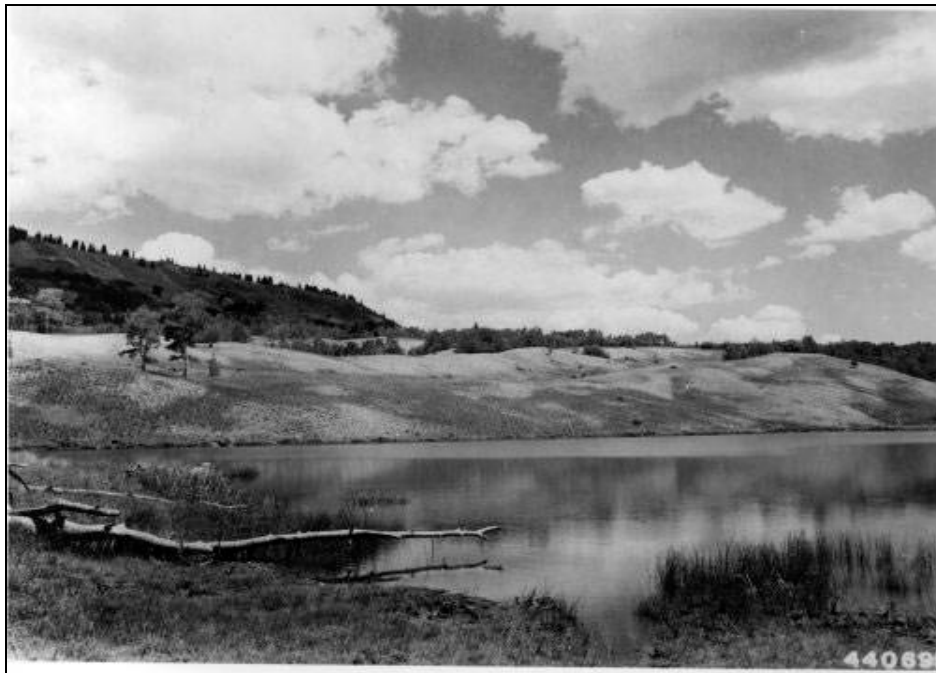
**Figure 17.** Historic photograph depicting land use in the upper Rio Chama watershed from the Carson National Forest (<http://www.fs.fed.us/r3/about/history/carson/>). “Small lake with the burned over, overgrazed, and eroded slopes of Canjilon Mountain in the distance.” Photo by R. King; FS #440695; 1946.

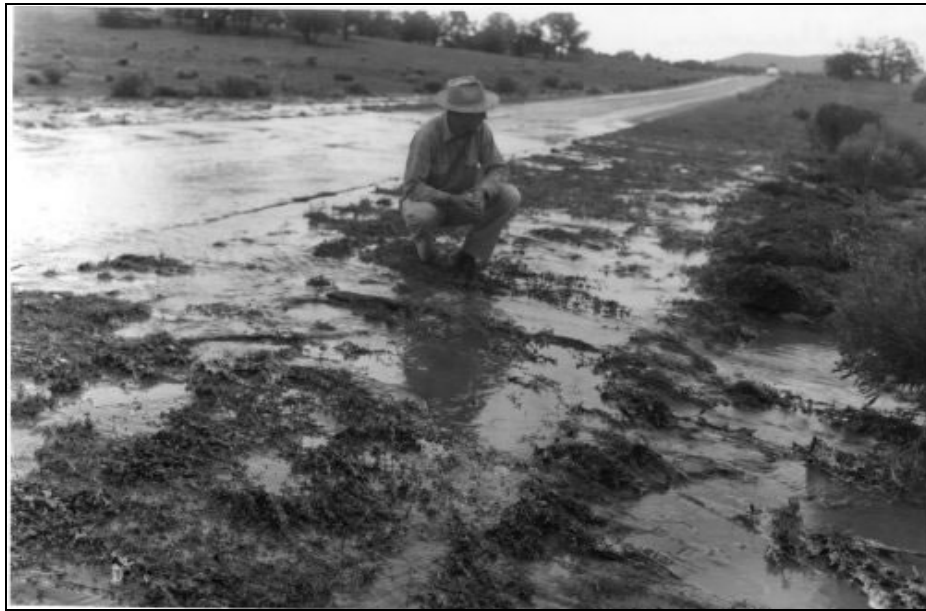
**Figure 18.** Historic photograph depicting land use in the upper Rio Chama watershed from the Carson National Forest (<http://www.fs.fed.us/r3/about/history/carson/>). ““Rain digging gullies and carrying away soil. The heavy, silt-laden water runs off during a heavy rain on nearly barren slopes.” Photo by D. O. Todd; FS #482982; 1957.

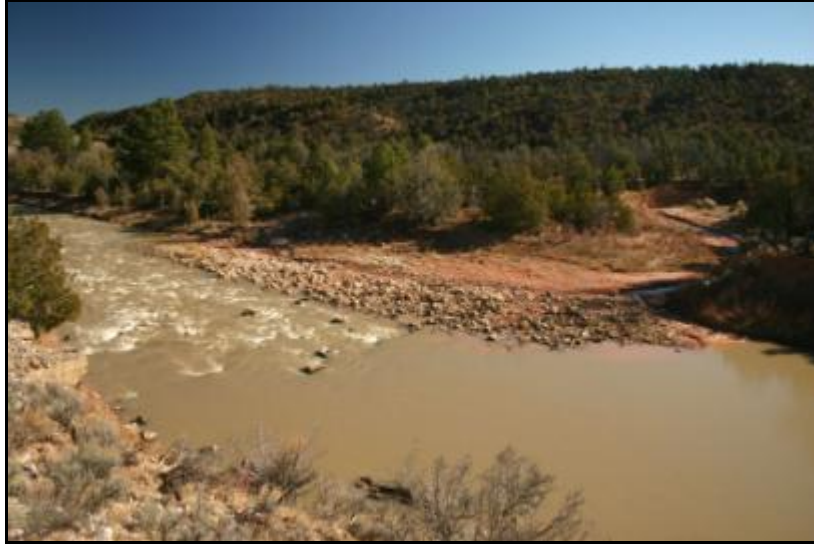
**Figure 4.** Tributary fan and rapid formed at the mouth of Canada del Presa. Flow is from right to left. The fan comprises newly deposited sand and small gravels (2007) over debris-flow cobbles and boulders. The deposit creates an area of deeper, low-velocity flow upstream, and steeper, shallower flow downstream.

At each tributary site along the study reach, however, the fluctuations in bed-sediment sizes are more complicated than the grouped data suggest (Figure 4, Table 2). Compared to the sediment at all the cross-sections classified as *intermediate*, fans with significantly larger bed sediment occurred at 18 of the 26 tributary junctions, but clast sizes at *Gallinas*, *Boat Access*, *Hill*, and *Cottonwood Arroyos* were significantly smaller. The modified Rice and Church (1998) sediment link analysis found 33 cross-sections that could be classified as supply points (Figure 4). Of these 33 cross-sections, 27 are directly related to tributary fans at 19 of the 26 confluences (73%). Four additional significant points of sediment supply were identified where eroding banks included gravel deposits instead of primarily sand (i.e.,
