# Water Resources Assessment of the Rito Peñas Negras

## **Final Report**

**Water Resources Program  
University of New Mexico  
Albuquerque, NM 87131**

**September 2011**

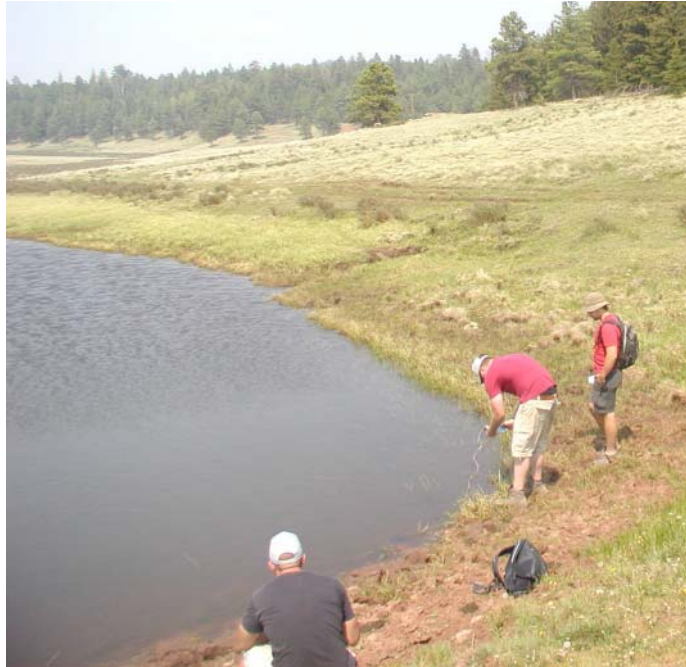
Figure 20 plots the  $\delta^{18}\text{O}$  and  $\delta\text{D}$  ratios that were measured along the Rito Peñas Negras. The data show a consistent increase in the ratio of heavier waters that is slightly greater than but very similar to the increase in electrical conductivity (Figure 17). The highest values were obtained for samples taken at a pond at the headwaters. Water samples from this pond were taken from the water surface right at the shoreline in the late afternoon (Figure 21) and it is believed that this result is due to concentration of the heavy water by evaporation.

Figure 21. Photograph of pond at the headwaters of the Rito Peñas Negras showing students measuring water quality parameters and collecting water samples for laboratory analysis.

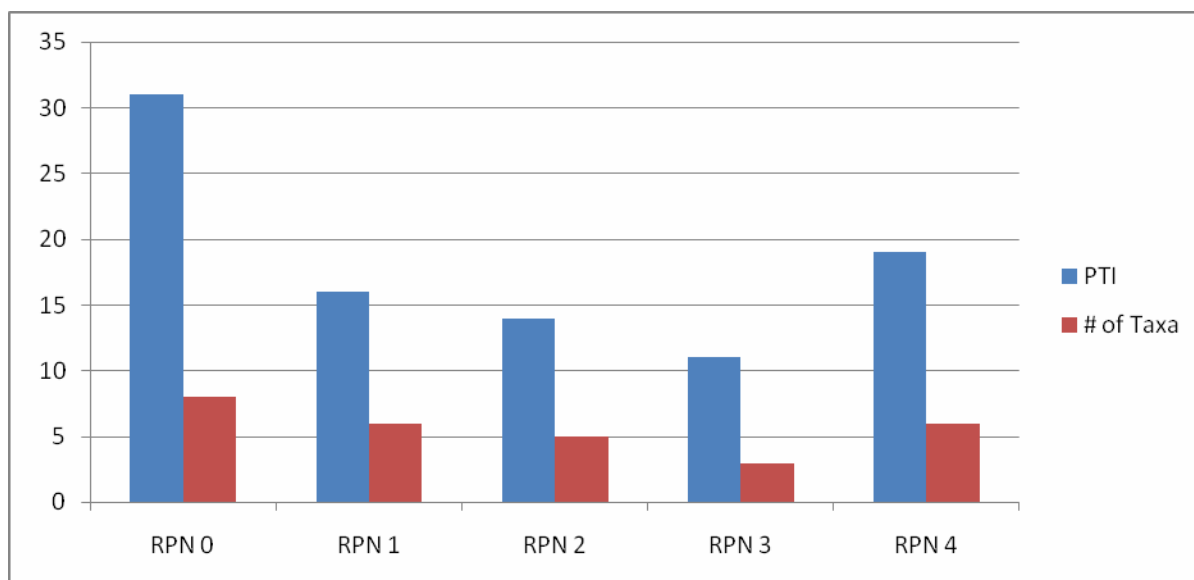
The benthic macroinvertebrate data were used to calculate a pollution tolerance index (PTI) at each site (INDNR, 2011). The PTI ratings for the Rito Peñas Negras range from Fair to Excellent (Figure 22). The excellent rating was observed downstream of the new exclosures in the lower reaches of the stream. The fair ratings were collected from the three middle sample locations and a good index reading was recorded approximately a quarter mile downstream from the head waters. Because all of the other water quality parameters and descriptive characteristics were similar, it is believed that the lower PTI values in the middle reaches of the stream were due primarily to the low gradient and therefore lower velocities of the stream rather than the presence of any stressors. The stream at sites RPN1 through RPN2 had low velocities, less exposed gravel, and more silt than in the steeper reaches. These factors resulted in lower biological diversity.

Figure 22. Pollution Tolerance Index (PTI) based on the population of benthic macroinvertebrates.
