Justification for Class III Permit Modification March 2005, DSS Site 1029, Operable Unit 1295 Building 6584 North Septic System at Technical Area III

Sandia National Laboratories/NM

Drain and Septic Systems (DSS) Area of Concern (AOC) Sites 1006, 1007, 1010, 1015 1020, 1024, 1028, 1029, 1083, 1086, 1108, and 1110

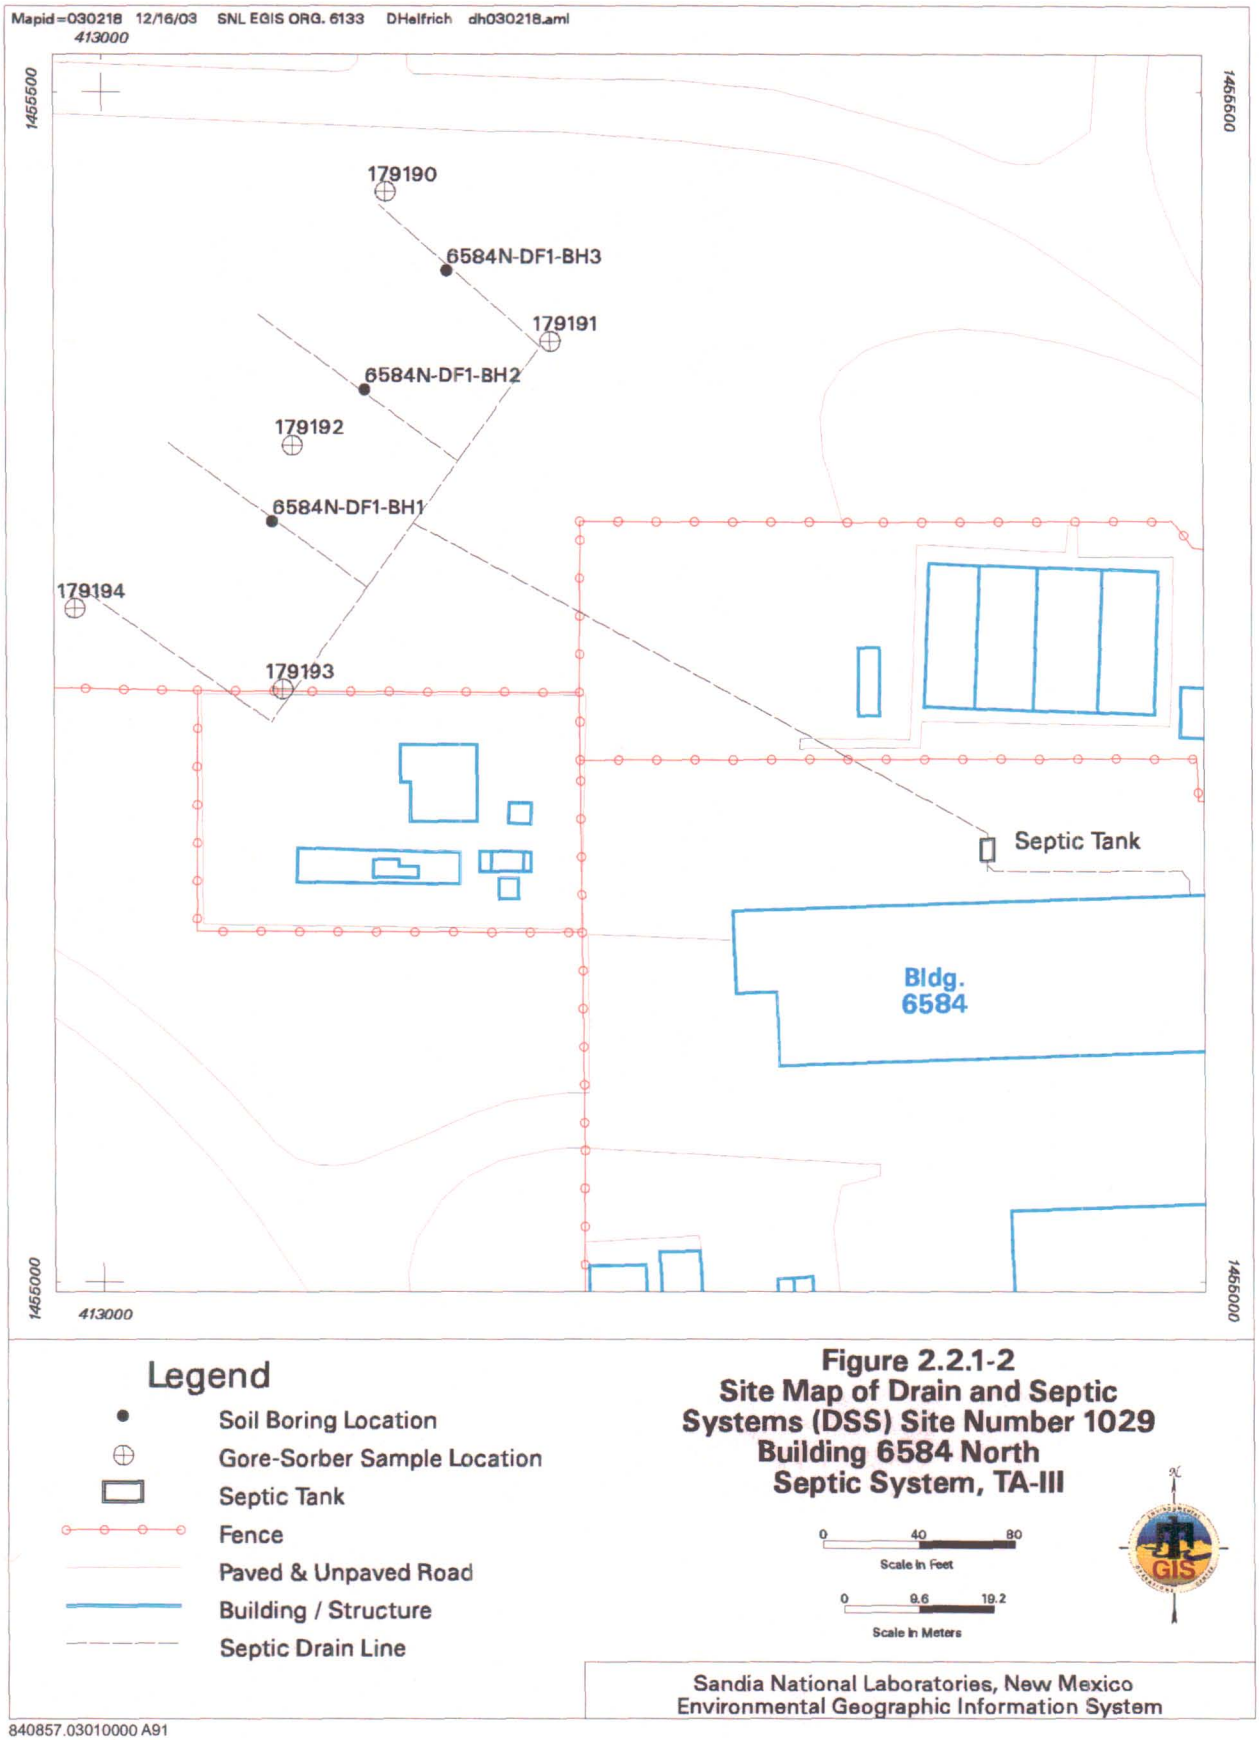
Figure 2.2.1-2
Site Map of Drain and Septic Systems (DSS) Site Number 1029
Building 6584 North Septic System, TA-III

On May 30, 1997, a backhoe was used to determine the location, dimensions, and average depth of the DSS Site 1029 drainfield system. The drainfield was found to consist of four parallel drain lines, arranged as shown on Figure 2.2.1-2, with an average drain line depth of approximately 3 feet bgs. No visible evidence of stained or discolored soil or odors indicating

residual contamination was observed during the excavation. No samples were collected during the backhoe excavation at the site.

SVOC analytical results for the five soil samples and one duplicate collected from the drainfield boreholes are summarized in Table 3.4.2-3. MDLs for the SVOC soil analyses are presented in Table 3.4.2-4. Twelve SVOCs were detected in the duplicate sample collected at 5 feet bgs in borehole BH2 (Figure 2.2.1-2), and no SVOCs were detected in the primary sample from this interval, or in any other SVOC sample collected at this site. The 12 SVOCs appear to be common components of asphalt (NPS July 1997), and probably indicate the presence of asphalt material in the duplicate sample. The area of the DSS Site 1029 drainfield is undeveloped and is easily accessed by vehicles. Small amounts of construction debris were also noted at the site during the sampling, and it is possible that asphalt fragments could have been incorporated into the sample while it was being collected. The absence of SVOCs in the other samples collected at this site suggests an isolated SVOC source (e.g., asphalt), rather than any kind of significant or widespread SVOC contamination at the site.
