STABILIZATION PROCESSES OF EXISTING ADOBE STRUCTURES

BY
DOUGLAS L. GALLAGHER
B.F.A., University of New Mexico, 1972

THESIS

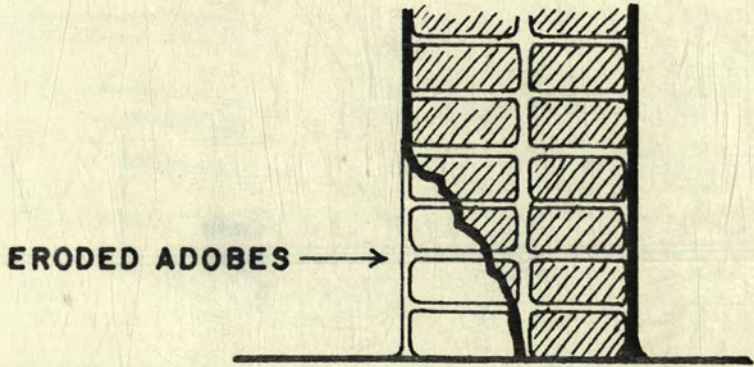
Visible Problem	Possible Cause	Explanation
<p>COVING ACTION</p>

<p>ERODED ADOBES →</p>	<ul style="list-style-type: none"> Started by spalling but intensified by capillary action and the redistribution of soluble salts through moisture evaporation. Splashback of water from rain or run-off on the ground which erodes the adobe. 	<ul style="list-style-type: none"> See Pages 9, 13, 24
<p>SLUMPING ACTION</p>

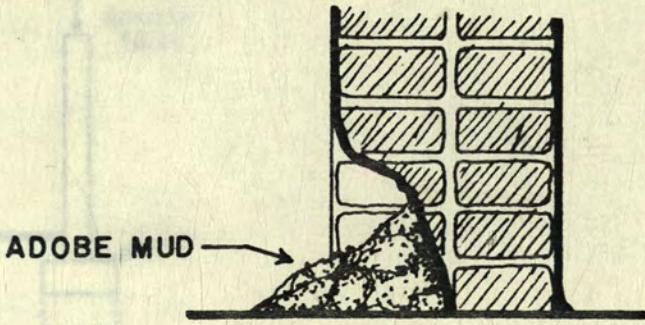
<p>ADOBE MUD →</p>	<ul style="list-style-type: none"> Intense capillary action plus addition moisture weakens adobe masonry till it becomes mud and collapses. 	<ul style="list-style-type: none"> See Pages 27
<p>FOUNDATION SETTLEMENT</p>

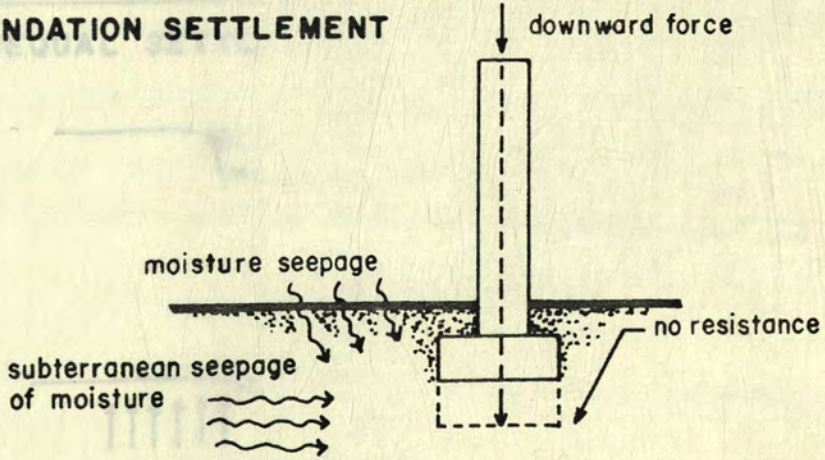
<p>downward force</p> <p>moisture seepage</p> <p>subterranean seepage of moisture</p> <p>no resistance</p>	<ul style="list-style-type: none"> Lack of sufficient foundation for support. Moisture seepage has weakened the soil under the foundation. 	<ul style="list-style-type: none"> See Pages 32-35

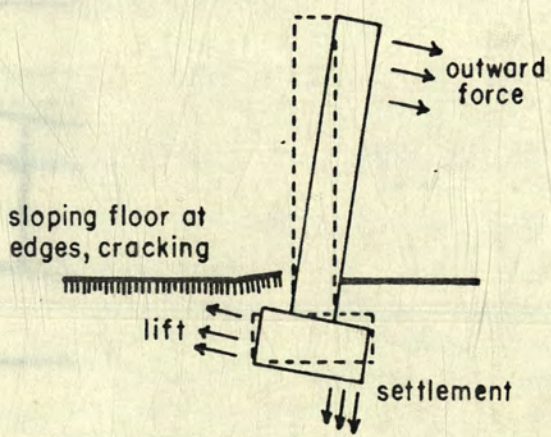
Visible Problem	Possible Cause	Explanation
<p>LEANING OF WALL</p>

<ul style="list-style-type: none"> Irregular settlement coupled with outward force of structure's weight. Outward force of structure's weight but there is no structural settlement. 	<ul style="list-style-type: none"> See Pages 32-39
<p>EQUAL SETTLEMENT</p>

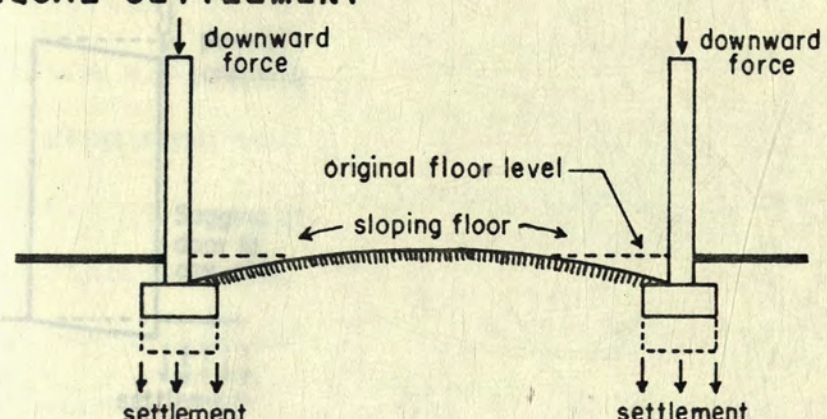
<ul style="list-style-type: none"> Settlement of both foundations from moisture seepage. As the foundations settle, the edges of the floor may also settle. 	<ul style="list-style-type: none"> See Pages 30-39
<p>UNEQUAL SETTLEMENT</p>

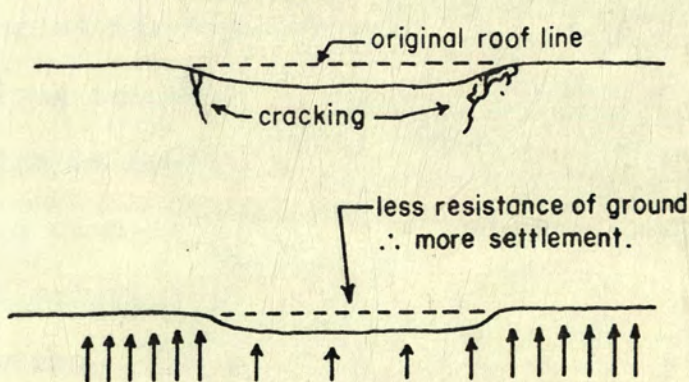
<ul style="list-style-type: none"> Weakening of soil under one portion causing that portion to settle and the remaining portions stable. 	<ul style="list-style-type: none"> See Pages 30-39

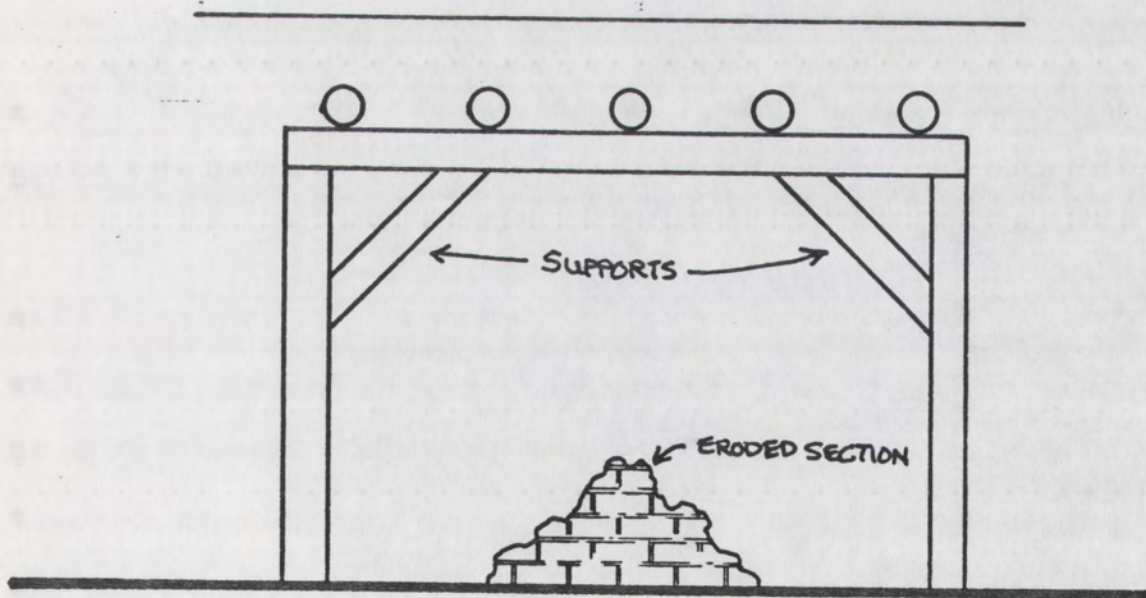
Figure 2-8. Relieve Load Above Section

The first step is to relieve or transfer the pressure away from the weakened area. This can be accomplished by the use of supports and bracings (Reference Figure 2-8). After this has been accomplished, then the removal of damaged bricks and basic preparation of the section for rebuilding may begin. In most cases, the removal of damaged bricks involves cutting
