# Water resources assessment of the Cimarron River and evaluation of water quality characteristics at the Maxwell National Wildlife Refuge

**Water Resources Assessment of the Cimarron River  
and  
Evaluation of Water Quality Characteristics at the  
Maxwell National Wildlife Refuge**

**Final Report**

**Water Resources Program  
University of New Mexico  
Albuquerque, NM 87131**

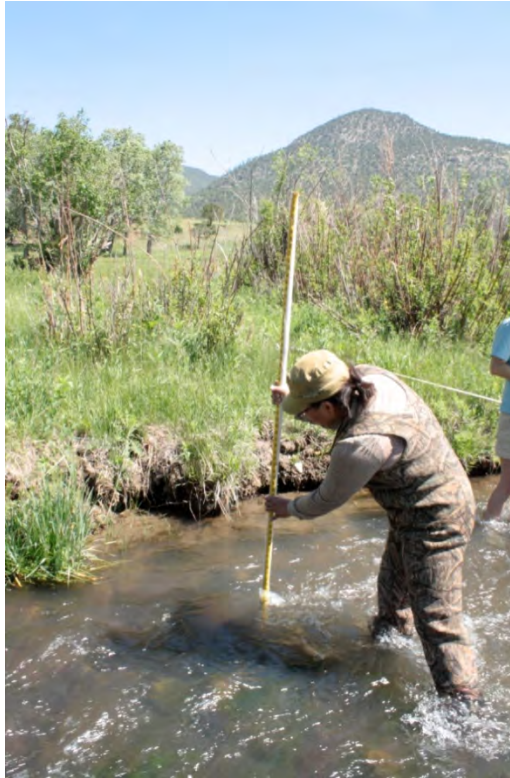
Figure 11. Measurement of thalweg depth at EMAP site number 2, Cimarroncita Ranch

- The thalweg depth (the deepest point in the stream's cross section) was measured every ten feet for entire reach of stream assessed (400 ft at all sites except Rayado Creek at the Philmont Ranch which was 200 ft in length) centered on the baseline transect using a surveyor's rod (Figure 11).
