Justification for Class III Permit Modification March 2005 DSS Site 1024 Operable Unit 1295 MO 242-245 Septic System at Technical Area III

Sandia National Laboratories/NM

Drain and Septic Systems (DSS) Area of Concern (AOC) Sites 1006, 1007, 1010, 1015 1020, 1024, 1028, 1029, 1083, 1086, 1108, and 1110

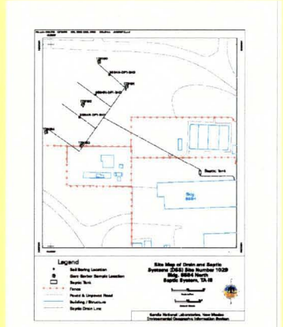
Collecting soil samples with the Geoprobe.

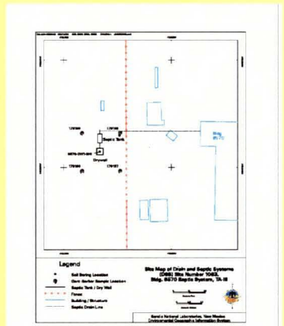
Subsurface soil recovered for analyses.

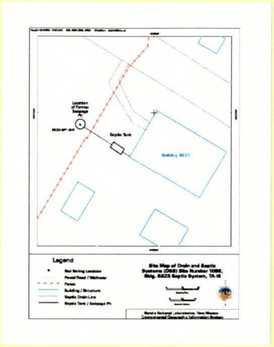
Seepage pit demolition and backfilling.
