# Justification for Class III Permit Modification April 2000 Solid Waste Management Unit 144 Operable Unit 1295 Round 7

**PROPOSAL FOR  
RISK-BASED NO FURTHER ACTION  
ENVIRONMENTAL RESTORATION SITE 144  
BUILDING 9980 SEPTIC SYSTEM  
OPERABLE UNIT 1295  
May 1997**

Prepared by  
Sandia National Laboratories/New Mexico  
Environmental Restoration Project  
Albuquerque, New Mexico

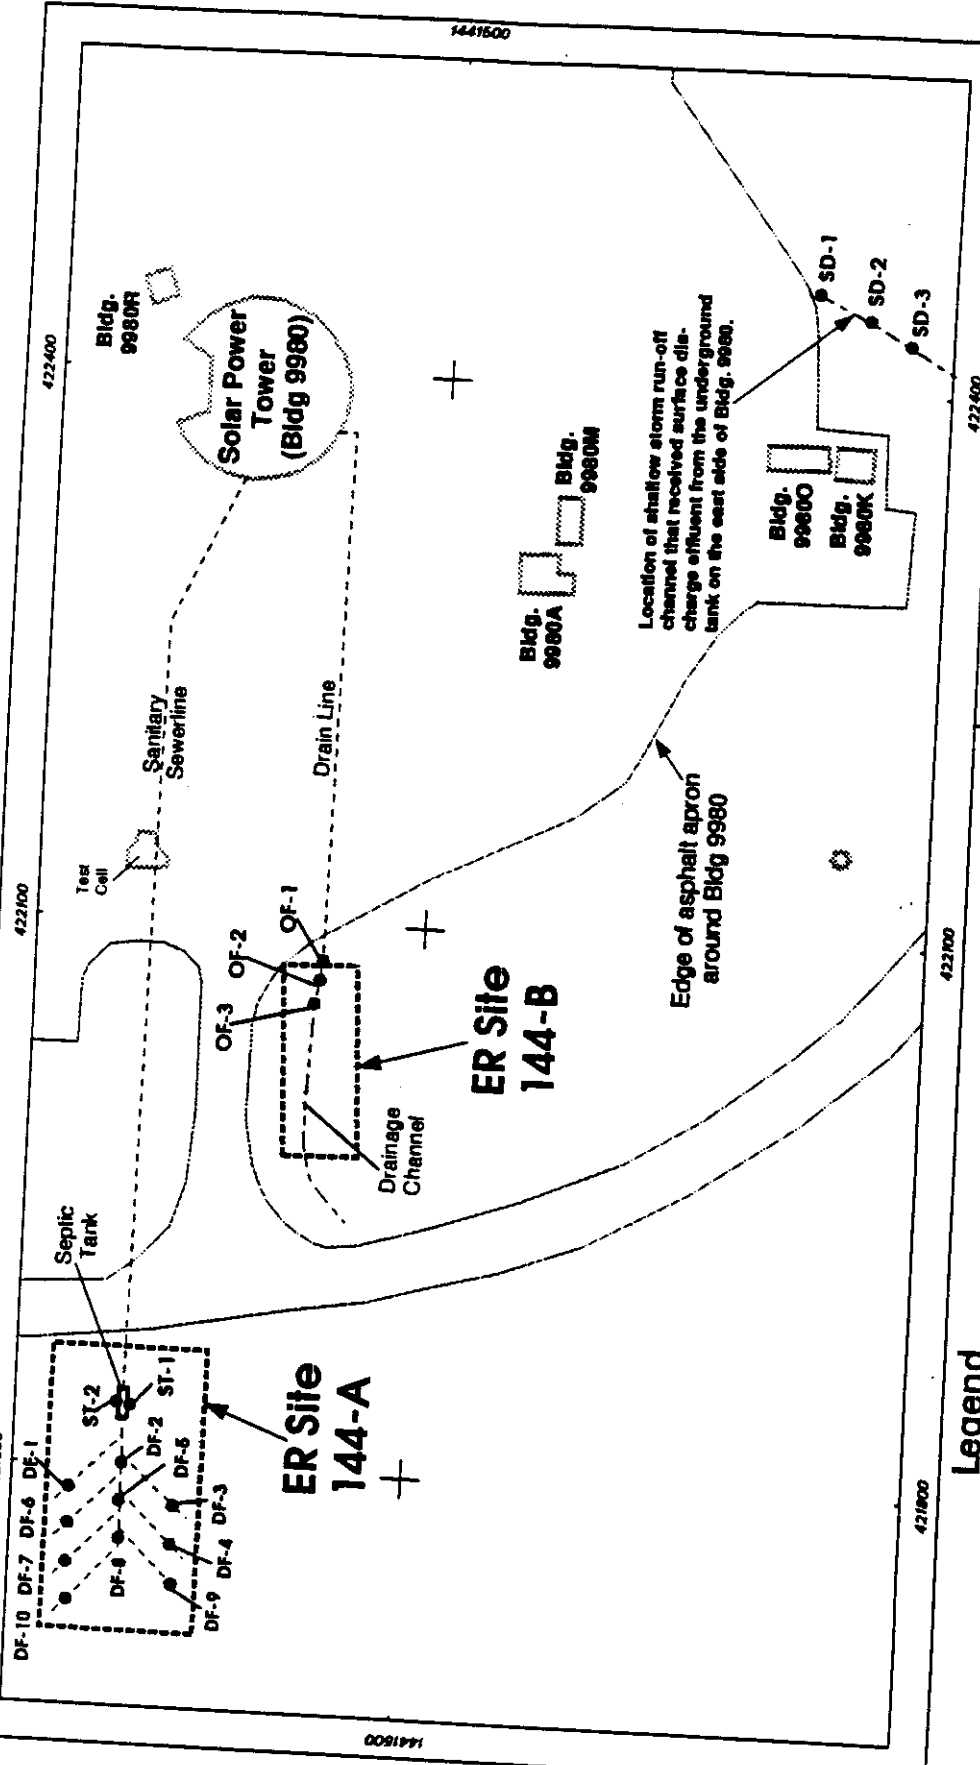
- Boring Location
- Drainage Channel
- KAFB Roads
- Septic Tank
- Sanitary Sewerline, Drainfield, Drain line
- ▭ Buildings
- ▭ ER Site 144
- Storm Channel

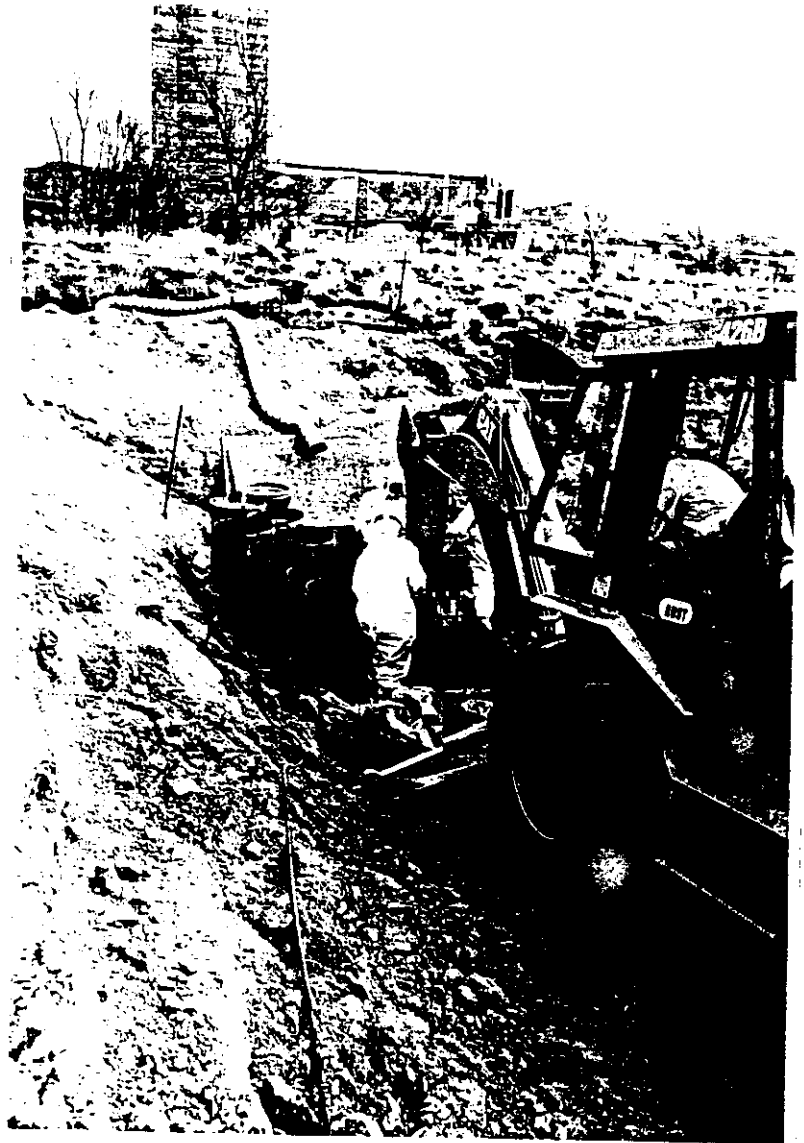
Figure 3-1  
ER Site 144 Photographs

Above: Photo showing the Building 9980 (Solar Power Tower) surface outfall location (below the cutoff tree on the right side of the tower), and the drainage channel where the surface outfall soil samples were collected in November 1994. View looking east.

Below: Building 9980 septic tank septage removal and tank cleaning operation. October 24, 1995  
View looking east.

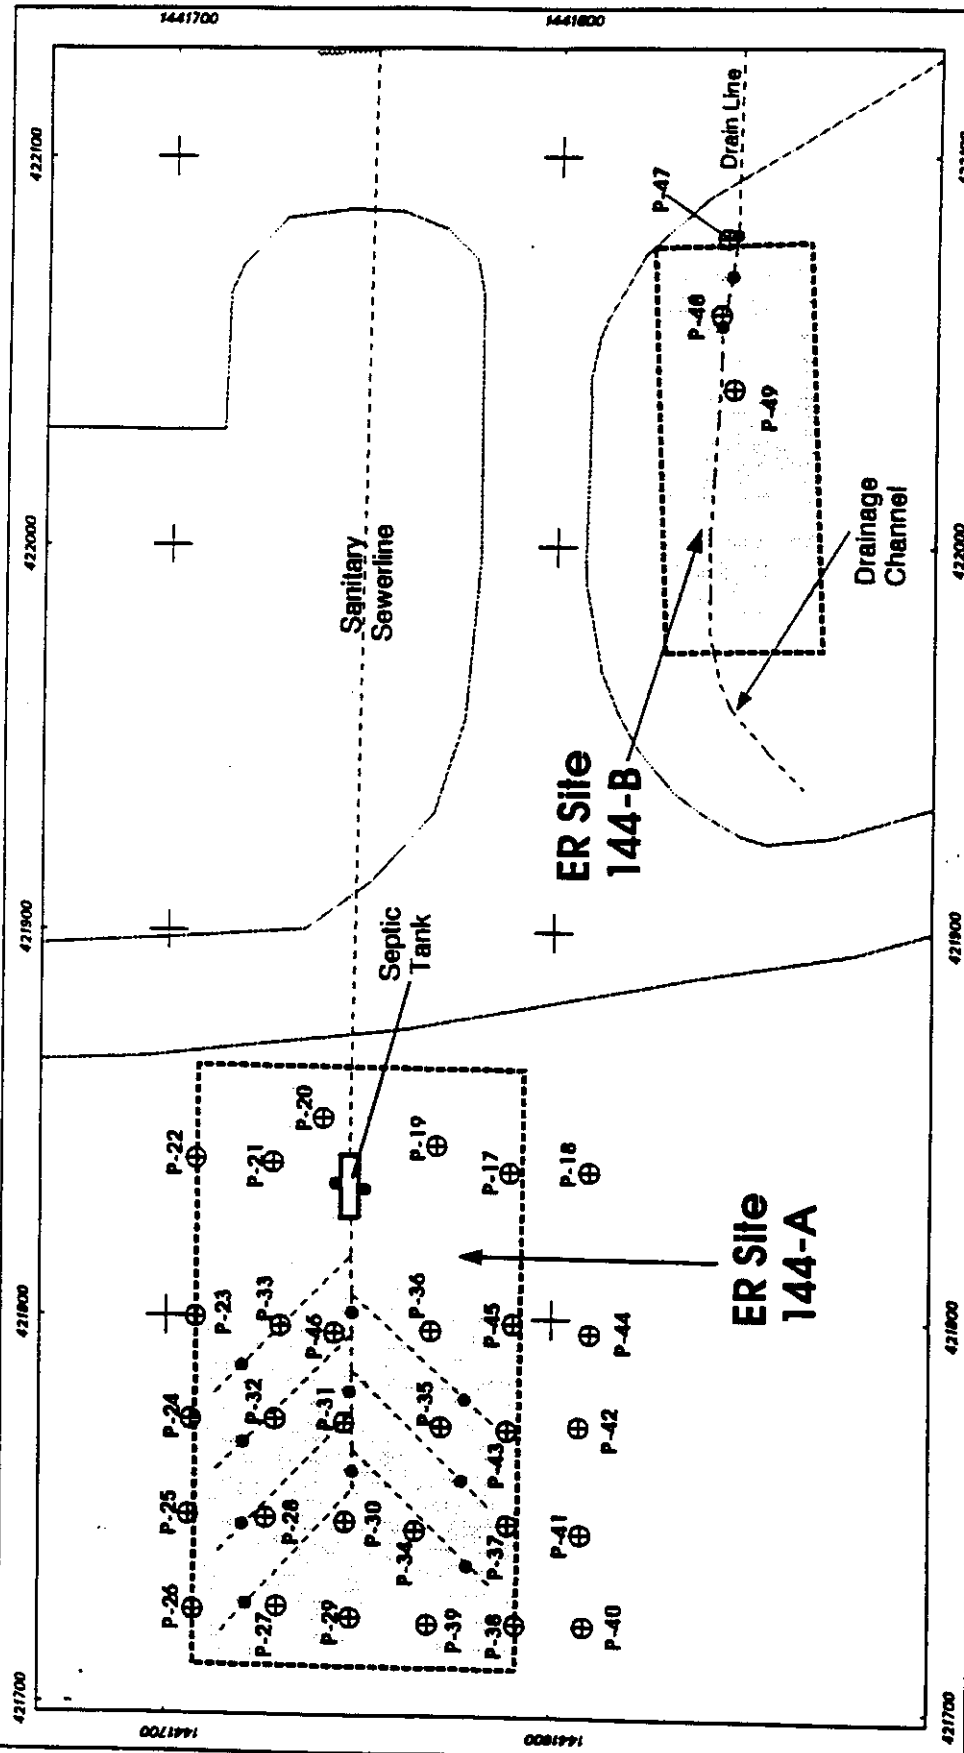
- ⊕ PETREX™ Sampling Location
- Boring Location
- - - Drainage Channel
- KAFB Roads
- · - · - Sanitary Sewerline, Drainfield, Drain line
- Septic Tank
- ..... Buildings
- [ ] ER Site 144

provided information in the vicinity of the possible leachate plume identified in the geophysical survey. One of the samplers (P-23) was broken in transit to the laboratory and was therefore not analyzed (NERI July 1994). Three samplers (numbers P-47 through P-49) were also placed in the short drainage channel that received discharge from the Building 9980 surface outfall (SNL/NM May 1994b). One was placed at the discharge point and the two others were located about 20 feet and 40 feet downgradient from the discharge point of the surface outfall. All of the PETREX™ samplers placed at this site were analyzed for two individual constituents (PCE and TCE) and two groups of compounds (BTEX and aliphatic compounds); significant contaminant concentrations were not detected in soil gas at any of the 32 PETREX™ sampling locations at this site.

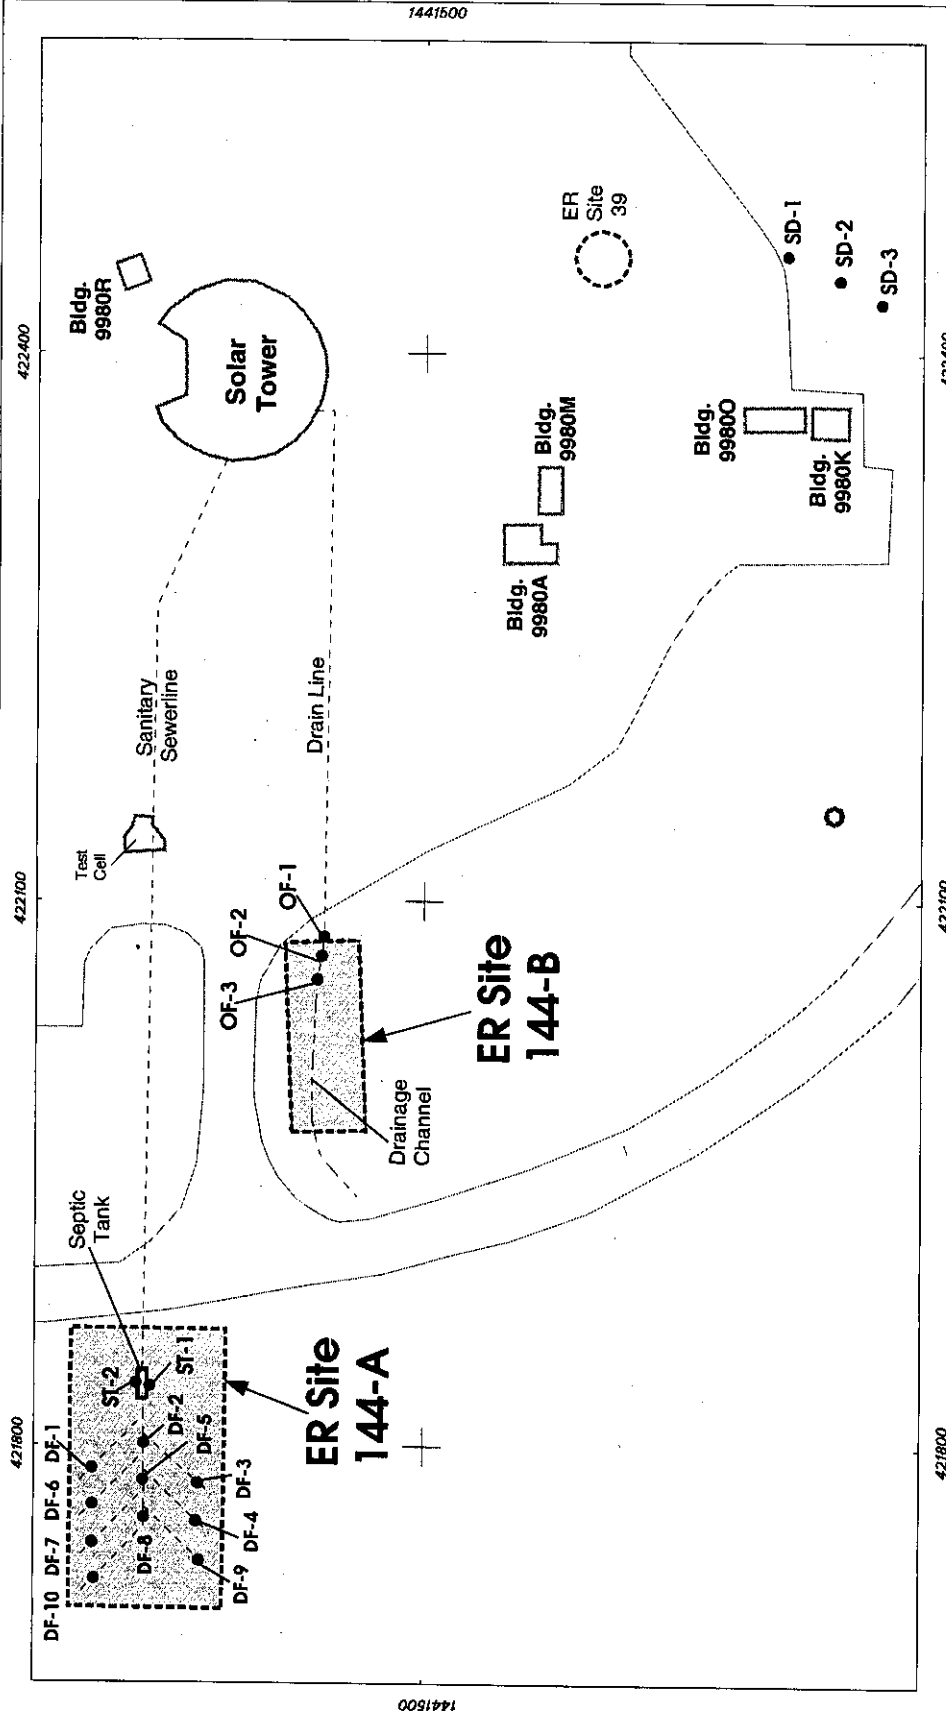
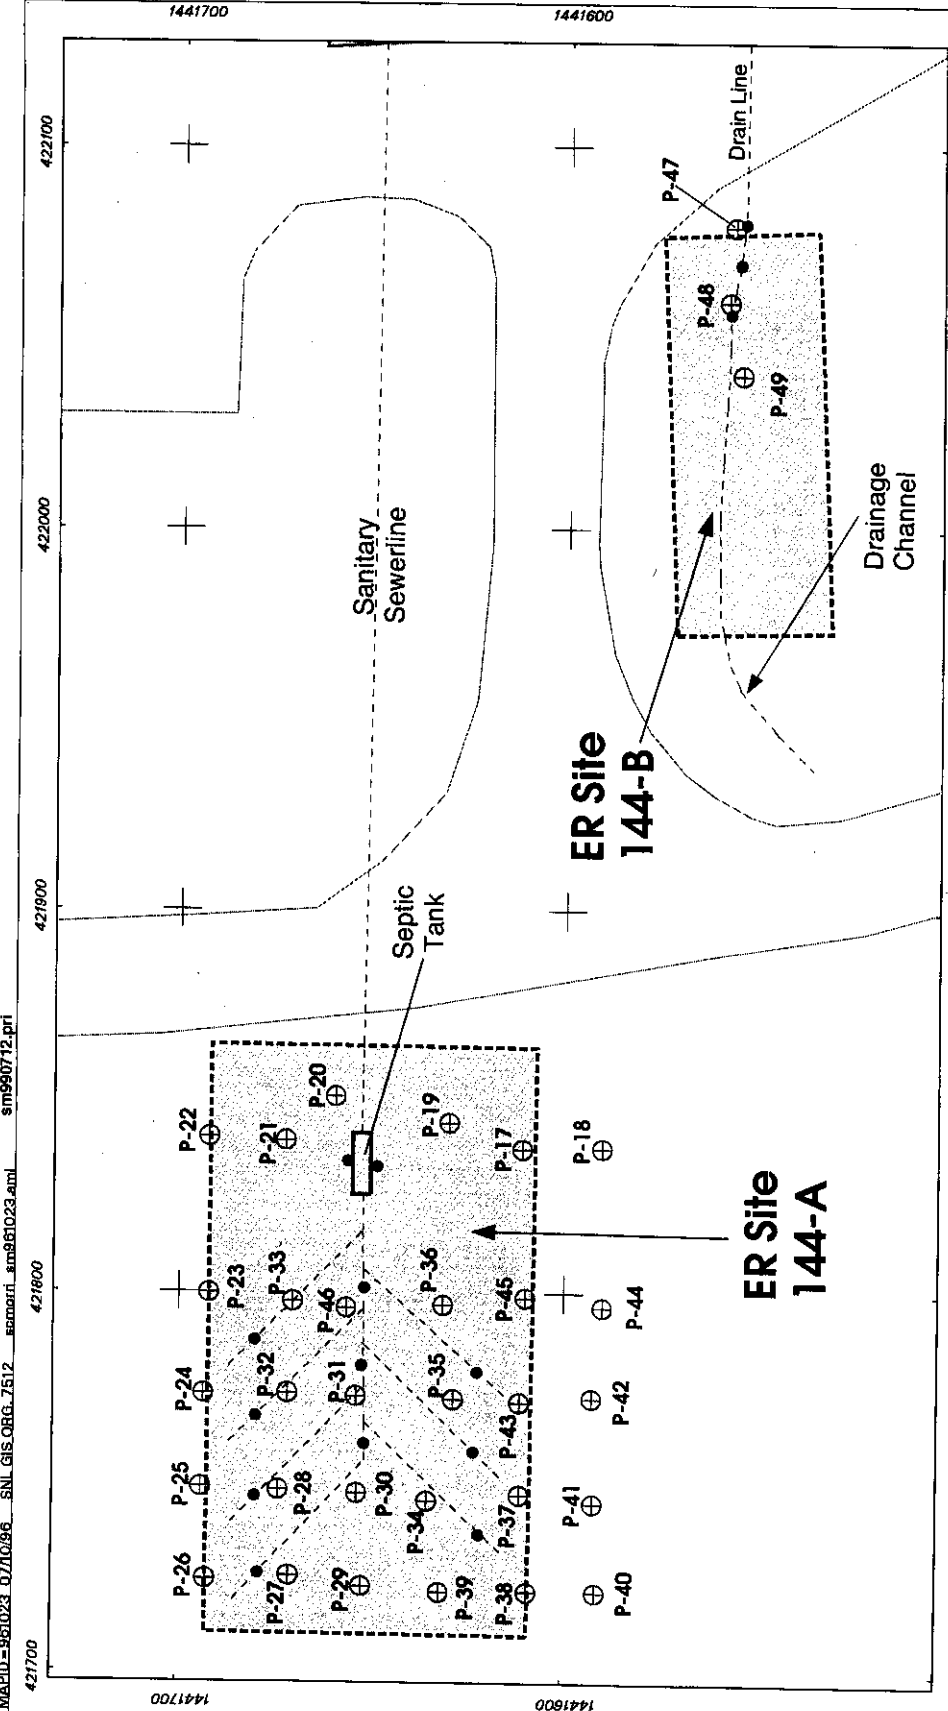
**REVISED FIGURES 1-2 AND PETREX (APPENDIX A.3) SAMPLE LOCATIONS**

- Boring Location
- Drainage Channel
- KAFB Roads
- Septic Tank
- Sanitary Sewerline, Drainfield, Drain line
- ▭ Buildings
- ▭ ER Site 144

- ⊕ PETREX™ Sampling Location
- Boring Location
- - - Drainage Channel
- KAFB Roads
- - - Sanitary Sewerline, Drainfield, Drain line
- ▭ Septic Tank
- ▭ Buildings
- ▭ ER Site 144
