Chemical Waste Landfill Annual Post-Closure Care Report Calendar Year 2011

Sandia National Laboratories/NM

**CHEMICAL WASTE LANDFILL
ANNUAL POST-CLOSURE CARE REPORT
CALENDAR YEAR 2011**

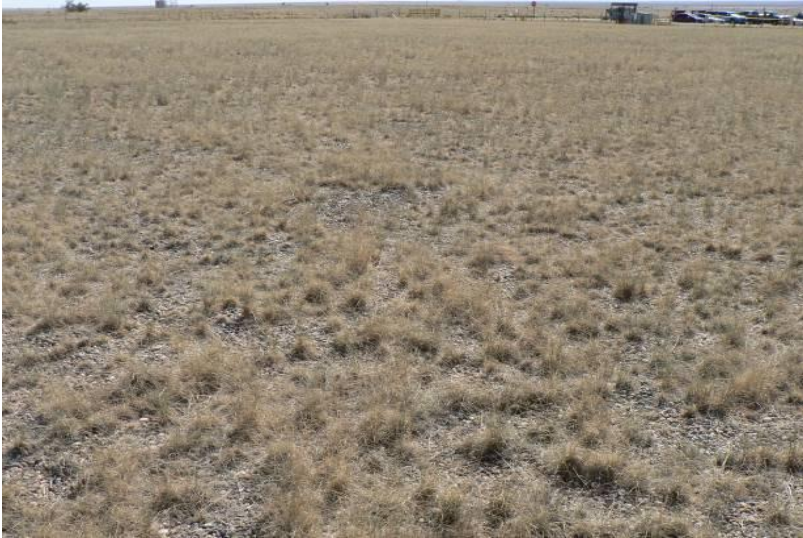
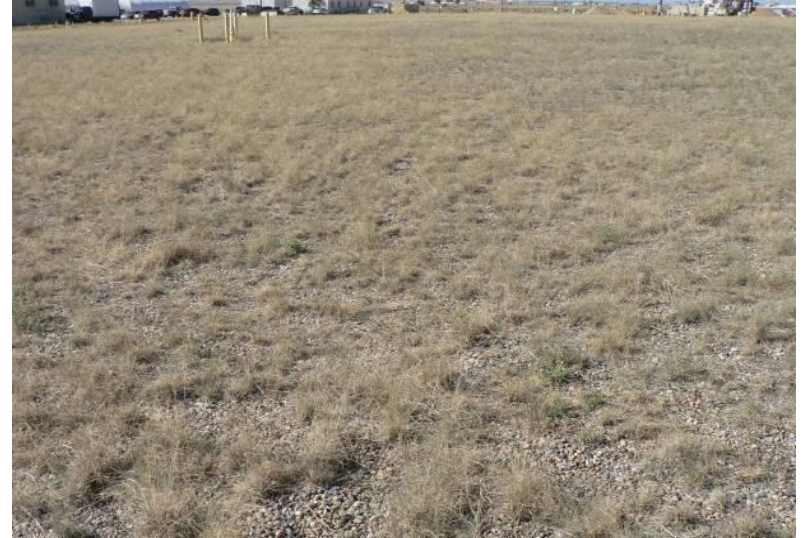
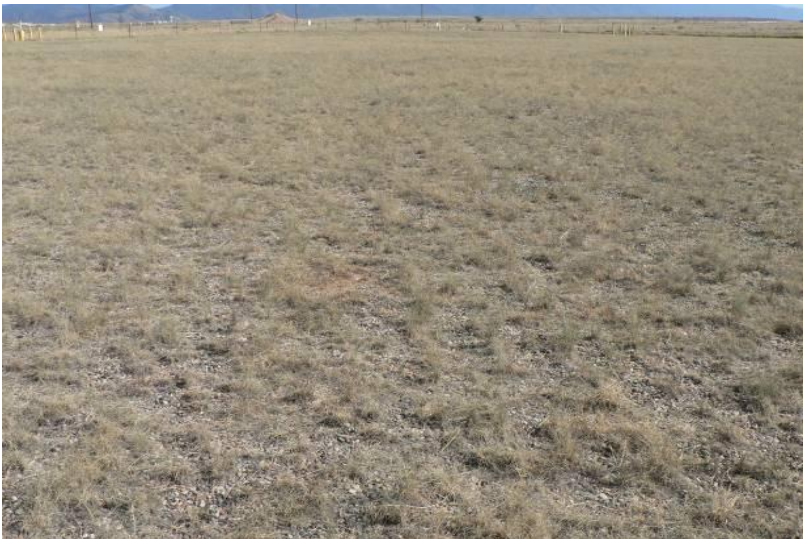
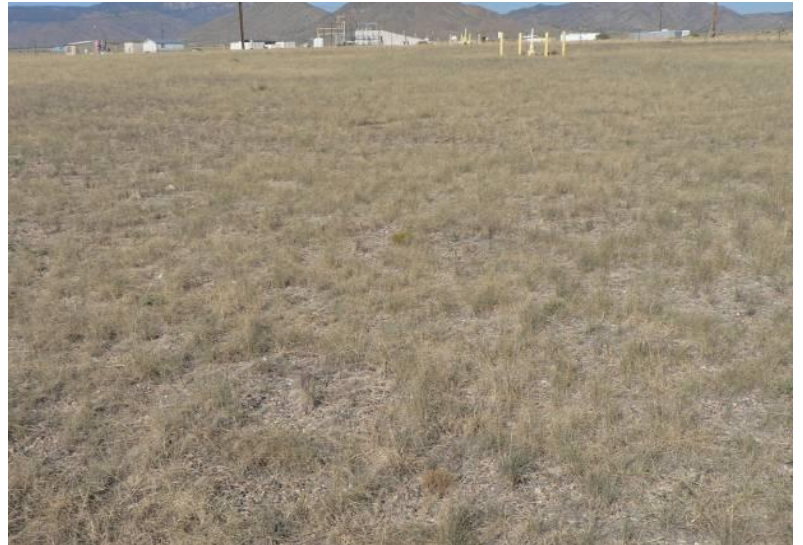
Figure 1 September 22, 2011 CWL ET Cover Photos

Southwest portion of the cover

Northwest portion of the cover

Southeast portion of the cover

Northeast portion of the cover
